# SONOMA COUNTY FIRE DISTRICT MASTER PLAN

DRAFT REPORT | NOV 19, 2024

PREPARED BY KITCHELL AND SHAH KAWASAKI ARCHITECTS

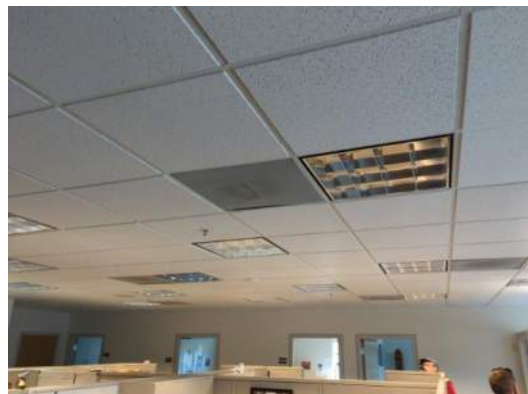
**Record ID:** 974  
**System:** C2050 - CEILING FINISHES  
**Item No.:** C2050.80.001  
**Floor/Room:** 2nd Floor / Open office  
**Priority:** Potential - Long Term (4-5 Years)  
**Quantity/Unit of Measure:** 100/SF  
**Total Deficiency Cost:** \$1,810  
**Deficiency Description:** Lay-in acoustical ceiling tile is in poor condition.

**Description of Work:** Remove existing tiles and replace with new lay-in acoustical ceiling tiles.

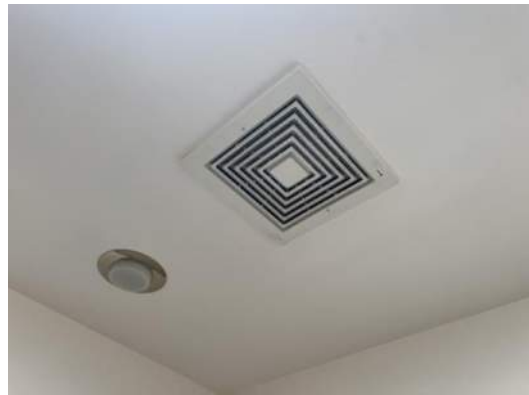
**Item No.:** D3060.30.002  
**Floor/Room:** 1st Floor / Restroom 1  
**Priority:** Potential - Long Term (4-5 Years)  
**Quantity/Unit of Measure:** 1/EA  
**Total Deficiency Cost:** \$2,680  
**Deficiency Description:** *Ceiling exhaust fan is approaching the end of its expected useful life.*

**Description of Work:** *Provide equipment replacement and installation.*

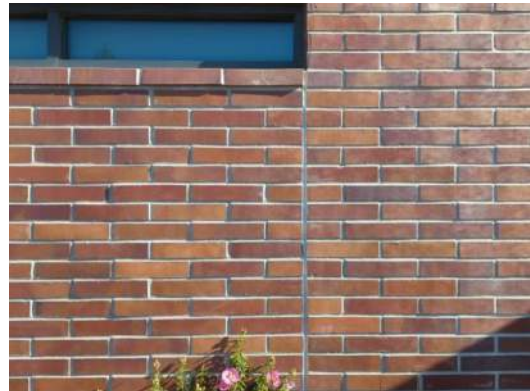
**Item No.:** B3010.90.002  
**Floor/Room:** Exterior / Exterior  
**Priority:** Impending (2-3 Years)  
**Quantity/Unit of Measure:** 14/LF  
**Total Deficiency Cost:** \$1,240  
**Deficiency Description:** Elastomeric sealant at expansion joint is failing.

**Description of Work:** Replace sealant at expansion joints.

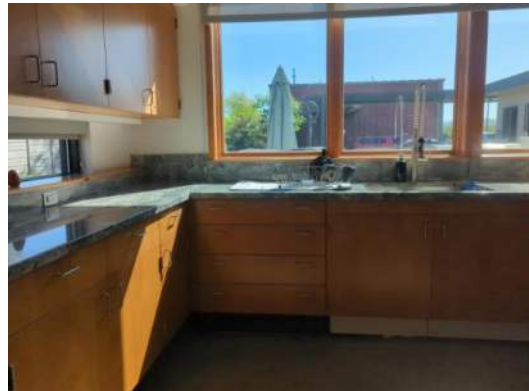
**Record ID:** 928  
**System:** B2050 - EXTERIOR DOORS AND GRILLES  
**Item No.:** B2050.90.011  
**Floor/Room:** 1st Floor / Kitchen  
**Priority:** Potential - Long Term (4-5 Years)  
**Quantity/Unit of Measure:** 20/EA  
**Total Deficiency Cost:** \$19,180  
**Deficiency Description:** *The existing casework is in need of refurbishment.*

**Description of Work:** *Repair, refurbish, and refinish the existing wood casework and counters.*

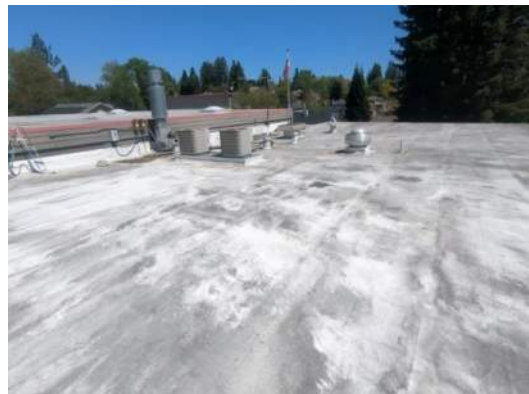
**Item No.:** B3010.50.002  
**Floor/Room:** Roof / -  
**Priority:** **Crucial (1-2 Years)**  
**Quantity/Unit of Measure:** 8,000/SF  
**Total Deficiency Cost:** \$311,770  
**Deficiency Description:** *EPDM roofing membrane is failing.*

**Description of Work:** *Remove roofing and replace with single-ply roofing.*

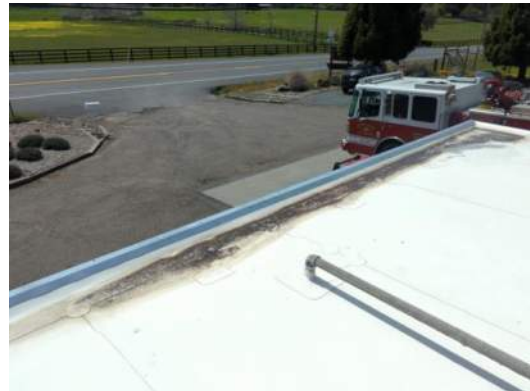
**Item No.:** D2030.30.001  
**Floor/Room:** Roof / -  
**Priority:** **Crucial (1-2 Years)**  
**Quantity/Unit of Measure:** 2/EA  
**Total Deficiency Cost:** \$6,780  
**Deficiency Description:** *Roof drains are damaged and clogged.*

**Description of Work:** *Repair or replace roof drains.*

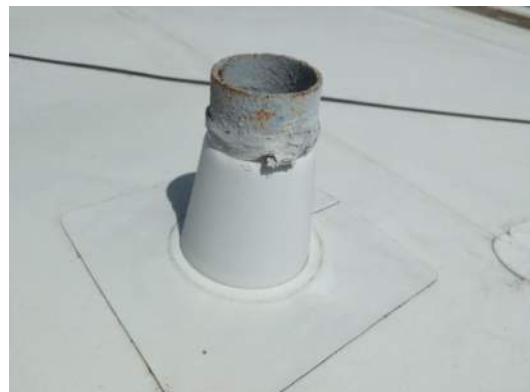
**Item No.:** B2010.50.004  
**Floor/Room:** Roof / -  
**Priority:** **Necessary - Long Term (3-4 Years)**  
**Quantity/Unit of Measure:** 5/LF  
**Total Deficiency Cost:** \$30  
**Deficiency Description:** *Elastomeric sealant at roof jack is deteriorating.*

**Description of Work:** *Remove old sealant, clean the associated joints and re-seal it with new sealant.*

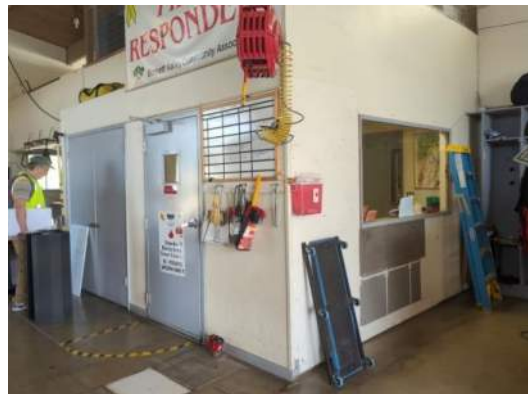
**Item No.:** C2010.70.001  
**Floor/Room:** 1st Floor / Apparatus Bay  
**Priority:** **Impending (2-3 Years)**  
**Quantity/Unit of Measure:** 200/SF  
**Total Deficiency Cost:** \$4,420  
**Deficiency Description:** *Painted gypsum wallboard is showing signs of wear.*

**Description of Work:** *Patch and paint the gypsum wallboard.*

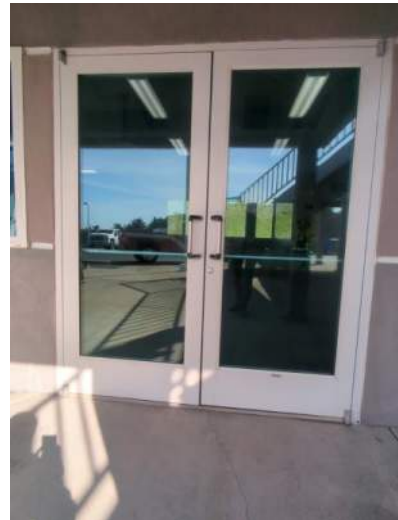
**Priority:** **Crucial (1-2 Years)**  
**Quantity/Unit of Measure:** 75/LF  
**Total Deficiency Cost:** \$6,360  
**Deficiency Description:** *Polyurethane sealant is showing signs of damage.*

**Description of Work:** *Replace sealant.*

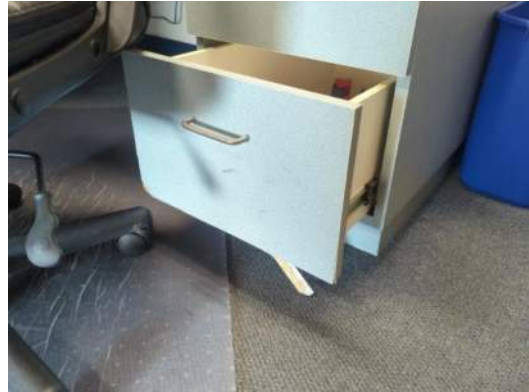
**Item No.:** E2010.30.005  
**Floor/Room:** 1st Floor / Work Room  
**Priority:** Potential - Long Term (4-5 Years)  
**Quantity/Unit of Measure:** 5/LF  
**Total Deficiency Cost:** \$3,820  
**Deficiency Description:** *The existing casework is in need of refurbishment.*

**Description of Work:** *Repair, refurbish, and refinish the existing wood casework and counters.*

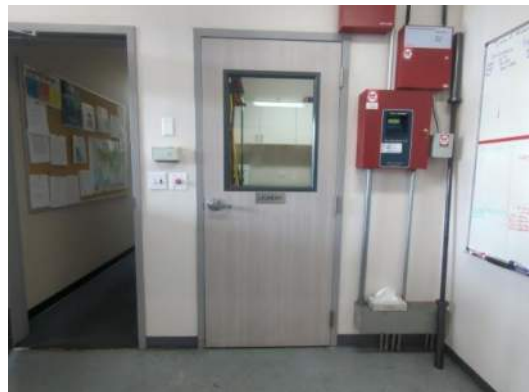
**Item No.:** C1030.90.005  
**Floor/Room:** 1st Floor / Laundry  
**Priority:** Impending (2-3 Years)  
**Quantity/Unit of Measure:** 1/EA  
**Total Deficiency Cost:** \$1,240  
**Deficiency Description:** *Interior door is sagging.*

**Description of Work:** *Replace interior door hardware.*
