# SONOMA COUNTY FIRE DISTRICT MASTER PLAN

DRAFT REPORT | NOV 19, 2024

PREPARED BY KITCHELL AND SHAH KAWASAKI ARCHITECTS

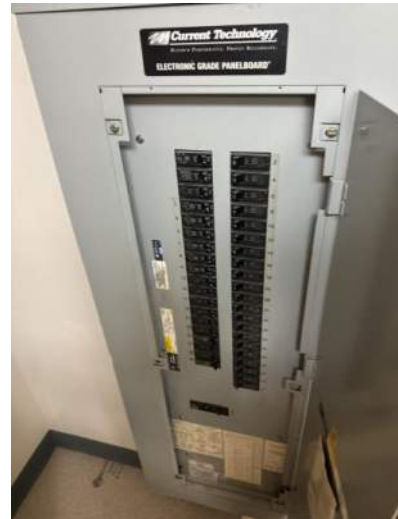
**Record ID:** 776  
**System:** D5020 - ELECTRICAL SERVICE AND DISTRIBUTION  
**Item No.:** D5020.30.1008  
**Floor/Room:** 2nd Floor / Closet  
**Priority:** Necessary - Long Term (3-4 Years)  
**Quantity/Unit of Measure:** 1/EA  
**Total Deficiency Cost:** \$21,330  
**Deficiency Description:** *The 225A (42 ckts, 120/208, 3P) panelboard is approaching the end of its expected useful life.*

**Description of Work:** *Replace the existing panelboard with a new panelboard.*

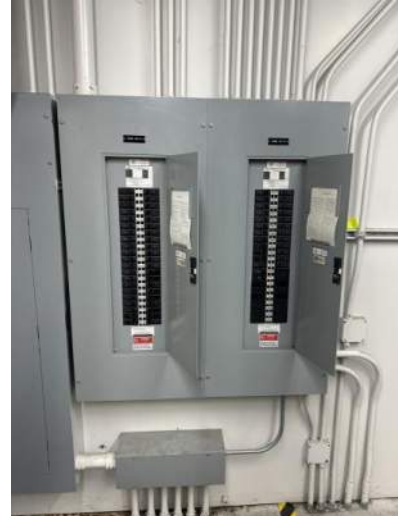
**Record ID:** 780  
**System:** D5020 - ELECTRICAL SERVICE AND DISTRIBUTION  
**Item No.:** D5020.30.1008  
**Floor/Room:** 1st Floor / Electrical  
**Priority:** Necessary - Long Term (3-4 Years)  
**Quantity/Unit of Measure:** 1/EA  
**Total Deficiency Cost:** \$21,330  
**Deficiency Description:** *The 225A (42 ckts, 120/208, 3P) panelboard is approaching the end of its expected useful life.*

**Description of Work:** *Replace the existing panelboard with a new panelboard.*

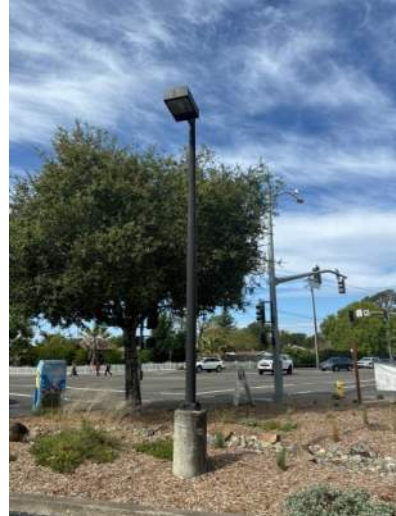
**Record ID:** 787  
**System:** D5040 - LIGHTING  
**Item No.:** D5040.50.009  
**Floor/Room:** All / Various  
**Priority:** Potential - Long Term (4-5 Years)  
**Quantity/Unit of Measure:** 17,800/SF  
**Total Deficiency Cost:** \$1,178,650  
**Deficiency Description:** Interior lighting systems are at or are approaching the end of their expected useful lives.

**Comments:** Lighting past its expected life but in but in good condition.

**Description of Work:** Replace the existing interior lighting systems and associated wiring devices, switches and controls.

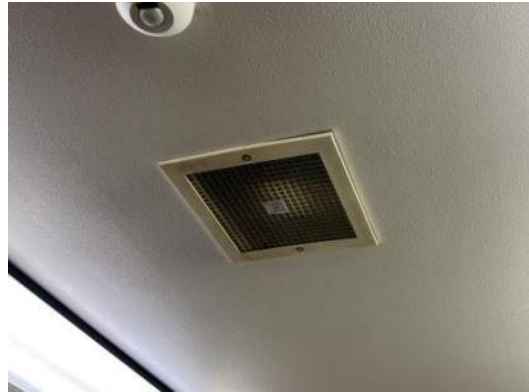
**Item No.:** D3060.30.002  
**Floor/Room:** 1st Floor / Air and Hose  
**Priority:** **Impending (2-3 Years)**  
**Quantity/Unit of Measure:** 1/EA  
**Total Deficiency Cost:** \$2,470  
**Deficiency Description:** *Ceiling exhaust fan is approaching the end of its expected useful life.*

**Description of Work:** *Provide equipment replacement and installation.*

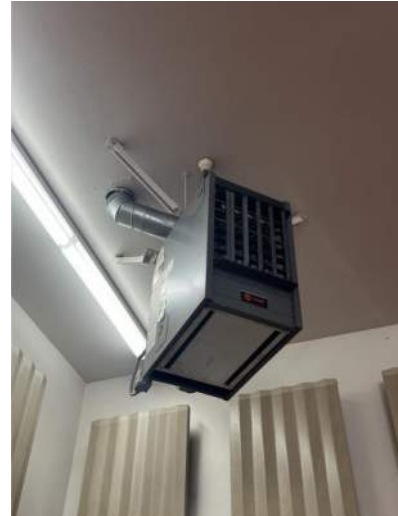
**Item No.:** D3020.70.003  
**Floor/Room:** 1st Floor / Apparatus  
**Priority:** **Planned - Long Term (6-10 Years)**  
**Quantity/Unit of Measure:** 1/EA  
**Total Deficiency Cost:** \$14,800  
**Deficiency Description:** *Gas fired unit heater is approaching the end of its expected useful life.*

**Description of Work:** *Provide equipment replacement and installation.*

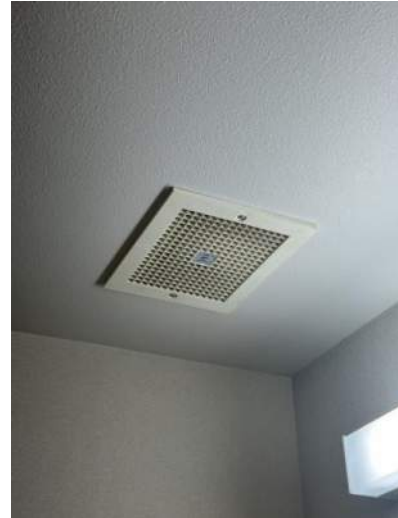
**Item No.:** D3060.30.002  
**Floor/Room:** 2nd Floor / Bath 2  
**Priority:** **Impending (2-3 Years)**  
**Quantity/Unit of Measure:** 1/EA  
**Total Deficiency Cost:** \$2,470  
**Deficiency Description:** *Ceiling exhaust fan is approaching the end of its expected useful life.*

**Description of Work:** *Provide equipment replacement and installation.*

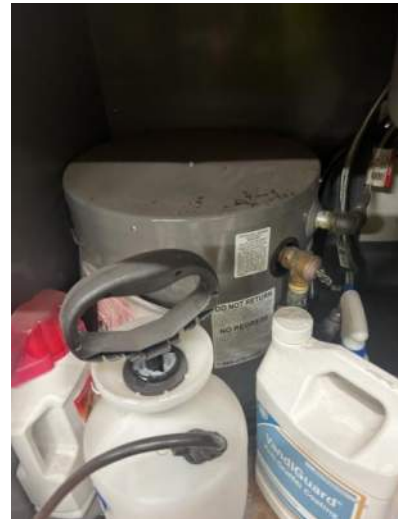
**Item No.:** D2010.20.020  
**Floor/Room:** 1st Floor / Tools  
**Priority:** **Planned - Long Term (6-10 Years)**  
**Quantity/Unit of Measure:** 1/EA  
**Total Deficiency Cost:** \$4,110  
**Deficiency Description:** *Electric water heater is approaching the end of its expected useful life.*

**Description of Work:** *Provide equipment replacement and installation.*

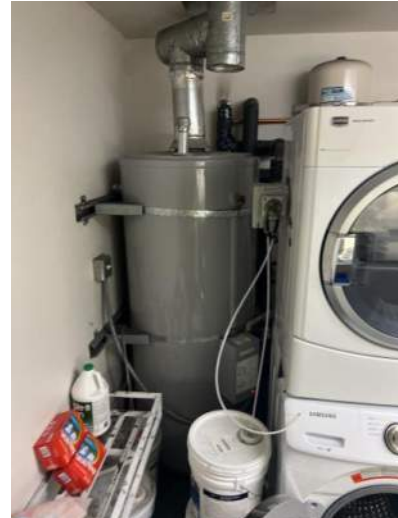
**Item No.:** D2010.20.003  
**Floor/Room:** 1st Floor / Laundry  
**Priority:** **Planned - Long Term (6-10 Years)**  
**Quantity/Unit of Measure:** 1/EA  
**Total Deficiency Cost:** \$30,830  
**Deficiency Description:** *Gas fired water heater is approaching the end of its expected useful life.*

**Description of Work:** *Provide equipment replacement and installation.*

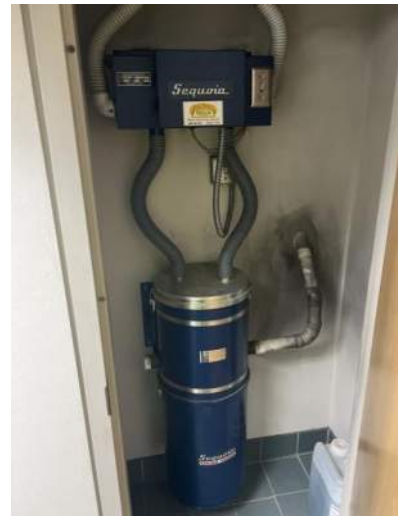
**Item No.:** E1030.40.001  
**Floor/Room:** 1st Floor / Laundry  
**Priority:** **Planned - Long Term (6-10 Years)**  
**Quantity/Unit of Measure:** 1/EA  
**Total Deficiency Cost:** \$129,450  
**Deficiency Description:** *Central vacuum system is approaching the end of its expected useful life.*

**Description of Work:** *Provide equipment replacement and installation.*

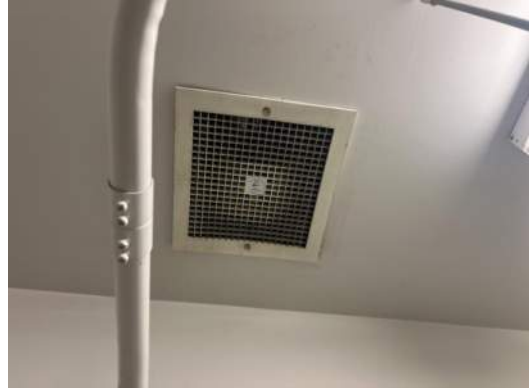
**Item No.:** D3060.30.002  
**Floor/Room:** 1st Floor / Electrical  
**Priority:** **Impending (2-3 Years)**  
**Quantity/Unit of Measure:** 1/EA  
**Total Deficiency Cost:** \$2,470  
**Deficiency Description:** *Ceiling exhaust fan is approaching the end of its expected useful life.*

**Description of Work:** *Provide equipment replacement and installation.*

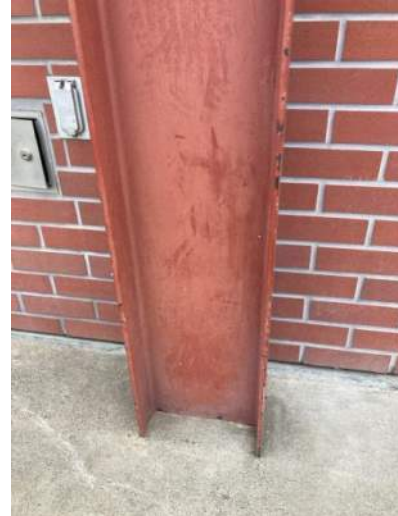
**Item No.:** B1010.20.007  
**Floor/Room:** Site / -  
**Priority:** Potential - Long Term (4-5 Years)  
**Quantity/Unit of Measure:** 200/SF  
**Total Deficiency Cost:** \$7,680  
**Deficiency Description:** *Paint on steel facade structure is peeling / wearing away.*

**Description of Work:** *Repaint metal façade structure.*

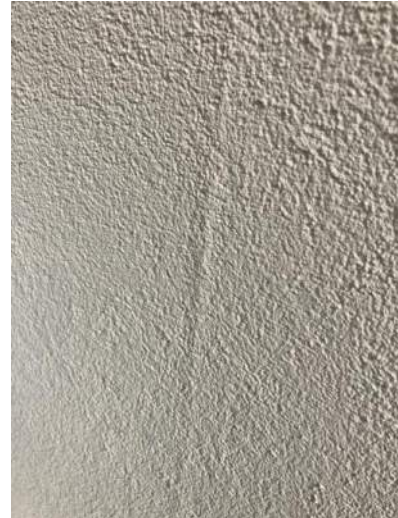
**Item No.:** B2010.10.009  
**Floor/Room:** Roof / -  
**Priority:** Potential - Long Term (4-5 Years)  
**Quantity/Unit of Measure:** 100/SF  
**Total Deficiency Cost:** \$6,540  
**Deficiency Description:** *Stucco is showing signs of cracking.*

**Description of Work:** *Clean, patch, and repair the cement plaster wall finish.*

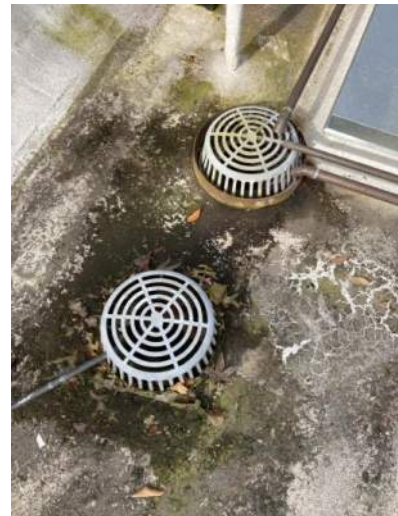
**Item No.:** D2030.30.001  
**Floor/Room:** Roof / -  
**Priority:** Crucial (1-2 Years)  
**Quantity/Unit of Measure:** 2/EA  
**Total Deficiency Cost:** \$6,780  
**Deficiency Description:** *Roof drains are damaged and clogged.*

**Description of Work:** *Repair or replace roof drains.*

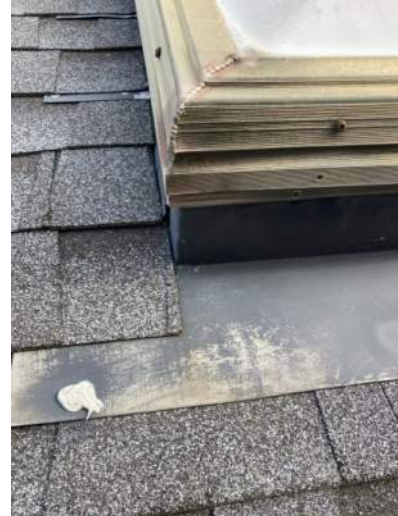
**Item No.:** B3060.10.001  
**Floor/Room:** Roof / -  
**Priority:** **Impending (2-3 Years)**  
**Quantity/Unit of Measure:** 8/SF  
**Total Deficiency Cost:** \$2,130  
**Deficiency Description:** *Original prismatic skylight 2 x 4 are past useful life*

**Comments:** *Known to leak when open.*

**Description of Work:** *Remove the existing skylight and replace it with a new skylight.*

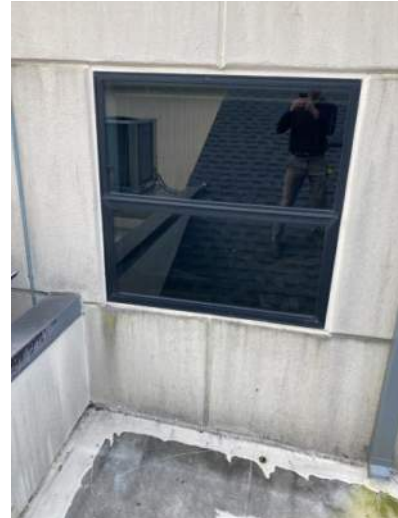
**Record ID:** 903  
**System:** B2020 - EXTERIOR WINDOWS

**Item No.:** B2020.20.010  
**Floor/Room:** Roof / -  
**Priority:** **Potential - Long Term (4-5 Years)**  
**Quantity/Unit of Measure:** 16/LF  
**Total Deficiency Cost:** \$500  
**Deficiency Description:** *Window sealant is approaching the end of its useful life and cracking.*

**Description of Work:** *Replace window sealant.*

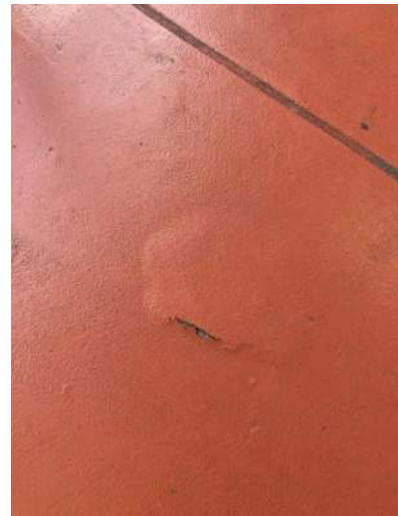
**Record ID:** 904  
**System:** C2030 - FLOORING

**Item No.:** C2030.10.002  
**Floor/Room:** 1st Floor / App bay  
**Priority:** **Potential - Long Term (4-5 Years)**  
**Quantity/Unit of Measure:** 5,600/SF  
**Total Deficiency Cost:** \$322,450  
**Deficiency Description:** *Epoxy flooring is approaching the end of its useful life.*

**Description of Work:** *Remove the existing epoxy and replace.*

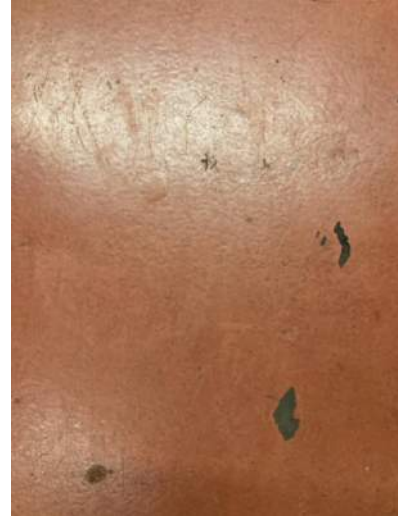
**Record ID:** 905  
**System:** C2030 - FLOORING  
**Item No.:** C2030.10.002  
**Floor/Room:** 1st Floor / Shop  
**Priority:** Potential - Long Term (4-5 Years)  
**Quantity/Unit of Measure:** 200/SF  
**Total Deficiency Cost:** \$11,530  
**Deficiency Description:** *Epoxy is approaching the end of its useful life.*

**Description of Work:** *Remove the existing epoxy and replace.*

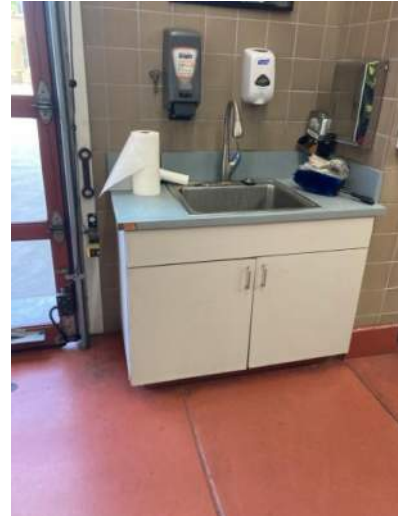
**Record ID:** 906  
**System:** E2010 - FIXED FURNISHINGS  
**Item No.:** E2010.30.008  
**Floor/Room:** 1st Floor / App bay  
**Priority:** Potential - Long Term (4-5 Years)  
**Quantity/Unit of Measure:** 10/LF  
**Total Deficiency Cost:** \$19,580  
**Deficiency Description:** *Plastic laminate base cabinet and countertop are in poor condition.*

**Description of Work:** *Remove and replace with new plastic laminate base cabinet and countertop.*

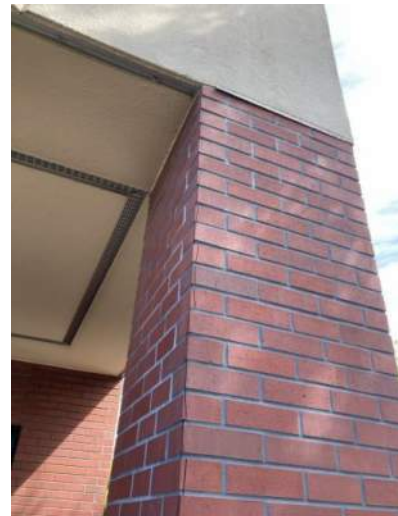
**Record ID:** 907  
**System:** B2010 - EXTERIOR WALLS  
**Item No.:** B2010.10.004  
**Floor/Room:** Site / -  
**Priority:** Potential - Long Term (4-5 Years)  
**Quantity/Unit of Measure:** 50/LF  
**Total Deficiency Cost:** \$2,880  
**Deficiency Description:** *Brick veneer damaged; crack runs from top to bottom of column corner*

**Description of Work:** *Repair brick masonry.*

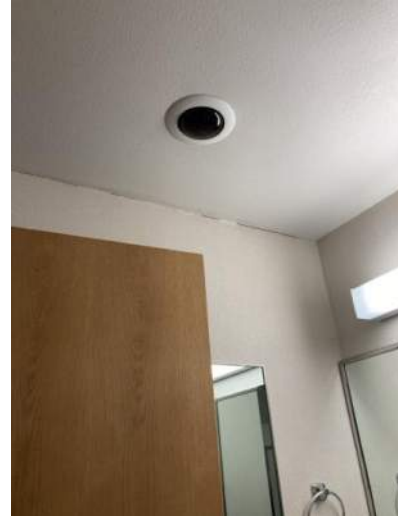
**Item No.:** C2050.10.001  
**Floor/Room:** 1st Floor / Dorm 1  
**Priority:** Potential - Long Term (4-5 Years)  
**Quantity/Unit of Measure:** 20/SF  
**Total Deficiency Cost:** \$470  
**Deficiency Description:** *Painted gypsum wallboard is approaching the end of its useful life.*

**Description of Work:** *Remove the existing gypsum board and replace. Tape and paint.*

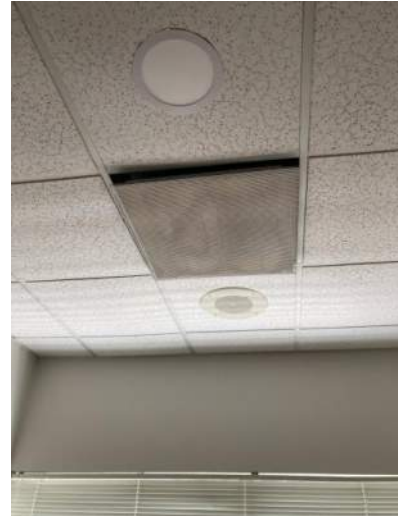
**Record ID:** 909  
**System:** D3060 - VENTILATION

**Item No.:** D3060.70.001  
**Floor/Room:** 1st Floor / Dorm 7  
**Priority:** Potential - Long Term (4-5 Years)  
**Quantity/Unit of Measure:** 4/SF  
**Total Deficiency Cost:** \$30  
**Deficiency Description:** *Loose air register.*

**Description of Work:** *Provide equipment maintenance.*

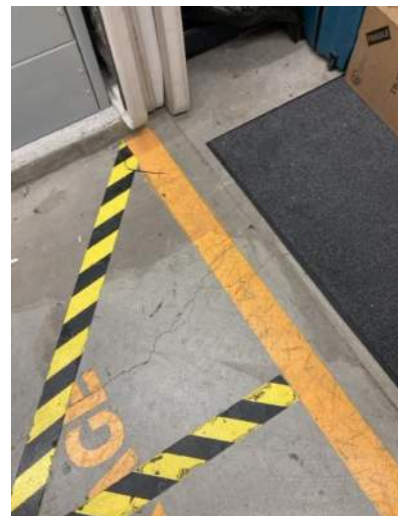
**Record ID:** 910  
**System:** A4010 - STANDARD SLABS-ON-GRADE

**Item No.:** A4010.10.001  
**Floor/Room:** 1st Floor / Electrical room  
**Priority:** Potential - Long Term (4-5 Years)  
**Quantity/Unit of Measure:** 15/LF  
**Total Deficiency Cost:** \$400  
**Deficiency Description:** *Moderate cracking in concrete slab in electrical room.*

**Description of Work:** *Fill the slab-on-grade cracks with caulking.*

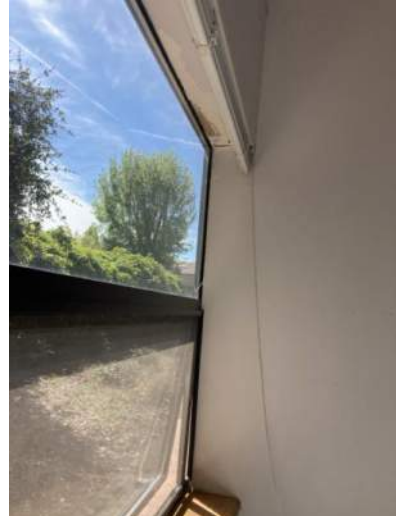
**Item No.:** C2010.70.001  
**Floor/Room:** 1st Floor / Dorm 8  
**Priority:** **Impending (2-3 Years)**  
**Quantity/Unit of Measure:** 12/SF  
**Total Deficiency Cost:** \$280  
**Deficiency Description:** *Painted gypsum wallboard is showing signs of wear.*

**Comments:** *Water damage observed above windows in Dorm Rooms 7 & 8.*

**Description of Work:** *Patch and paint the gypsum wallboard.*

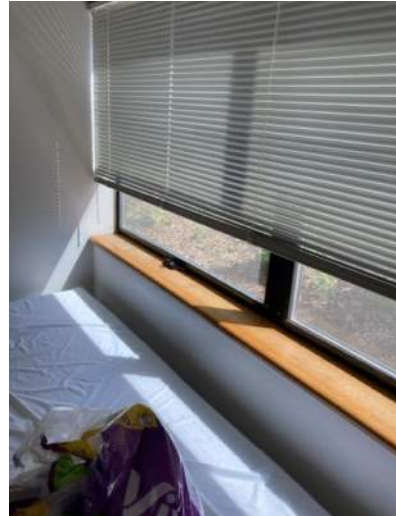
**Record ID:** 913  
**System:** C1020 - INTERIOR WINDOWS

**Item No.:** C1020.90.001  
**Floor/Room:** 1st Floor / Dorms  
**Priority:** **Potential - Long Term (4-5 Years)**  
**Quantity/Unit of Measure:** 9/EA  
**Total Deficiency Cost:** \$6,910  
**Deficiency Description:** *Wood window sill has deteriorated.*

**Comments:** *Window sill finish is worn typ all 8' 7"*

**Description of Work:** *Remove and replace the existing wood sill with new wood sill.*

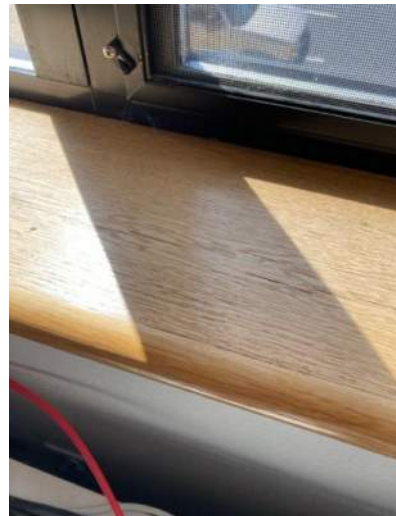
**Record ID:** 914  
**System:** C1020 - INTERIOR WINDOWS

**Item No.:** C1020.90.001  
**Floor/Room:** 2nd Floor / Finance manager office  
**Priority:** **Impending (2-3 Years)**  
**Quantity/Unit of Measure:** 1/EA  
**Total Deficiency Cost:** \$710  
**Deficiency Description:** *Wood sill is worn and cracking.*

**Comments:** *Window is 7'-11"*

**Description of Work:** *Remove and replace the existing wood sill with new wood sill.*

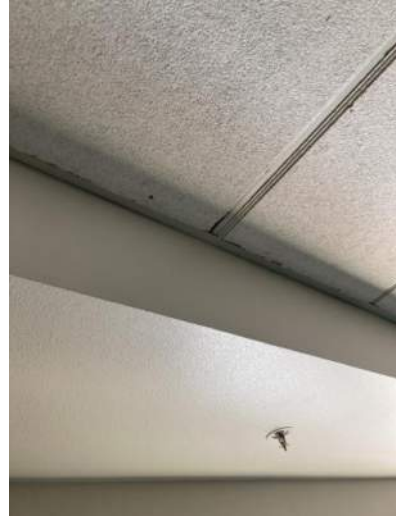
**Record ID:** 915  
**System:** C2050 - CEILING FINISHES  
**Item No.:** C2050.80.001  
**Floor/Room:** 2nd Floor / Lobby  
**Priority:** Potential - Long Term (4-5 Years)  
**Quantity/Unit of Measure:** 1,000/SF  
**Total Deficiency Cost:** \$17,940  
**Deficiency Description:** Lay-in acoustical ceiling tile is in poor condition.

**Description of Work:** Remove existing tiles and replace with new lay-in acoustical ceiling tiles.

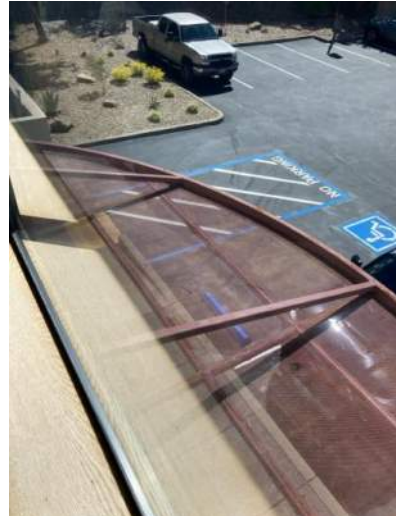
**Record ID:** 916  
**System:** B1020 - ROOF CONSTRUCTION  
**Item No.:** B1020.30.001  
**Floor/Room:** 2nd Floor / Lobby  
**Priority:** Potential - Long Term (4-5 Years)  
**Quantity/Unit of Measure:** 40/LF  
**Total Deficiency Cost:** \$4,530  
**Deficiency Description:** Tube steel canopy showing signs of rusting.

**Description of Work:** Clean rusted areas and repaint.

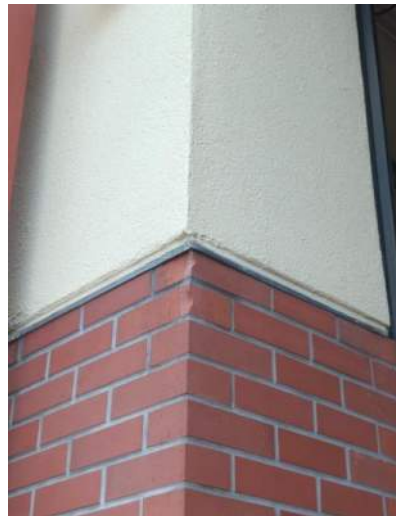
**Record ID:** 944  
**System:** B2010 - EXTERIOR WALLS  
**Item No.:** B2010.10.004  
**Floor/Room:** 1st Floor / Center Apparatus Bay Exterior  
**Priority:** Necessary - Long Term (3-4 Years)  
**Quantity/Unit of Measure:** 8/LF  
**Total Deficiency Cost:** \$450  
**Deficiency Description:** Brick masonry is damaged.

**Description of Work:** Repair brick masonry.

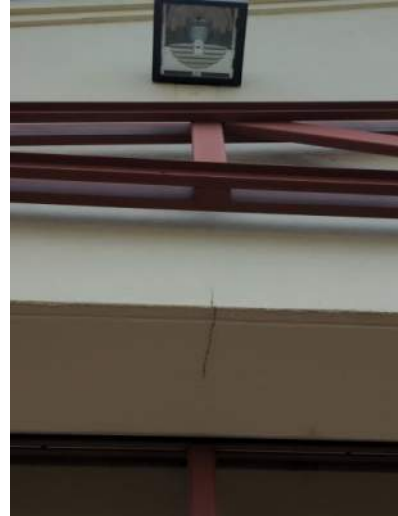
**Item No.:** B2010.10.009  
**Floor/Room:** 1st Floor / Left Apparatus Bay Door Exterior  
**Priority:** **Impending (2-3 Years)**  
**Quantity/Unit of Measure:** 2/SF  
**Total Deficiency Cost:** \$120  
**Deficiency Description:** *Cement plaster finish is showing signs of cracking.*

**Comments:** *Above the overhead bay door.*

**Description of Work:** *Clean, patch, and repair the cement plaster wall finish.*

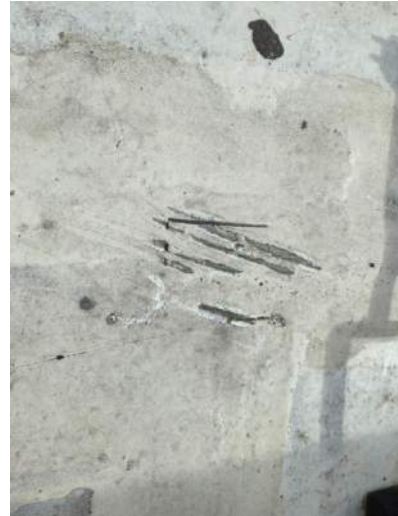
**Record ID:** 946  
**System:** B3010 - ROOFING

**Item No.:** B3010.50.004  
**Floor/Room:** Roof / -  
**Priority:** **Impending (2-3 Years)**  
**Quantity/Unit of Measure:** 10/SF  
**Total Deficiency Cost:** \$400  
**Deficiency Description:** *Modified-bitumen roofing is showing signs of wear.*

**Comments:** *Located on the west end of the low slope roof.*

**Description of Work:** *Replace modified bitumen roofing.*

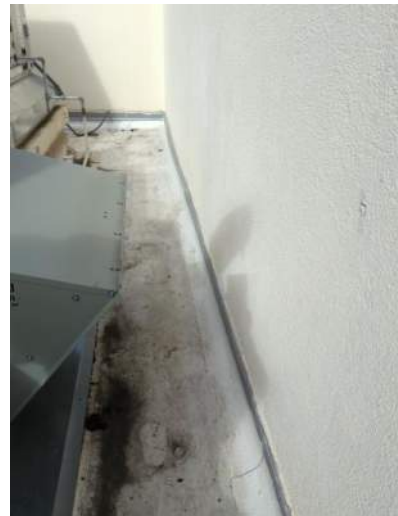
**Record ID:** 948  
**System:** B2010 - EXTERIOR WALLS

**Item No.:** B2010.50.004  
**Floor/Room:** Roof / -  
**Priority:** **Necessary - Long Term (3-4 Years)**  
**Quantity/Unit of Measure:** 100/LF  
**Total Deficiency Cost:** \$930  
**Deficiency Description:** *Elastomeric sealant at the roof reglets are failing.*

**Comments:** *At low-sloping roof.*

**Description of Work:** *Remove old sealant, clean the associated joints and re-seal it with new sealant.*

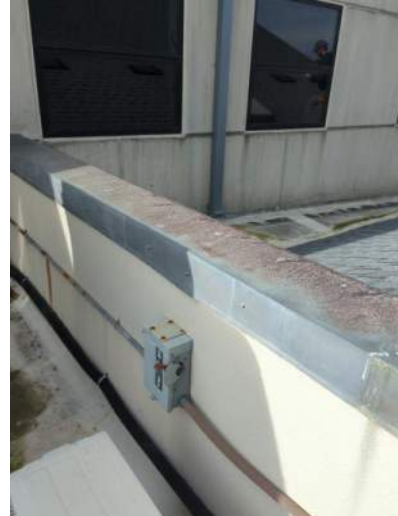
**Record ID:** 949  
**System:** B2010 - EXTERIOR WALLS

**Item No.:** B2010.50.005  
**Floor/Room:** Roof / -  
**Priority:** *Impending (2-3 Years)*  
**Quantity/Unit of Measure:** 40/LF  
**Total Deficiency Cost:** \$250  
**Deficiency Description:** *Paint finish at parapet wall cap is worn.*

**Comments:** *Located at west parapet.*

**Description of Work:** *Repaint sheet metal cap.*

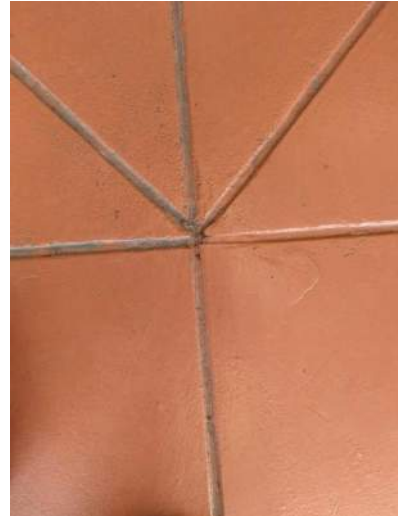
**Record ID:** 950  
**System:** G2030 - PEDESTRIAN PLAZAS AND WALKWAYS

**Item No.:** G2030.20.002  
**Floor/Room:** 1st Floor / Apparatus Bay  
**Priority:** *Necessary - Long Term (3-4 Years)*  
**Quantity/Unit of Measure:** 570/LF  
**Total Deficiency Cost:** \$8,410  
**Deficiency Description:** *The floor sealant on the slab control joints are failing.*

**Description of Work:** *Remove/replace pavement sealant at control joints.*

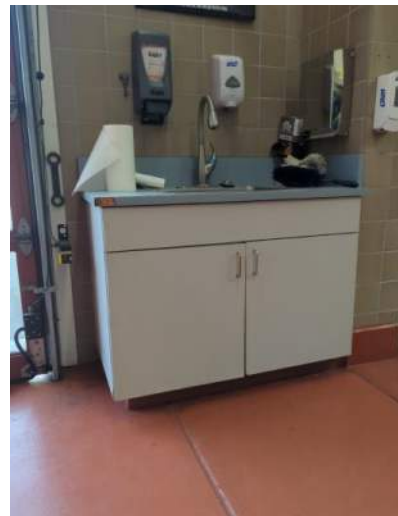
**Record ID:** 951  
**System:** E2010 - FIXED FURNISHINGS

**Item No.:** E2010.30.008  
**Floor/Room:** 1st Floor / Apparatus Bay  
**Priority:** *Impending (2-3 Years)*  
**Quantity/Unit of Measure:** 4/LF  
**Total Deficiency Cost:** \$7,230  
**Deficiency Description:** *Plastic laminate base cabinet and countertop are in poor condition.*

**Description of Work:** *Remove and replace with new plastic laminate base cabinet and countertop.*

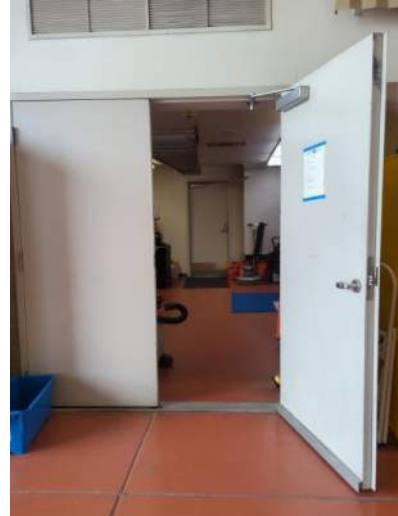
**Item No.:** B2050.20.002  
**Floor/Room:** 1st Floor / Air /Hose  
**Priority:** Potential - Long Term (4-5 Years)  
**Quantity/Unit of Measure:** 2/EA  
**Total Deficiency Cost:** \$9,220  
**Deficiency Description:** *Metal door and frames are damaged or deteriorated.*

**Description of Work:** *Repair door and repaint.*

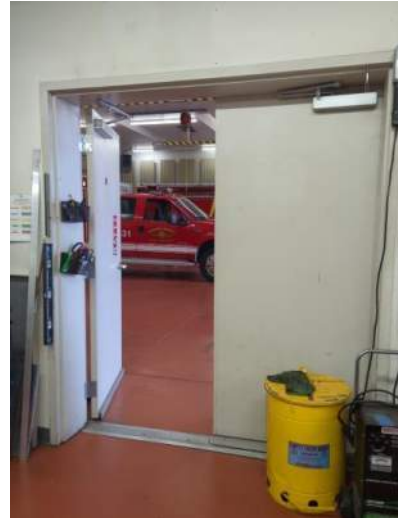
**Record ID:** 953  
**System:** C1030 - INTERIOR DOORS

**Item No.:** C1030.90.003  
**Floor/Room:** 1st Floor / Tools (Shop)  
**Priority:** Necessary - Long Term (3-4 Years)  
**Quantity/Unit of Measure:** 2/EA  
**Total Deficiency Cost:** \$1,840  
**Deficiency Description:** *Metal door and frames are in fair to poor condition.*

**Description of Work:** *Repair and refinish the metal door and frame.*

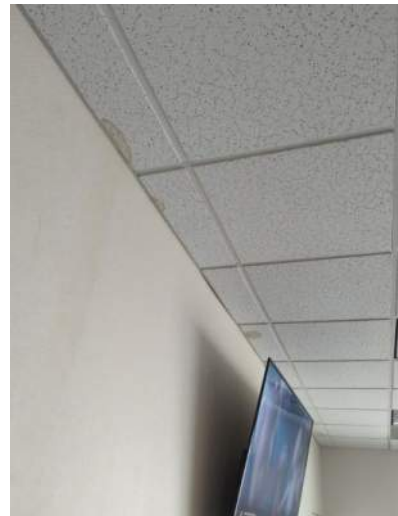
**Record ID:** 954  
**System:** C2050 - CEILING FINISHES

**Item No.:** C2050.80.001  
**Floor/Room:** 1st Floor / Exercise  
**Priority:** Potential - Long Term (4-5 Years)  
**Quantity/Unit of Measure:** 160/SF  
**Total Deficiency Cost:** \$2,880  
**Deficiency Description:** *Lay-in acoustical ceiling tile is in poor condition.*

**Comments:** *Signs of water damage were observed. Per staff, source of water was leak in low slope roof cricket above.*

**Description of Work:** *Remove existing tiles and replace with new lay-in acoustical ceiling tiles.*

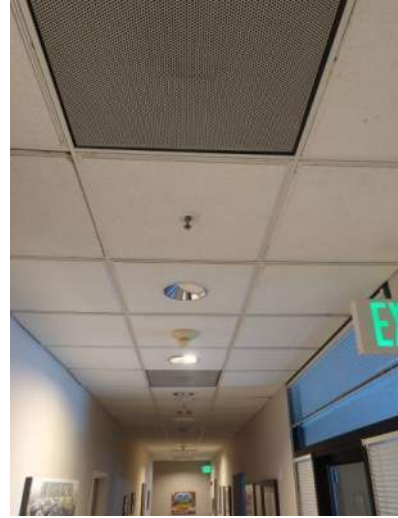
**Item No.:** C2050.80.001  
**Floor/Room:** 1st Floor / South Corridor  
**Priority:** Potential - Long Term (4-5 Years)  
**Quantity/Unit of Measure:** 1,000/SF  
**Total Deficiency Cost:** \$17,940  
**Deficiency Description:** Lay-in acoustical ceiling tile is in poor condition.

**Description of Work:** Remove existing tiles and replace with new lay-in acoustical ceiling tiles.

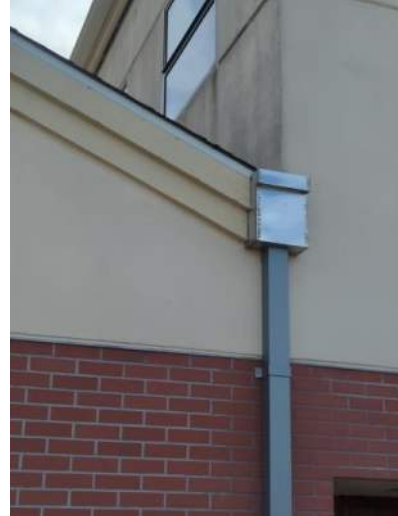
**Record ID:** 956  
**System:** B3010 - ROOFING

**Item No.:** B3010.90.010  
**Floor/Room:** Exterior / Exterior  
**Priority:** Impending (2-3 Years)  
**Quantity/Unit of Measure:** 12/LF  
**Total Deficiency Cost:** \$430  
**Deficiency Description:** The fascia is deteriorated and shows signs of wood rot.

**Description of Work:** Selectively remove deteriorated fascia and replace with new material to match.

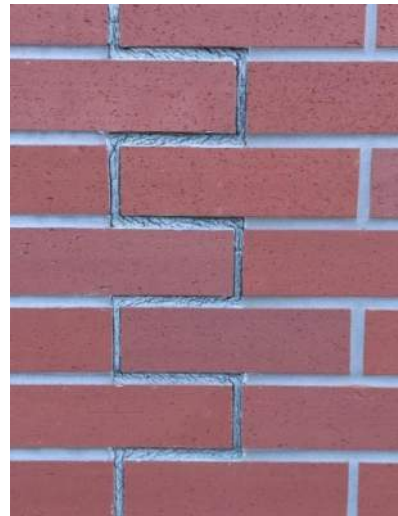
**Record ID:** 957  
**System:** G2030 - PEDESTRIAN PLAZAS AND WALKWAYS

**Item No.:** G2030.20.002  
**Floor/Room:** Exterior / Exterior  
**Priority:** Impending (2-3 Years)  
**Quantity/Unit of Measure:** 360/LF  
**Total Deficiency Cost:** \$5,100  
**Deficiency Description:** Brick control joint sealants are failing.

**Comments:** Full brick units are used at all control joints so joints are not vertical per typical practice.

**Description of Work:** Remove/replace pavement sealant at control joints.

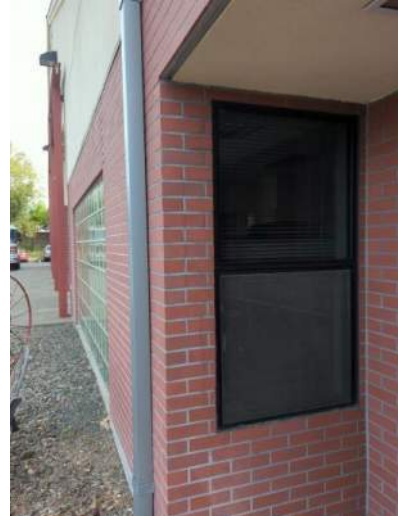
**Record ID:** 958  
**System:** B2010 - EXTERIOR WALLS  
**Item No.:** B2010.10.004  
**Floor/Room:** 1st Floor / Exercise Room Exterior  
**Priority:** **Impending (2-3 Years)**  
**Quantity/Unit of Measure:** 5/LF  
**Total Deficiency Cost:** \$280  
**Deficiency Description:** *Brick masonry is showing signs of cracking.*

**Description of Work:** *Repair brick masonry.*

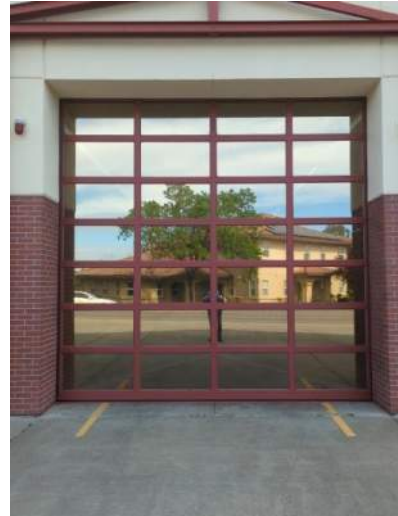
**Record ID:** 960  
**System:** B2020 - EXTERIOR WINDOWS  
**Item No.:** B2020.20.010  
**Floor/Room:** 1st floor / Apparatus OH Doors  
**Priority:** **Impending (2-3 Years)**  
**Quantity/Unit of Measure:** 1,600/LF  
**Total Deficiency Cost:** \$45,310  
**Deficiency Description:** *Sealant for glazing panes are failing.*

**Description of Work:** *Replace window sealant.*

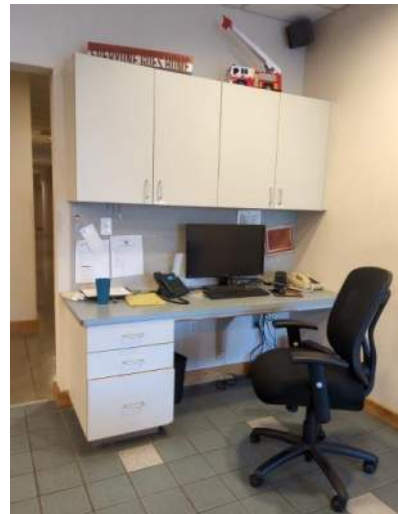
**Record ID:** 961  
**System:** E2010 - FIXED FURNISHINGS  
**Item No.:** E2010.30.009  
**Floor/Room:** First Floor / Dining  
**Priority:** **Planned - Long Term (6-10 Years)**  
**Quantity/Unit of Measure:** 6/LF  
**Total Deficiency Cost:** \$16,090  
**Deficiency Description:** *Plastic laminate casework is at or will be approaching the end of its expected useful life.*

**Description of Work:** *Provide new plastic laminate casework (upper, lower, and countertop)*

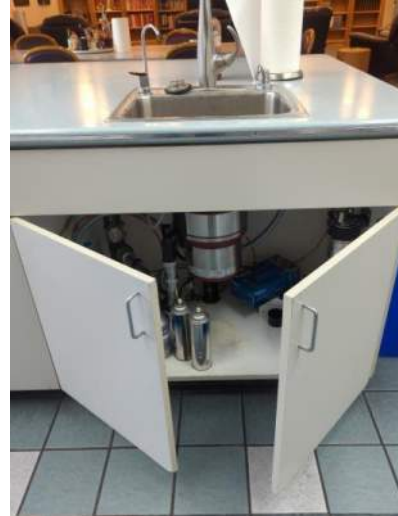
**Item No.:** E2010.30.009  
**Floor/Room:** 1st Floor / Kitchen  
**Priority:** Potential - Long Term (4-5 Years)  
**Quantity/Unit of Measure:** 20/LF  
**Total Deficiency Cost:** \$51,600  
**Deficiency Description:** *Plastic laminate casework is at or will be approaching the end of its expected useful life.*

**Description of Work:** *Provide new plastic laminate casework (upper, lower, and countertop)*

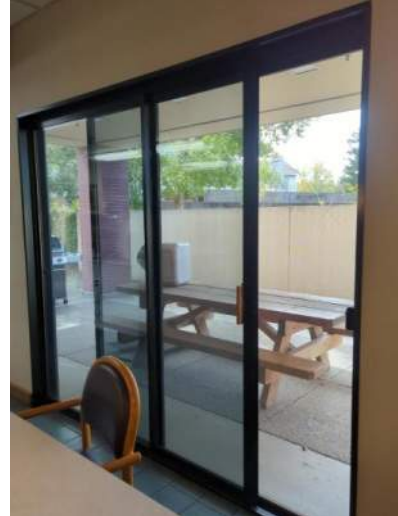
**Record ID:** 963  
**System:** C1030 - INTERIOR DOORS

**Item No.:** C1030.25.002  
**Floor/Room:** 1st Floor / Kitchen  
**Priority:** Impending (2-3 Years)  
**Quantity/Unit of Measure:** 2/EA  
**Total Deficiency Cost:** \$2,130  
**Deficiency Description:** *Interior door does not operate properly.*

**Description of Work:** *Repair interior aluminum sliding door.*

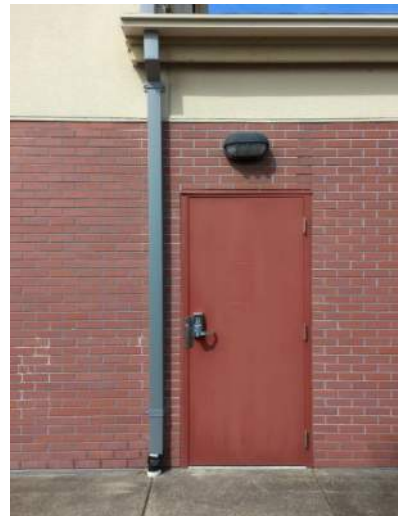
**Record ID:** 964  
**System:** B2050 - EXTERIOR DOORS AND GRILLES

**Item No.:** B2050.90.003  
**Floor/Room:** Exterior / Exterior  
**Priority:** Necessary - Long Term (3-4 Years)  
**Quantity/Unit of Measure:** 7/EA  
**Total Deficiency Cost:** \$3,870  
**Deficiency Description:** *Metal door is showing signs of wear.*

**Comments:** *Typical for all exterior doors.*

**Description of Work:** *Refinish metal door.*

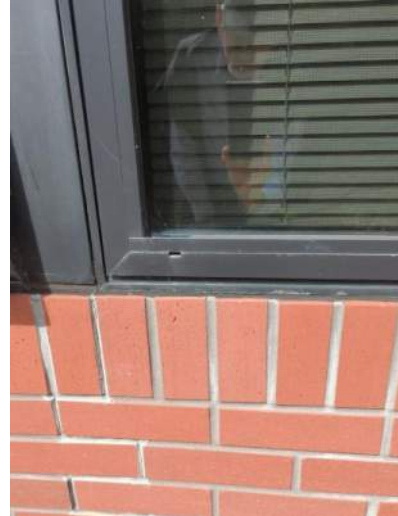
**Item No.:** B2020.20.010  
**Floor/Room:** 1st Floor / -  
**Priority:** **Crucial (1-2 Years)**  
**Quantity/Unit of Measure:** 400/LF  
**Total Deficiency Cost:** \$10,830  
**Deficiency Description:** *East window sealant (elastomeric ) near failing.*

**Comments:** *Typical for all windows on brick.*

**Description of Work:** *Replace window sealant.*

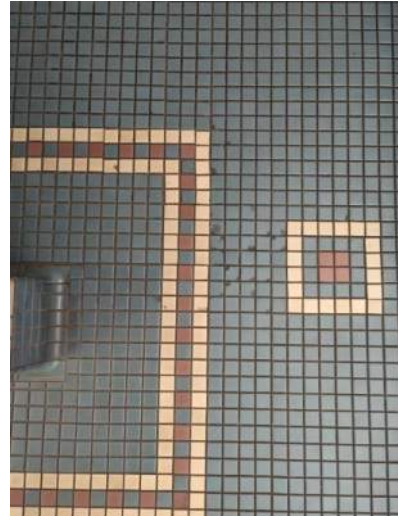
**Record ID:** 966  
**System:** C2030 - FLOORING

**Item No.:** C2030.20.001  
**Floor/Room:** 1st Floor / Men's Shower  
**Priority:** **Impending (2-3 Years)**  
**Quantity/Unit of Measure:** 100/SF  
**Total Deficiency Cost:** \$7,020  
**Deficiency Description:** *Ceramic tile flooring is showing signs of cracking.*

**Description of Work:** *Remove the existing ceramic tile flooring and replace.*

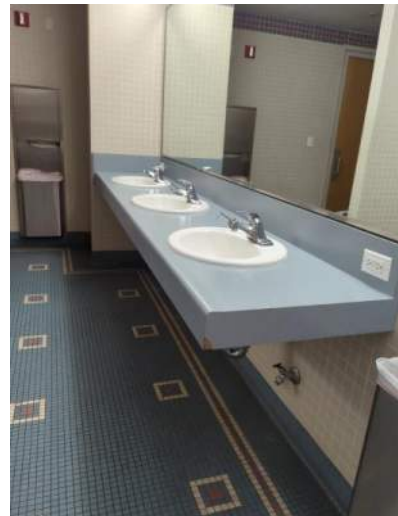
**Record ID:** 967  
**System:** E2010 - FIXED FURNISHINGS

**Item No.:** E2010.30.001  
**Floor/Room:** 1st Floor / Men's Shower  
**Priority:** **Necessary - Long Term (3-4 Years)**  
**Quantity/Unit of Measure:** 10/LF  
**Total Deficiency Cost:** \$1,480  
**Deficiency Description:** *Plastic laminate countertops are at or are approaching the end of their useful life.*

**Description of Work:** *Repair or replace plastic laminate countertops.*

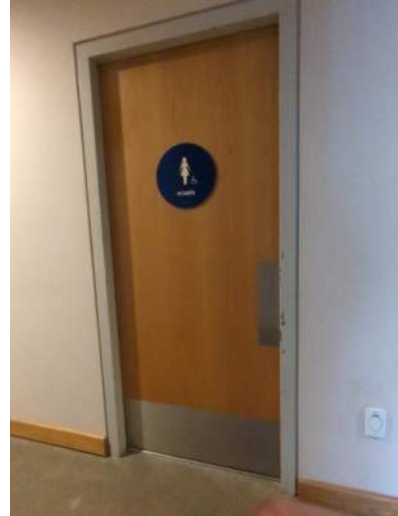
**Item No.:** C1030.90.003  
**Floor/Room:** 1st Floor / -  
**Priority:** Potential - Long Term (4-5 Years)  
**Quantity/Unit of Measure:** 14/EA  
**Total Deficiency Cost:** \$13,440  
**Deficiency Description:** *Chipped paint on metal door frames.  
Typical of all frames.*

**Description of Work:** *Repair and refinish the metal door frames.*

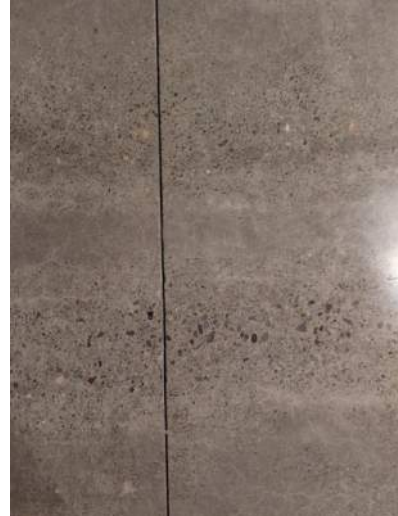
**Record ID:** 972  
**System:** G2030 - PEDESTRIAN PLAZAS AND WALKWAYS  
**Item No.:** G2030.20.002  
**Floor/Room:** 1st Floor / East Corridor  
**Priority:** Potential - Long Term (4-5 Years)  
**Quantity/Unit of Measure:** 1,000/LF  
**Total Deficiency Cost:** \$15,350  
**Deficiency Description:** No sealant in control joints.

**Comments:** Typical for all corridor joints.

**Description of Work:** Add sealant at control joints.

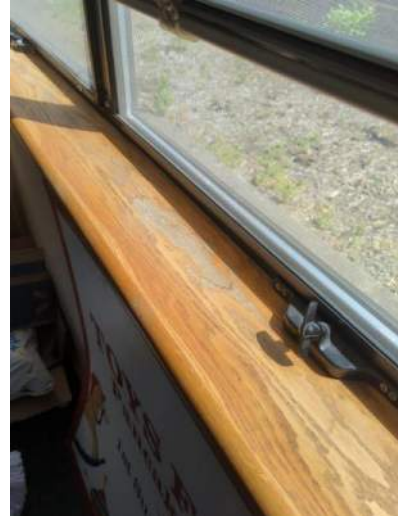
**Record ID:** 973  
**System:** C1020 - INTERIOR WINDOWS  
**Item No.:** C1020.90.001  
**Floor/Room:** 1st Floor / Chief Dorm  
**Priority:** Impending (2-3 Years)  
**Quantity/Unit of Measure:** 1/EA  
**Total Deficiency Cost:** \$710  
**Deficiency Description:** Warped/damaged window sill.

**Description of Work:** Remove and replace the existing wood sill with new wood sill.

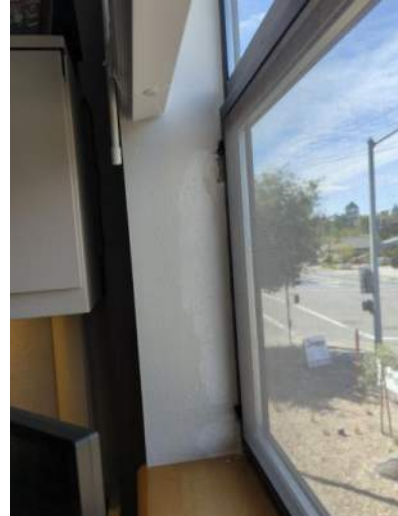
**Record ID:** 975  
**System:** C1010 - INTERIOR PARTITIONS

**Item No.:** C1010.10.001  
**Floor/Room:** 2nd Floor / Deputy Fire Marshal Work Area  
**Priority:** **Crucial (1-2 Years)**  
**Quantity/Unit of Measure:** 3/SF  
**Total Deficiency Cost:** \$30  
**Deficiency Description:** *Damaged drywall at window jamb.*

**Description of Work:** *Remove and replace existing gypsum board with a new gypsum board and expansion joints. Tape and paint.*

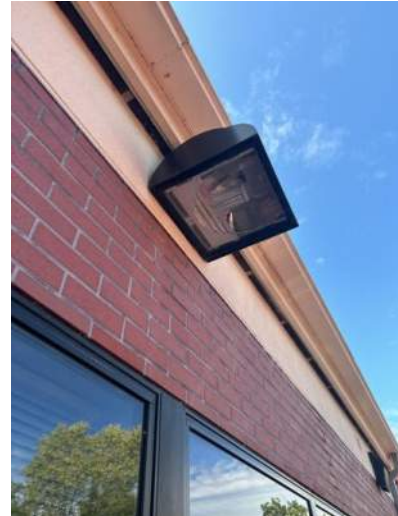
**Record ID:** 976  
**System:** D5040 - LIGHTING

**Item No.:** D5040.50.305  
**Floor/Room:** Site / -  
**Priority:** **Potential - Long Term (4-5 Years)**  
**Quantity/Unit of Measure:** 4/EA  
**Total Deficiency Cost:** \$13,140  
**Deficiency Description:** *The wall pack is approaching the end of its useful life and should be replaced.*

**Description of Work:** *Replace the existing lighting fixture with a new lighting fixture.*

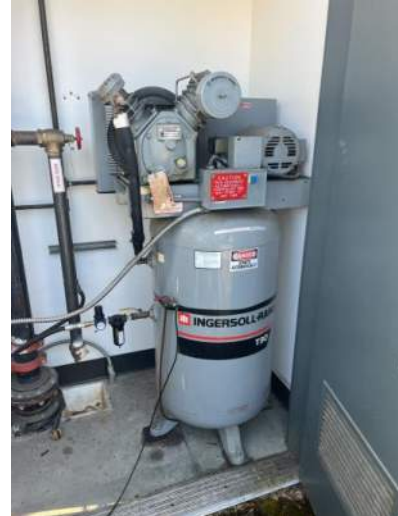
**Record ID:** 648  
**System:** D2060 - PROCESS SUPPORT PLUMBING SYSTEMS  
**Item No.:** D2060.10.001  
**Floor/Room:** 1st Floor / Fire Riser  
**Priority:** **Planned - Long Term (6-10 Years)**  
**Quantity/Unit of Measure:** 1/EA  
**Total Deficiency Cost:** \$19,930  
**Deficiency Description:** *Air compressor is approaching the end of its expected useful life.*

**Description of Work:** *Provide equipment replacement and installation.*

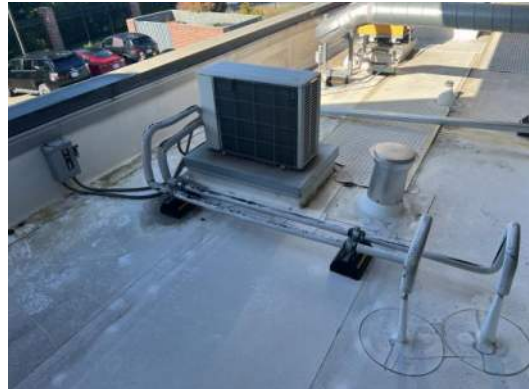
**Record ID:** 650  
**System:** D3030 - COOLING SYSTEMS  
**Item No.:** D3030.70.014  
**Floor/Room:** Roof / -  
**Priority:** **Crucial (1-2 Years)**  
**Quantity/Unit of Measure:** 1/EA  
**Total Deficiency Cost:** \$25,420  
**Deficiency Description:** *Split ductless AC unit is approaching the end of its expected useful life.*

**Comments:** *Serves Fitness Room.*

**Description of Work:** *Provide equipment replacement and installation.*

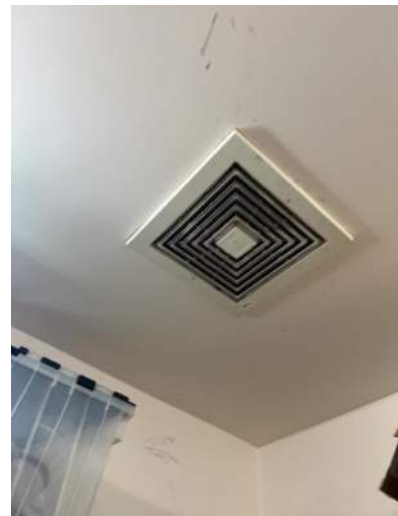
**Record ID:** 652  
**System:** D3060 - VENTILATION  
**Item No.:** D3060.30.002  
**Floor/Room:** 1st Floor / Shop  
**Priority:** **Potential - Long Term (4-5 Years)**  
**Quantity/Unit of Measure:** 1/EA  
**Total Deficiency Cost:** \$2,680  
**Deficiency Description:** *Ceiling exhaust fan is approaching the end of its expected useful life.*

**Description of Work:** *Provide equipment replacement and installation.*

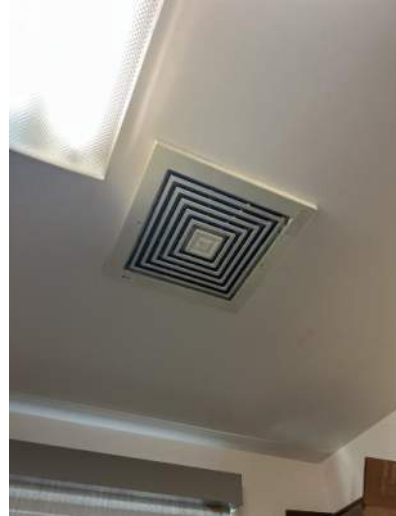
**Record ID:** 654  
**System:** D3060 - VENTILATION

**Item No.:** D3060.30.002  
**Floor/Room:** 1st Floor / App Bay Restroom  
**Priority:** Potential - Long Term (4-5 Years)  
**Quantity/Unit of Measure:** 1/EA  
**Total Deficiency Cost:** \$2,680  
**Deficiency Description:** *Ceiling exhaust fan is approaching the end of its expected useful life.*

**Description of Work:** *Provide equipment replacement and installation.*

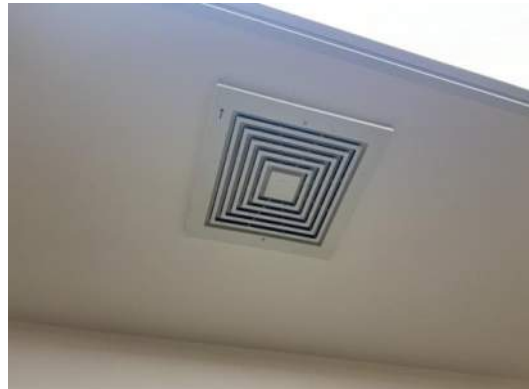
**Record ID:** 659  
**System:** D3060 - VENTILATION

**Item No.:** D3060.30.002  
**Floor/Room:** 1st Floor / Janitor  
**Priority:** Potential - Long Term (4-5 Years)  
**Quantity/Unit of Measure:** 1/EA  
**Total Deficiency Cost:** \$2,680  
**Deficiency Description:** *Ceiling exhaust fan is approaching the end of its expected useful life.*

**Description of Work:** *Provide equipment replacement and installation.*

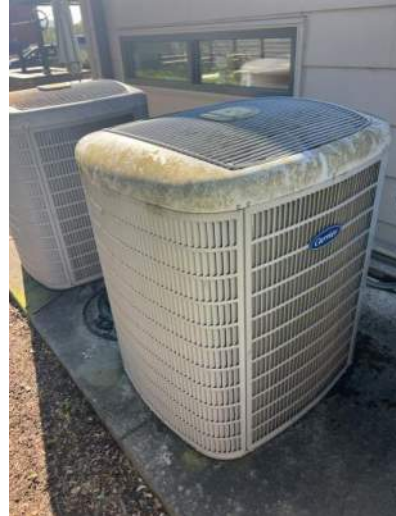
**Record ID:** 661  
**System:** D3030 - COOLING SYSTEMS

**Item No.:** D3030.70.006  
**Floor/Room:** Site / Site  
**Priority:** **Crucial (1-2 Years)**  
**Quantity/Unit of Measure:** 1/EA  
**Total Deficiency Cost:** \$12,190  
**Deficiency Description:** *Split system with furnace heating and (2-ton) outdoor condensing unit is approaching the end of its expected useful life.*

**Description of Work:** *Provide equipment replacement and installation.*

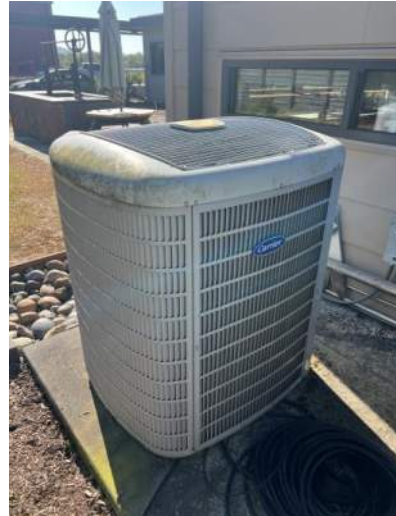
**Record ID:** 662  
**System:** D3030 - COOLING SYSTEMS

**Item No.:** D3030.70.014  
**Floor/Room:** Site / Site  
**Priority:** **Crucial (1-2 Years)**  
**Quantity/Unit of Measure:** 1/EA  
**Total Deficiency Cost:** \$25,420  
**Deficiency Description:** *Split ductless AC unit is approaching the end of its expected useful life.*

**Description of Work:** *Provide equipment replacement and installation.*

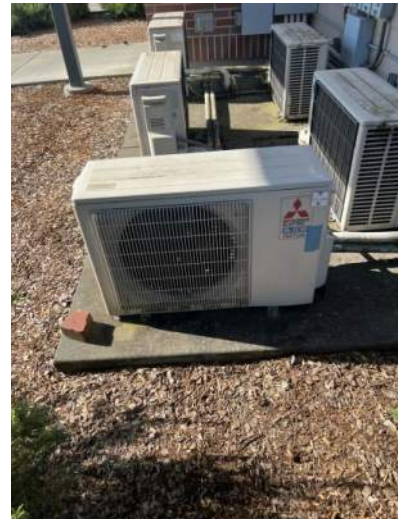
**Record ID:** 666  
**System:** D3030 - COOLING SYSTEMS

**Item No.:** D3030.70.014  
**Floor/Room:** Site / Site  
**Priority:** **Crucial (1-2 Years)**  
**Quantity/Unit of Measure:** 1/EA  
**Total Deficiency Cost:** \$25,420  
**Deficiency Description:** *Split ductless AC unit is approaching the end of its expected useful life.*

**Description of Work:** *Provide equipment replacement and installation.*

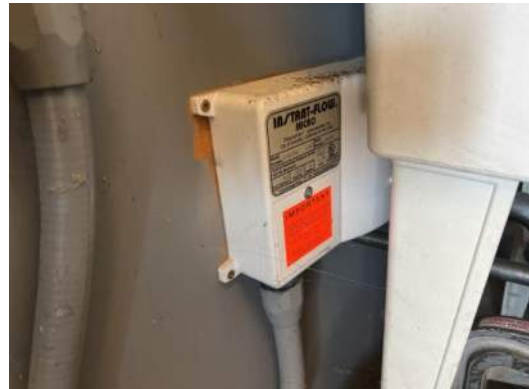
**Record ID:** 667  
**System:** D2010 - DOMESTIC WATER DISTRIBUTION

**Item No.:** D2010.20.006  
**Floor/Room:** 1st Floor / Separate Apparatus  
**Priority:** **Crucial (1-2 Years)**  
**Quantity/Unit of Measure:** 1/EA  
**Total Deficiency Cost:** \$1,690  
**Deficiency Description:** *Instantaneous water heater is approaching the end of its expected useful life.*

**Comments:** *Shop Building*

**Description of Work:** *Provide equipment replacement and installation.*

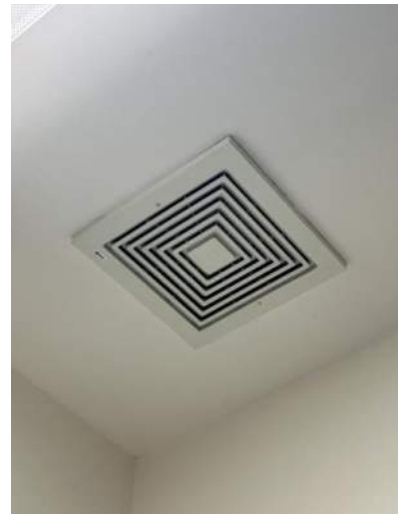
**Record ID:** 676  
**System:** D3060 - VENTILATION

**Item No.:** D3060.30.002  
**Floor/Room:** 1st Floor / Laundry  
**Priority:** **Potential - Long Term (4-5 Years)**  
**Quantity/Unit of Measure:** 1/EA  
**Total Deficiency Cost:** \$2,680  
**Deficiency Description:** *Ceiling exhaust fan is approaching the end of its expected useful life.*

**Description of Work:** *Provide equipment replacement and installation.*

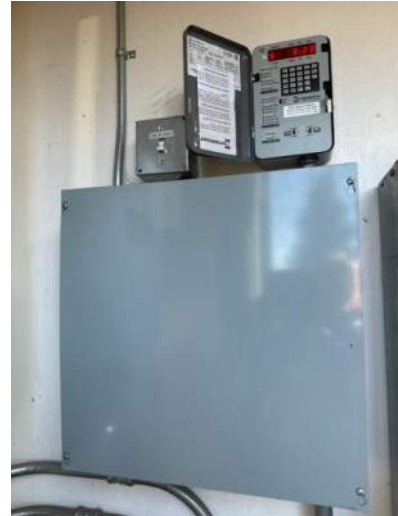
**Record ID:** 739  
**System:** D5040 - LIGHTING

**Item No.:** D5040.10.002  
**Floor/Room:** 1st / Electrical  
**Priority:** Potential - Long Term (4-5 Years)  
**Quantity/Unit of Measure:** 8,500/SF  
**Total Deficiency Cost:** \$37,510  
**Deficiency Description:** *The low voltage lighting relays and switches are approaching the end of their expected useful life.*

**Description of Work:** *Replace the existing switches and provide a new lighting control system.*

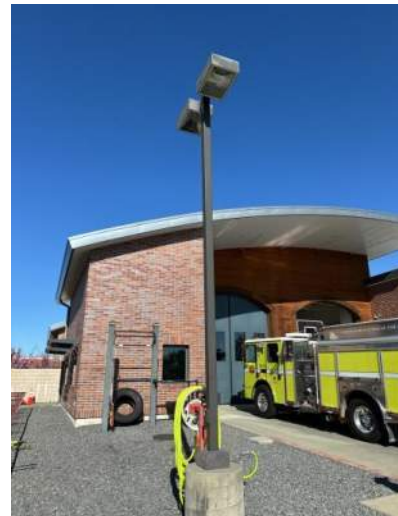
**Record ID:** 740  
**System:** G2020 - PARKING LOTS

**Item No.:** G2020.70.014  
**Floor/Room:** Site / -  
**Priority:** Potential - Long Term (4-5 Years)  
**Quantity/Unit of Measure:** 1/EA  
**Total Deficiency Cost:** \$1,110  
**Deficiency Description:** *Existing lighting pole shows wear and should be retrofitted to be an LED fixture.*

**Description of Work:** *Retrofit the lighting pole with an LED fixture, clean and repaint pole.*

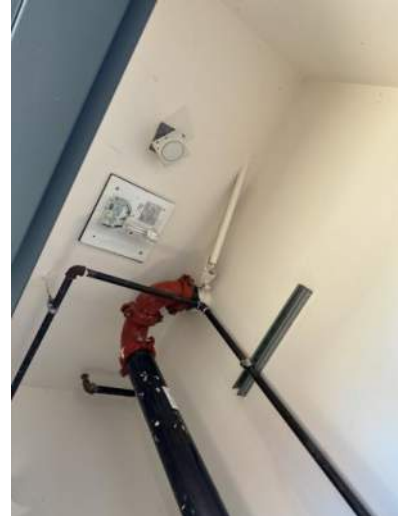
**Record ID:** 741  
**System:** D5040 - LIGHTING

**Item No.:** D5040.50.003  
**Floor/Room:** 1st / Fire sprinkler Room  
**Priority:** Immediate (0-1 Years)  
**Quantity/Unit of Measure:** 2/EA  
**Total Deficiency Cost:** \$1,220  
**Deficiency Description:** *Light fixture and motion sensor are damaged.*

**Description of Work:** *Replace the existing interior light fixture and sensore with new.*

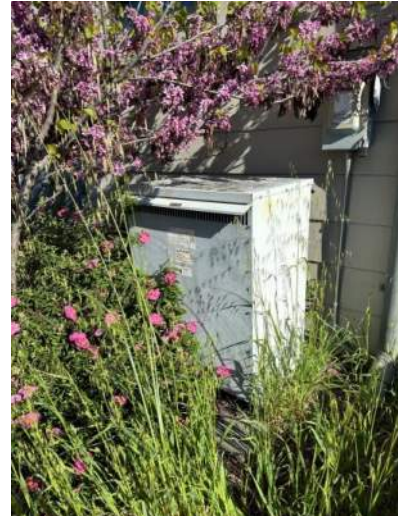
The outdoor transformer had some signs of rust, and the landscaping was in contact with the enclosure. The landscaping should be cut back to protect the enclosure and to keep debris out of the vented openings of the equipment.

**Record ID:** 743  
**System:** G2080 - LANDSCAPING

**Item No.:** G2080.30.007  
**Floor/Room:** Site / -  
**Priority:** Immediate (0-1 Years)  
**Quantity/Unit of Measure:** 75/SF  
**Total Deficiency Cost:** \$880  
**Deficiency Description:** *Exterior dry-type transformer is in contact with landscaping.*

**Description of Work:** *Create a clear space around equipment.*

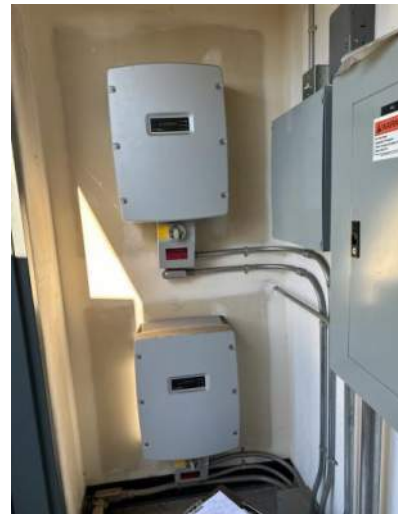
**Record ID:** 744  
**System:** D5010 - FACILITY POWER GENERATION

**Item No.:** D5010.30.003  
**Floor/Room:** 1st / Electrical  
**Priority:** Potential - Long Term (4-5 Years)  
**Quantity/Unit of Measure:** 10,000/W  
**Total Deficiency Cost:** \$423,790  
**Deficiency Description:** *The stand-alone photovoltaic power system is in need of being replaced.*

**Description of Work:** *Replace the existing stand-alone photovoltaic power system and replace it with a new one.*
