# SONOMA COUNTY FIRE DISTRICT MASTER PLAN

DRAFT REPORT | NOV 19, 2024

PREPARED BY KITCHELL AND SHAH KAWASAKI ARCHITECTS

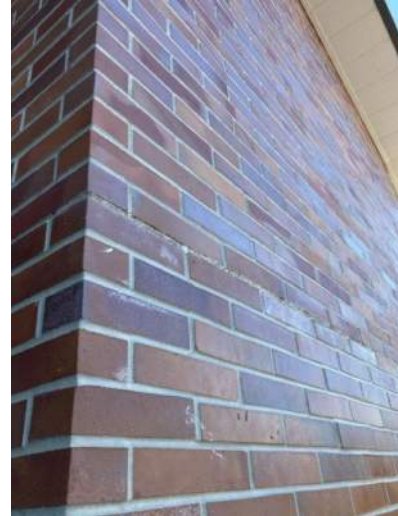
**Item No.:** B2010.10.004  
**Floor/Room:** 1st Floor / Site  
**Priority:** *Potential - Long Term (4-5 Years)*  
**Quantity/Unit of Measure:** 400/LF  
**Total Deficiency Cost:** \$23,030  
**Deficiency Description:** *Cracking in sealant in horizontal brick joint was observed.*

**Comments:** *Failing sealant at brick at ledger angle.*

**Description of Work:** *Replace sealant in control joint.*

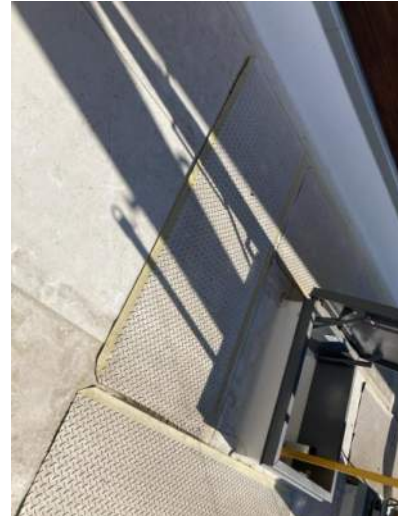
**Item No.:** B3040.50.001  
**Floor/Room:** Roof / -  
**Priority:** *Potential - Long Term (4-5 Years)*  
**Quantity/Unit of Measure:** 20/SF  
**Total Deficiency Cost:** \$1,140  
**Deficiency Description:** *Rooftop walk pads are loose.*

**Description of Work:** *Reattach walk pads on roofing membrane.*

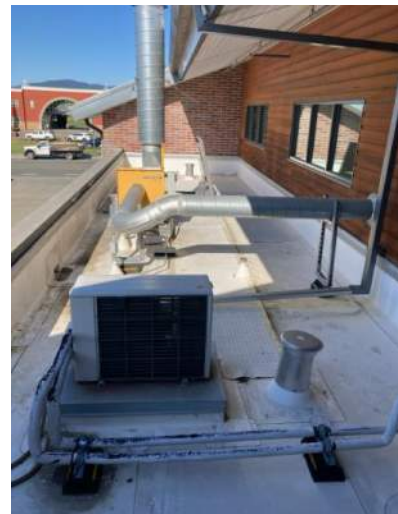
**Item No.:** B3010.50.002  
**Floor/Room:** Roof / -  
**Priority:** *Potential - Long Term (4-5 Years)*  
**Quantity/Unit of Measure:** 300/SF  
**Total Deficiency Cost:** \$13,240  
**Deficiency Description:** *Single-ply roofing is approaching the end of its useful life.*

**Description of Work:** *Remove and replace single-ply roofing.*

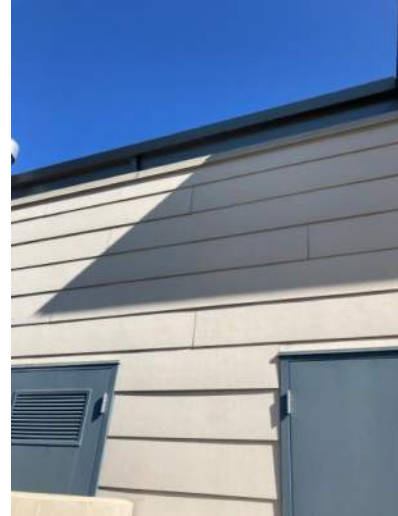
**Item No.:** B2010.20.007  
**Floor/Room:** Site / -  
**Priority:** Potential - Long Term (4-5 Years)  
**Quantity/Unit of Measure:** 400/LF  
**Total Deficiency Cost:** \$23,030  
**Deficiency Description:** Exterior cement fiber board vertical joints are failing.

**Description of Work:** Replace sealant in board joints.

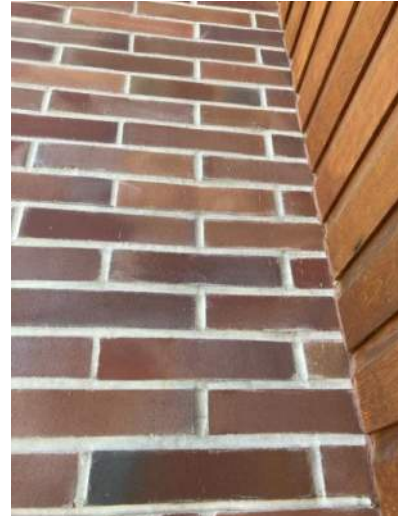
**Item No.:** B2010.10.004  
**Floor/Room:** Site / -  
**Priority:** Potential - Long Term (4-5 Years)  
**Quantity/Unit of Measure:** 10/LF  
**Total Deficiency Cost:** \$570  
**Deficiency Description:** Cracking in mortar joint across wall was observed.

**Description of Work:** Repair brick masonry.

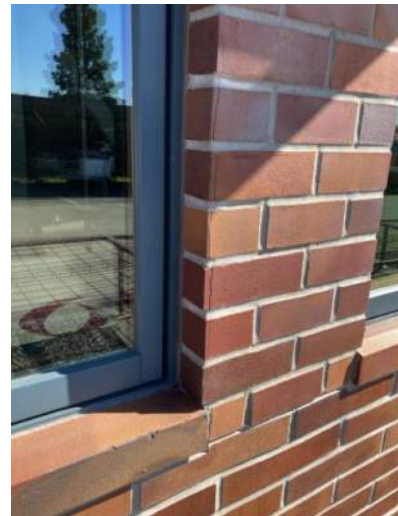
**Item No.:** B2010.10.004  
**Floor/Room:** Site / -  
**Priority:** Potential - Long Term (4-5 Years)  
**Quantity/Unit of Measure:** 50/LF  
**Total Deficiency Cost:** \$2,880  
**Deficiency Description:** Brick masonry is damaged.

**Comments:** Cracking brick masonry around windows on South façade.

**Description of Work:** Repair brick masonry.

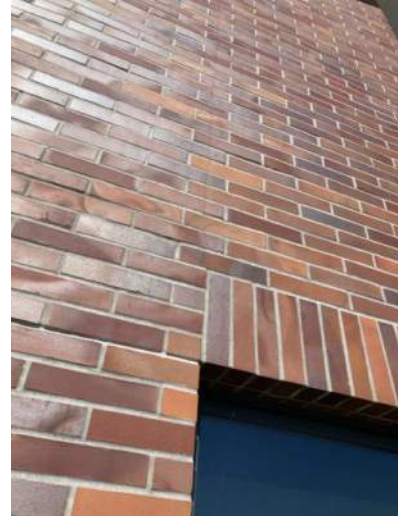
**Item No.:** B2010.10.004  
**Floor/Room:** Site / -  
**Priority:** Potential - Long Term (4-5 Years)  
**Quantity/Unit of Measure:** 50/LF  
**Total Deficiency Cost:** \$2,880  
**Deficiency Description:** *Significant vertical cracking of brick veneer was observed.*

**Comments:** *Located on rear (NE) elevation*

**Description of Work:** *Repair brick masonry.*

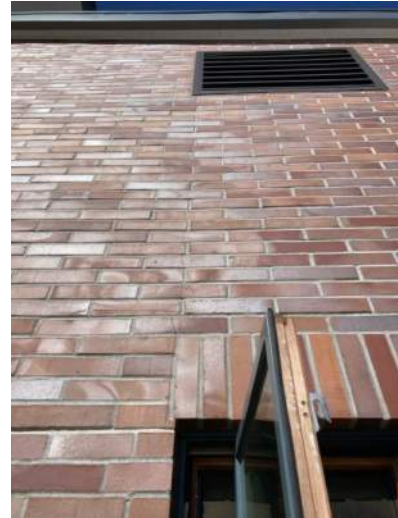
**Item No.:** B2010.10.004  
**Floor/Room:** Site / -  
**Priority:** Potential - Long Term (4-5 Years)  
**Quantity/Unit of Measure:** 50/LF  
**Total Deficiency Cost:** \$2,880  
**Deficiency Description:** *Significant vertical cracking of brick veneer was observed.*

**Comments:** *Located on rear (NE) elevation by the window; runs down both sides from attic vent.*

**Description of Work:** *Repair brick masonry.*

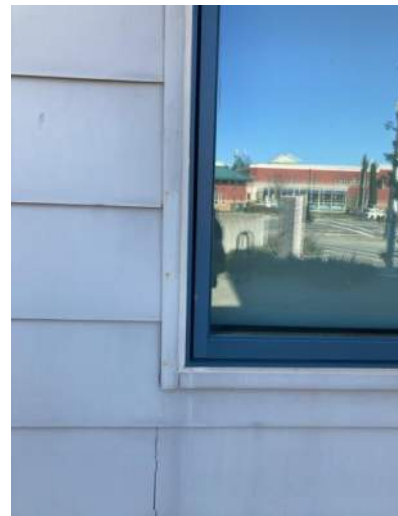
**Item No.:** B2010.10.006  
**Floor/Room:** Site / -  
**Priority:** Potential - Long Term (4-5 Years)  
**Quantity/Unit of Measure:** 16/LF  
**Total Deficiency Cost:** \$600  
**Deficiency Description:** *Trim is worn and should be replaced.*

**Description of Work:** *Replace trim and finish to match.*

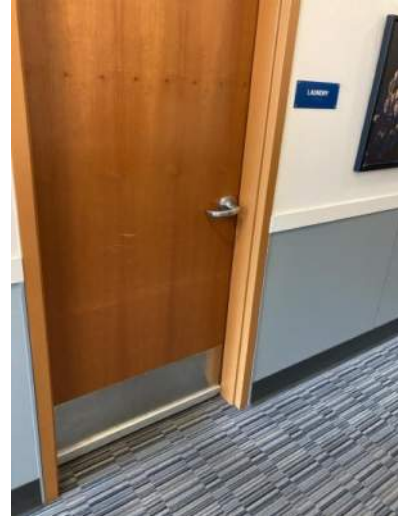
**Item No.:** C1030.10.008  
**Floor/Room:** 1st Floor / Laundry  
**Priority:** Potential - Long Term (4-5 Years)  
**Quantity/Unit of Measure:** 1/EA  
**Total Deficiency Cost:** \$1,140  
**Deficiency Description:** Interior wood door is in visual need of refurbishment.

**Description of Work:** Refurbish and restain the wood door.

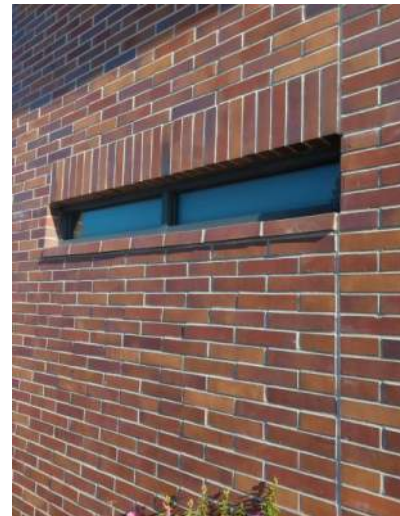
**Item No.:** B2010.10.004  
**Floor/Room:** Exterior / Exterior  
**Priority:** Impending (2-3 Years)  
**Quantity/Unit of Measure:** 10/LF  
**Total Deficiency Cost:** \$530  
**Deficiency Description:** Hairline fractures on brick were observed.

**Comments:** Located on the SW corner.

**Description of Work:** Repair brick masonry.

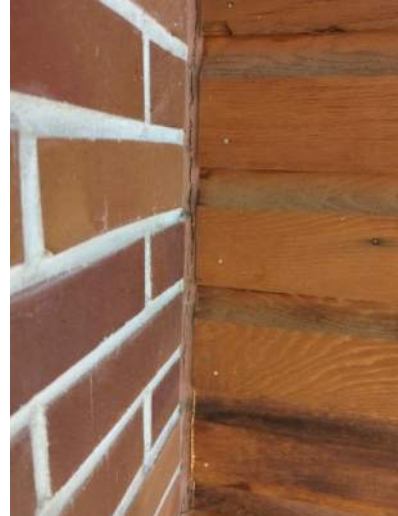
**Record ID:** 921  
**System:** G2030 - PEDESTRIAN PLAZAS AND WALKWAYS  
**Item No.:** G2030.20.002  
**Floor/Room:** Exterior / Exterior  
**Priority:** **Impending (2-3 Years)**  
**Quantity/Unit of Measure:** 16/LF  
**Total Deficiency Cost:** \$220  
**Deficiency Description:** *Sealant failure on wall intersection was observed.*

**Comments:** *Located above south low roof.*

**Description of Work:** *Remove/replace sealant at joint.*

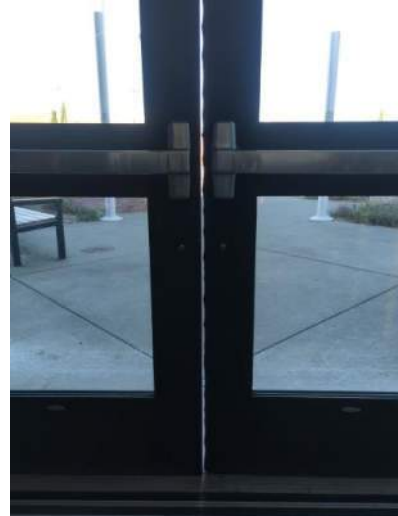
**Record ID:** 922  
**System:** B2050 - EXTERIOR DOORS AND GRILLES  
**Item No.:** B2050.90.010  
**Floor/Room:** 1st Floor / Lobby  
**Priority:** **Necessary - Long Term (3-4 Years)**  
**Quantity/Unit of Measure:** 1/EA  
**Total Deficiency Cost:** \$1,160  
**Deficiency Description:** *Entrance door astragal is missing.*

**Description of Work:** *Install missing astragal.*

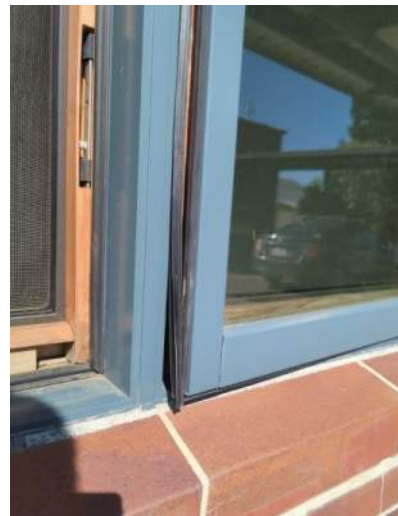
**Record ID:** 923  
**System:** B2020 - EXTERIOR WINDOWS  
**Item No.:** B2020.20.010  
**Floor/Room:** Exterior / Exterior  
**Priority:** **Necessary - Long Term (3-4 Years)**  
**Quantity/Unit of Measure:** 16/LF  
**Total Deficiency Cost:** \$480  
**Deficiency Description:** *Metal clad window gasket are failing.*

**Comments:** *Windows located on south and east wall.*

**Description of Work:** *Replace window gaskets.*

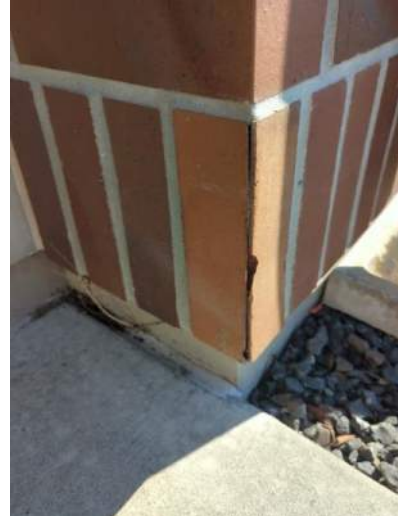
**Item No.:** B2010.10.004  
**Floor/Room:** Exterior / Exterior  
**Priority:** Necessary - Long Term (3-4 Years)  
**Quantity/Unit of Measure:** 20/LF  
**Total Deficiency Cost:** \$1,100  
**Deficiency Description:** *Soldier brick outside corner is damaged.*

**Comments:** *Approximately 4 locations affected.*

**Description of Work:** *Repair brick masonry.*

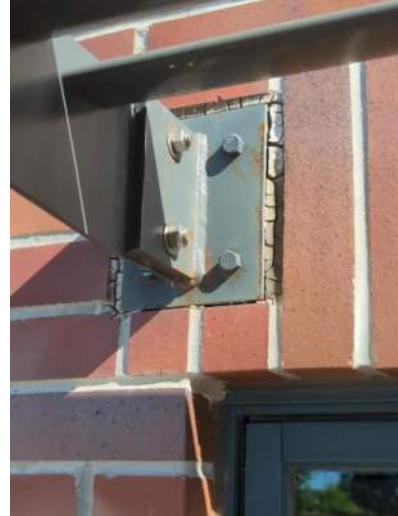
**Item No.:** B2050.90.009  
**Floor/Room:** Exterior / Exterior  
**Priority:** Necessary - Long Term (3-4 Years)  
**Quantity/Unit of Measure:** 40/LF  
**Total Deficiency Cost:** \$3,670  
**Deficiency Description:** *Sealant around sunshades are failing.*

**Comments:** *Sealant around sunshade anchor plates to brick has failed.*

**Description of Work:** *Replace sealant.*

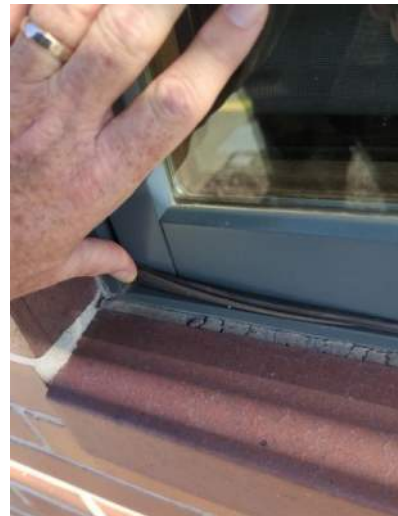
**Item No.:** B2050.90.011  
**Floor/Room:** Exterior / Exterior  
**Priority:** Crucial (1-2 Years)  
**Quantity/Unit of Measure:** 1/EA  
**Total Deficiency Cost:** \$860  
**Deficiency Description:** *South window gaskets failing.*

**Description of Work:** *Remove and replace failed window gaskets.*

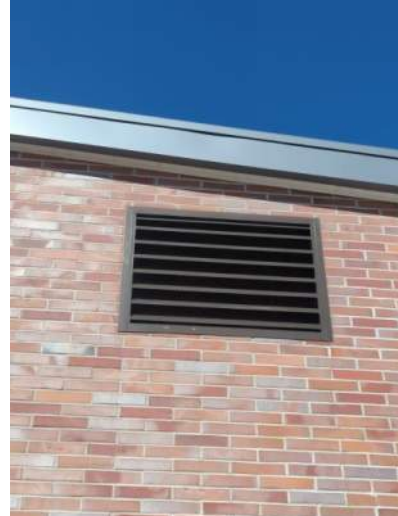
**Record ID:** 927  
**System:** B2070 - EXTERIOR LOUVERS AND VENTS  
**Item No.:** B2070.10.003  
**Floor/Room:** Exterior / Exterior  
**Priority:** Potential - Long Term (4-5 Years)  
**Quantity/Unit of Measure:** 10/SF  
**Total Deficiency Cost:** \$200  
**Deficiency Description:** *Pre finished air intake louver finish failing.*

**Description of Work:** *Clean and repaint louvers as required.*

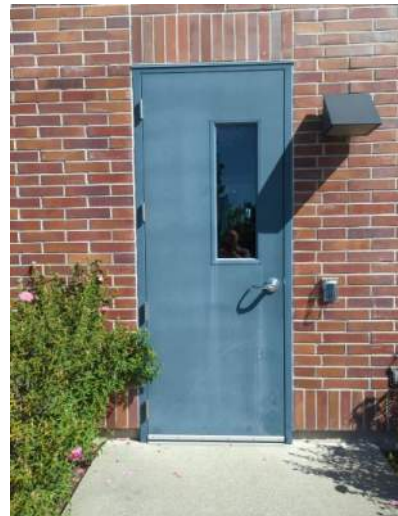
**Record ID:** 929  
**System:** B2050 - EXTERIOR DOORS AND GRILLES  
**Item No.:** B2050.90.003  
**Floor/Room:** Exterior / Exterior  
**Priority:** Potential - Long Term (4-5 Years)  
**Quantity/Unit of Measure:** 1/EA  
**Total Deficiency Cost:** \$570  
**Deficiency Description:** *Metal door is showing signs of wear.*

**Description of Work:** *Refinish metal door.*

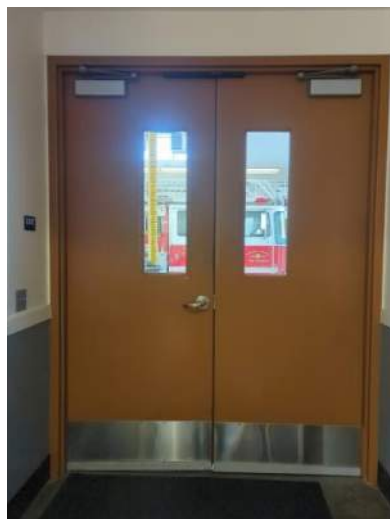
**Item No.:** B2050.90.003  
**Floor/Room:** 1st Floor / Hallway  
**Priority:** Potential - Long Term (4-5 Years)  
**Quantity/Unit of Measure:** 2/EA  
**Total Deficiency Cost:** \$1,140  
**Deficiency Description:** *Metal door is showing signs of wear.*

**Description of Work:** *Refinish metal door.*

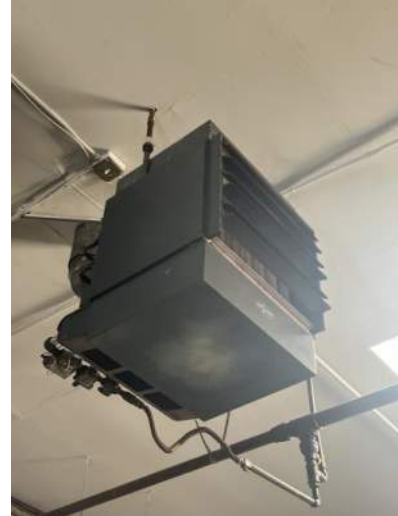
**Item No.:** D3020.70.003  
**Floor/Room:** 1st Floor / Apparatus  
**Priority:** **Impending (2-3 Years)**  
**Quantity/Unit of Measure:** 1/EA  
**Total Deficiency Cost:** \$13,140  
**Deficiency Description:** *Gas fired unit heater is approaching the end of its expected useful life.*

**Description of Work:** *Provide equipment replacement and installation.*

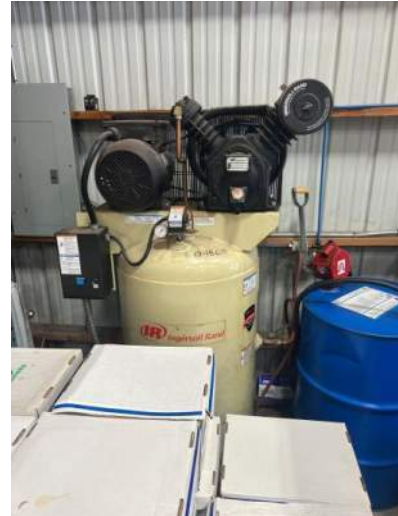
**Item No.:** D2060.10.001  
**Floor/Room:** 1st Floor / Storage Building  
**Priority:** **Planned - Long Term (6-10 Years)**  
**Quantity/Unit of Measure:** 1/EA  
**Total Deficiency Cost:** \$19,930  
**Deficiency Description:** *Air compressor is approaching the end of its expected useful life.*

**Comments:** *Storage Building*

**Description of Work:** *Provide equipment replacement and installation.*

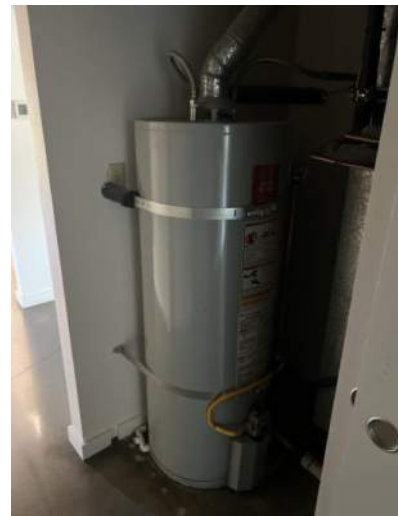
**Item No.:** D2010.20.002  
**Floor/Room:** 1st Floor / Mechanical  
**Priority:** **Crucial (1-2 Years)**  
**Quantity/Unit of Measure:** 1/EA  
**Total Deficiency Cost:** \$13,970  
**Deficiency Description:** *Gas fired water heater is approaching the end of its expected useful life.*

**Description of Work:** *Provide equipment replacement and installation.*

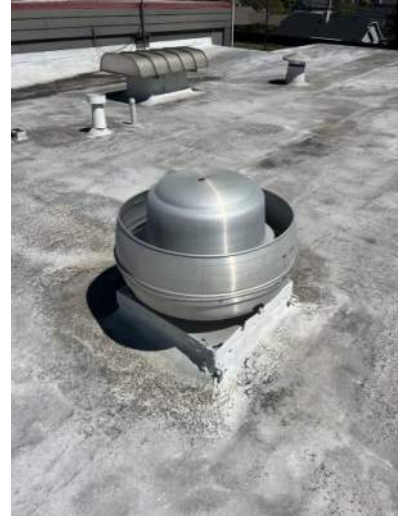
**Item No.:** D3060.30.005  
**Floor/Room:** Roof / -  
**Priority:** **Planned - Long Term (6-10 Years)**  
**Quantity/Unit of Measure:** 1/EA  
**Total Deficiency Cost:** \$8,780  
**Deficiency Description:** *Roof exhaust fan is approaching the end of its expected useful life.*

**Description of Work:** *Provide equipment replacement and installation.*

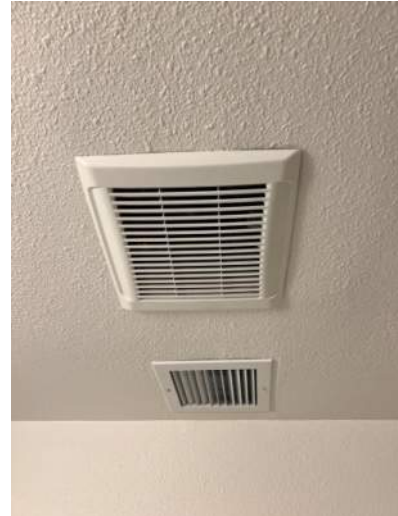
**Item No.:** D3060.30.002  
**Floor/Room:** 1st Floor / Restroom 2  
**Priority:** **Potential - Long Term (4-5 Years)**  
**Quantity/Unit of Measure:** 1/EA  
**Total Deficiency Cost:** \$2,680  
**Deficiency Description:** *Ceiling exhaust fan is approaching the end of its expected useful life.*

**Description of Work:** *Provide equipment replacement and installation.*

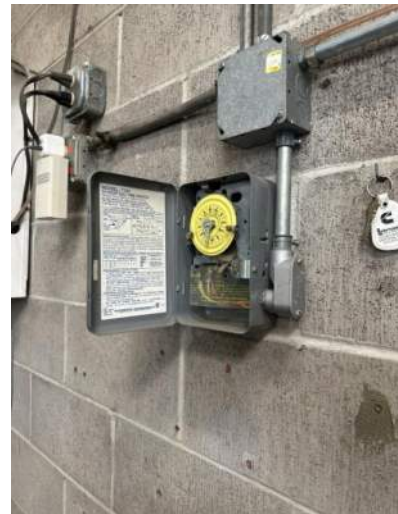
**Item No.:** D5040.10.001  
**Floor/Room:** 1st / Apparatus  
**Priority:** **Crucial (1-2 Years)**  
**Quantity/Unit of Measure:** 1/EA  
**Total Deficiency Cost:** \$770  
**Deficiency Description:** *The time clock is approaching the end of its expected useful life.*

**Description of Work:** *Replace the existing time clock with a new time clock.*

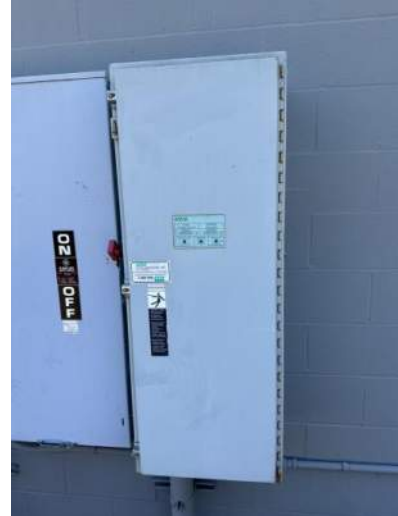
Adjacent to the main disconnect switch is a 400A, ASCO type Automatic Transfer Switch (ATS). The enclosure is made of galvanized steel and showed signs of rust at the hinges and along edges where the galvanizing is weaker. The output of the generator also connects to this switch. The load side of the ATS supplies power to the entire fire station.

**Comments:** *Rust at hinges.*

**Description of Work:** *Replace the existing ATS with new.*

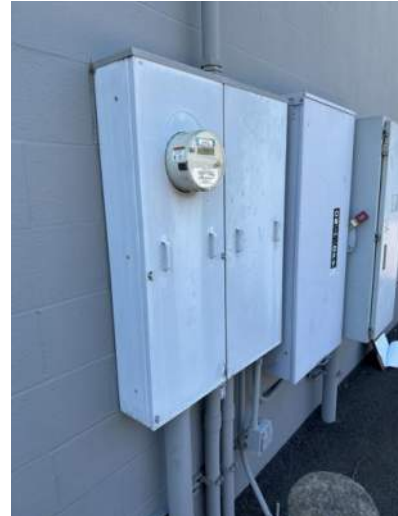
**Item No.:** D5020.10.003  
**Floor/Room:** 1st / Exterior  
**Priority:** Immediate (0-1 Years)  
**Quantity/Unit of Measure:** 1/EA  
**Total Deficiency Cost:** \$44,690  
**Deficiency Description:** *The 400A (120/240V, 1P) all-in-one combination service entrance device is approaching the end of its expected useful life.*

**Description of Work:** *Replace the existing all-in-one combination service entrance device with a new all-in-one combination service entrance device.*

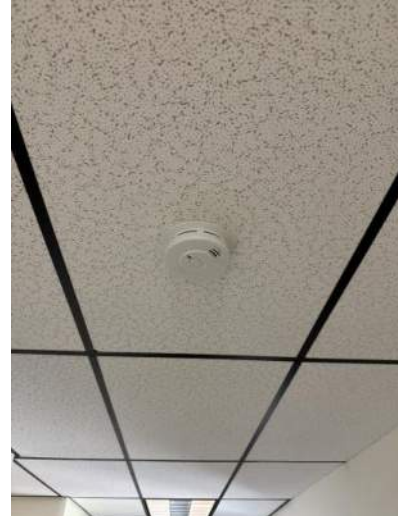
**Item No.:** D7050.10.023  
**Floor/Room:** 1st / Various  
**Priority:** **Immediate (0-1 Years)**  
**Quantity/Unit of Measure:** 9,600/SF  
**Total Deficiency Cost:** \$214,530  
**Deficiency Description:** *The existing fire alarm system is non-addressable and is lacking devices.*

**Description of Work:** *Provide a complete, site-wide, fully addressable fire alarm system.*

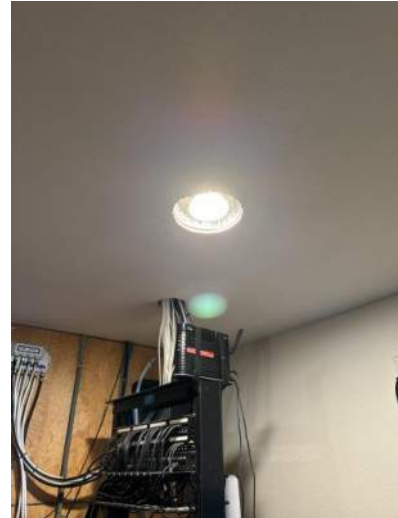
**Item No.:** D5040.50.007  
**Floor/Room:** 1st Floor / Vending  
**Priority:** **Immediate (0-1 Years)**  
**Quantity/Unit of Measure:** 2/EA  
**Total Deficiency Cost:** \$1,810  
**Deficiency Description:** *The recessed mounted downlight is damaged and should be replaced.*

**Comments:** *Housing missing.*

**Description of Work:** *Replace the damaged recessed mounted downlight fixture with a new recessed mounted downlight fixture.*

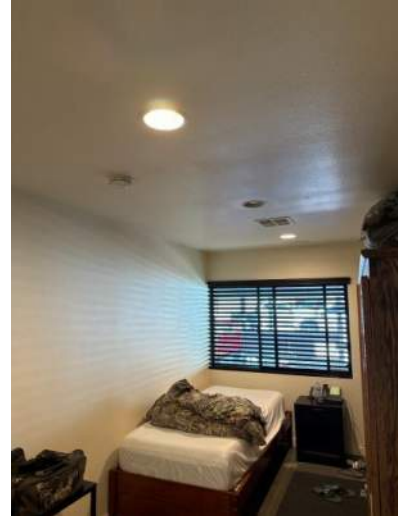
**Item No.:** D5040.50.009  
**Floor/Room:** 1st / Various  
**Priority:** Immediate (0-1 Years)  
**Quantity/Unit of Measure:** 9,600/SF  
**Total Deficiency Cost:** \$536,350  
**Deficiency Description:** Interior lighting systems are at or are approaching the end of their expected useful lives.

**Description of Work:** Replace the existing interior lighting systems and associated wiring devices, switches and controls.

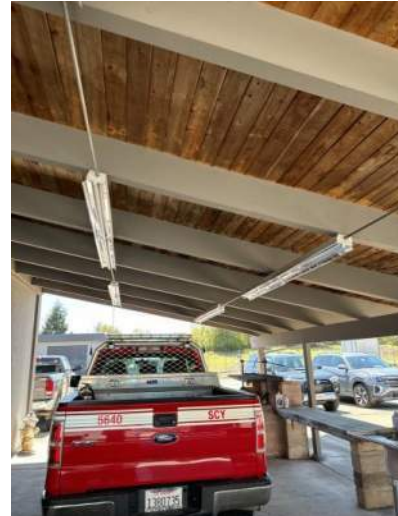
**Item No.:** D5040.50.003  
**Floor/Room:** Site / -  
**Priority:** Immediate (0-1 Years)  
**Quantity/Unit of Measure:** 8/EA  
**Total Deficiency Cost:** \$4,890  
**Deficiency Description:** 1'W x 4'L two 40 watt surface mounted interior light fixture is damaged and should be replaced.

**Description of Work:** Replace the existing interior light fixture with a new interior light fixture.

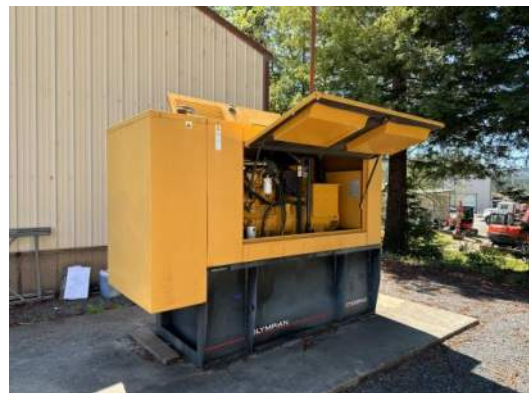
**Item No.:** D5010.10.003  
**Floor/Room:** Site / -  
**Priority:** Potential - Long Term (4-5 Years)  
**Quantity/Unit of Measure:** 1/EA  
**Total Deficiency Cost:** \$170,410  
**Deficiency Description:** The 100kW Diesel engine (including battery, charger, muffler, day tank) is at or is approaching end of its expected useful life.

**Description of Work:** Replace the existing generator with an appropriately sized new generator.

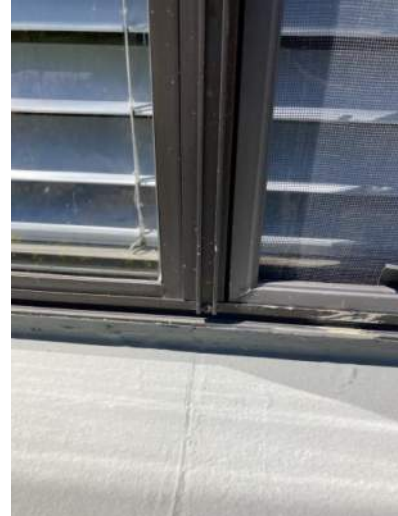
**Item No.:** B2020.20.003  
**Floor/Room:** 1st Floor / Exterior  
**Priority:** Potential - Long Term (4-5 Years)  
**Quantity/Unit of Measure:** 300/SF  
**Total Deficiency Cost:** \$178,490  
**Deficiency Description:** *Metal window is approaching the end of its useful life.*

**Description of Work:** *Replace metal window.*

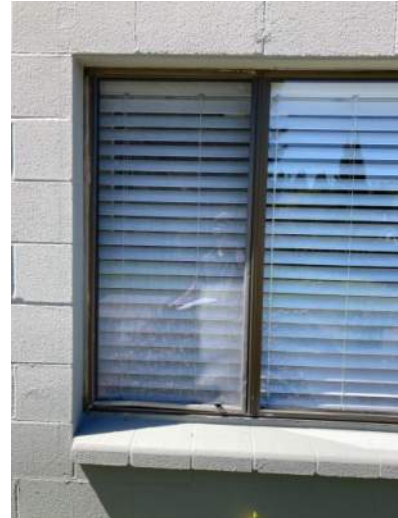
**Item No.:** B2020.10.012  
**Floor/Room:** 1st Floor / Exterior  
**Priority:** Impending (2-3 Years)  
**Quantity/Unit of Measure:** 100/SF  
**Total Deficiency Cost:** \$35,390  
**Deficiency Description:** *The existing screens are deteriorated.*

**Description of Work:** *Replace exterior window screens.*

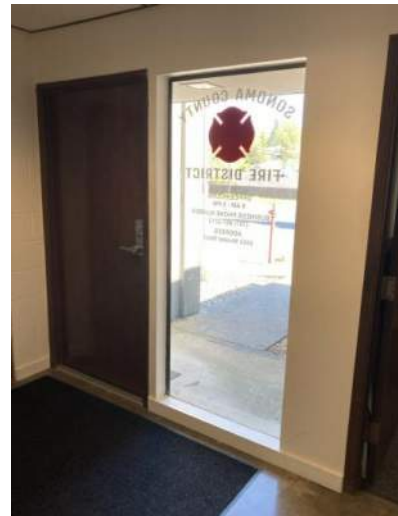
**Item No.:** B2020.20.003  
**Floor/Room:** 1st Floor / Lobby  
**Priority:** Impending (2-3 Years)  
**Quantity/Unit of Measure:** 21/SF  
**Total Deficiency Cost:** \$11,530  
**Deficiency Description:** *Metal window is approaching the end of its useful life.*

**Description of Work:** *Replace metal window.*

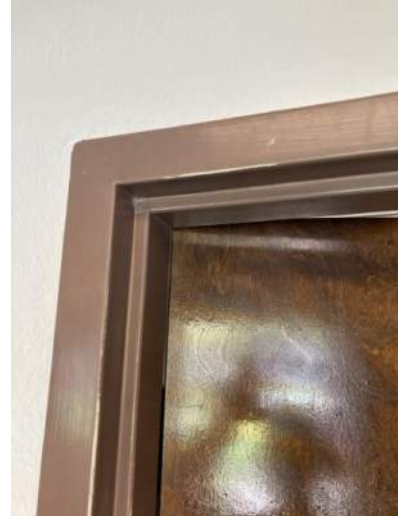
**Item No.:** C1030.10.001  
**Floor/Room:** 1st Floor / Radio Room  
**Priority:** **Impending (2-3 Years)**  
**Quantity/Unit of Measure:** 4/EA  
**Total Deficiency Cost:** \$31,150  
**Deficiency Description:** *Interior wood door is at or approaching the end of its useful life.*

**Description of Work:** *Replace with new wood door.*

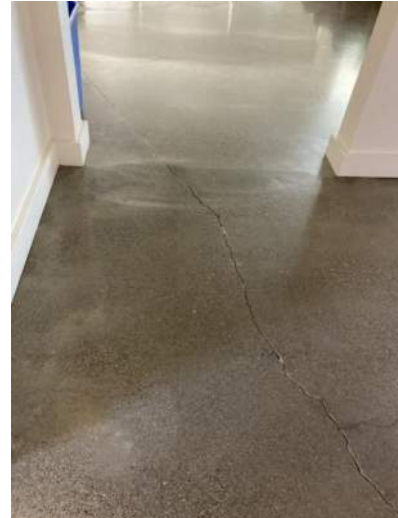
**Item No.:** A4010.10.001  
**Floor/Room:** 1st Floor / Hallway  
**Priority:** **Potential - Long Term (4-5 Years)**  
**Quantity/Unit of Measure:** 20/LF  
**Total Deficiency Cost:** \$540  
**Deficiency Description:** *Excessive cracks were detected in the floor slab-on-grade.*

**Comments:** *Further investigation is recommended to determine the source of cracking.*

**Description of Work:** *Fill the slab-on-grade cracks with caulking.*

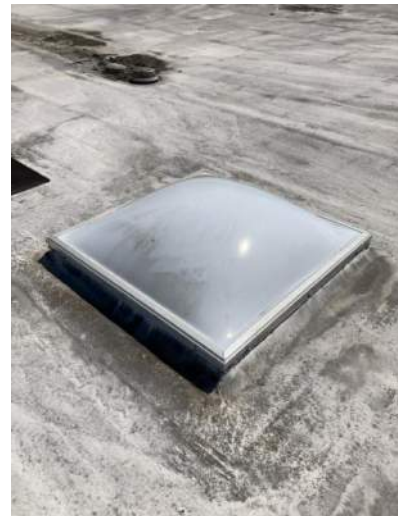
**Item No.:** B3060.10.001  
**Floor/Room:** Roof / Upper Roof  
**Priority:** **Crucial (1-2 Years)**  
**Quantity/Unit of Measure:** 64/SF  
**Total Deficiency Cost:** \$16,280  
**Deficiency Description:** *Skylights are leaking, damaged and discolored.*

**Comments:** *At four skylights.*

**Description of Work:** *Remove the existing skylight and replace it with a new skylight.*

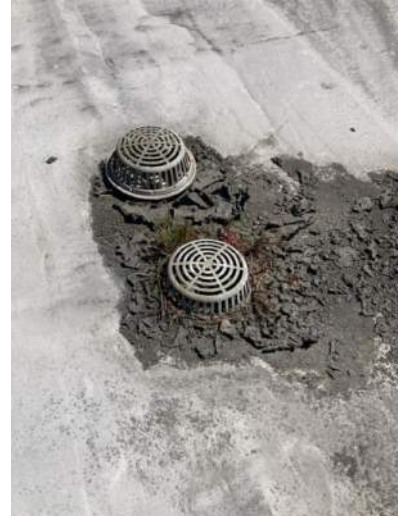
**Record ID:** 896  
**System:** D2030 - BUILDING SUPPORT PLUMBING SYSTEMS  
**Item No.:** D2030.30.001  
**Floor/Room:** Roof / Upper Roof  
**Priority:** Immediate (0-1 Years)  
**Quantity/Unit of Measure:** 2/EA  
**Total Deficiency Cost:** \$6,480  
**Deficiency Description:** *Roof drains are damaged and clogged.*

**Description of Work:** *Repair or replace roof drains and provide cleaning.*

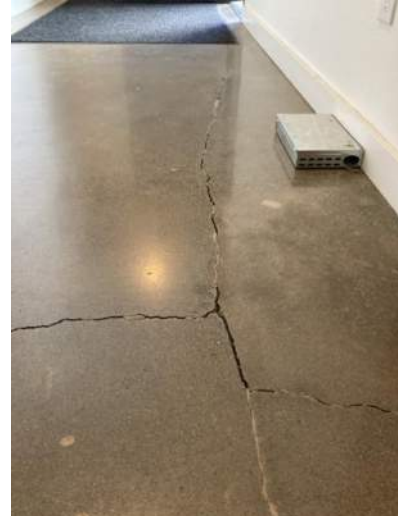
**Record ID:** 897  
**System:** A4010 - STANDARD SLABS-ON-GRADE  
**Item No.:** A4010.10.001  
**Floor/Room:** 1st Floor / Hallway  
**Priority:** Potential - Long Term (4-5 Years)  
**Quantity/Unit of Measure:** 50/LF  
**Total Deficiency Cost:** \$1,340  
**Deficiency Description:** *Excessive cracks were detected in the floor slab-on-grade.*

**Comments:** *Further investigation is recommended to determine the source of cracking.*

**Description of Work:** *Fill the slab-on-grade cracks with sealant.*

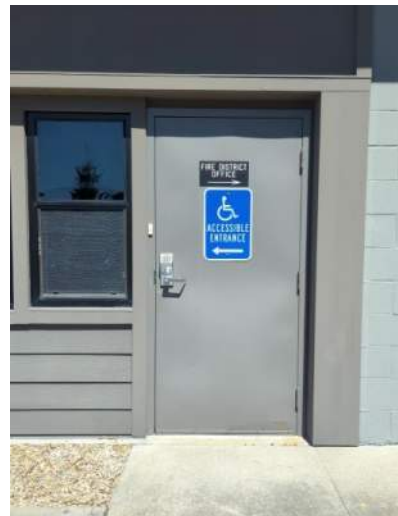
**Record ID:** 931  
**System:** B2050 - EXTERIOR DOORS AND GRILLES  
**Item No.:** B2050.20.003  
**Floor/Room:** 1st Floor / Exterior  
**Priority:** Impending (2-3 Years)  
**Quantity/Unit of Measure:** 1/EA  
**Total Deficiency Cost:** \$12,390  
**Deficiency Description:** *Exterior doors, frames and hardware are approaching the end of their useful life.*

**Description of Work:** *Replace the exterior doors, frames and hardware.*

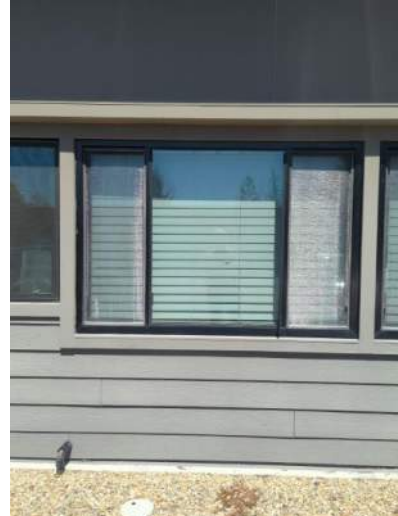
**Item No.:** B2010.10.006  
**Floor/Room:** 1st Floor / Exterior  
**Priority:** **Crucial (1-2 Years)**  
**Quantity/Unit of Measure:** 20/LF  
**Total Deficiency Cost:** \$680  
**Deficiency Description:** *Trim is showing signs of wood rot.*

**Description of Work:** *Replace trim and finish to match.*

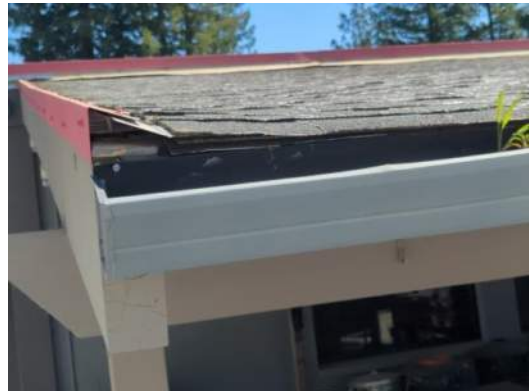
**Item No.:** B3010.90.001  
**Floor/Room:** Roof / Rear Porch  
**Priority:** **Crucial (1-2 Years)**  
**Quantity/Unit of Measure:** 30/LF  
**Total Deficiency Cost:** \$5,090  
**Deficiency Description:** *Roof flashing is missing.*

**Description of Work:** *Replace missing flashing.*

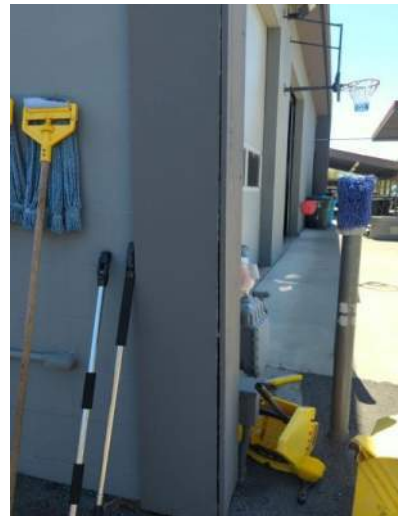
**Item No.:** B2010.10.006  
**Floor/Room:** 1st Floor / Apparatus Bay Exterior  
**Priority:** **Crucial (1-2 Years)**  
**Quantity/Unit of Measure:** 10/LF  
**Total Deficiency Cost:** \$330  
**Deficiency Description:** *Trim is worn and should be replaced.*

**Comments:** *At northwest corner.*

**Description of Work:** *Replace trim and finish to match.*

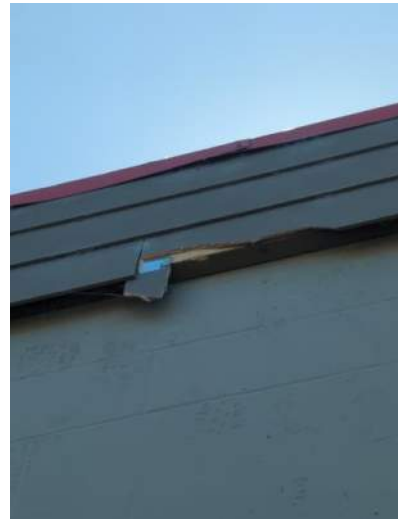
**Item No.:** B3010.90.010  
**Floor/Room:** Roof / Exterior  
**Priority:** **Impending (2-3 Years)**  
**Quantity/Unit of Measure:** 24/LF  
**Total Deficiency Cost:** \$830  
**Deficiency Description:** *The fascia is deteriorated.*

**Comments:** *North side of building.*

**Description of Work:** *Selectively remove deteriorated fascia and replace with new material to match.*

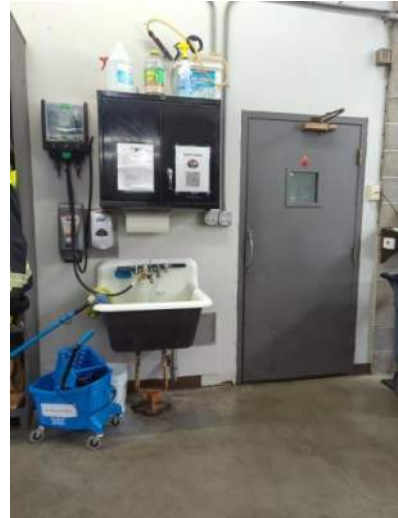
**Item No.:** C2010.70.001  
**Floor/Room:** 1st Floor / Apparatus Bay  
**Priority:** **Impending (2-3 Years)**  
**Quantity/Unit of Measure:** 32/SF  
**Total Deficiency Cost:** \$710  
**Deficiency Description:** *Painted gypsum wallboard is showing signs of wear.*

**Description of Work:** *Patch and paint the gypsum wallboard.*

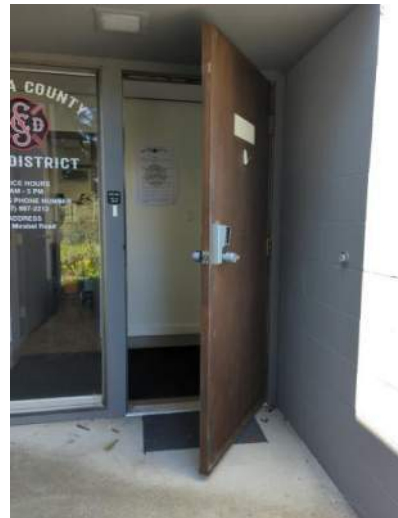
**Item No.:** B2050.10.006  
**Floor/Room:** 1st Floor / Lobby  
**Priority:** **Impending (2-3 Years)**  
**Quantity/Unit of Measure:** 1/EA  
**Total Deficiency Cost:** \$7,760  
**Deficiency Description:** *Exterior wood entrance door, frame and hardware is approaching the end of its useful life.*

**Description of Work:** *Replace with steel door, frame, and hardware.*

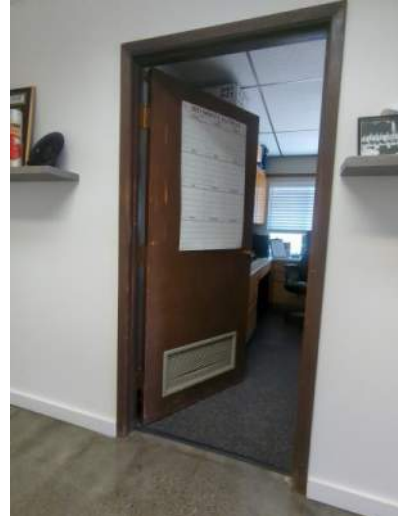
**Item No.:** C1030.10.008  
**Floor/Room:** 1st Floor / -  
**Priority:** **Necessary - Long Term (3-4 Years)**  
**Quantity/Unit of Measure:** 5/EA  
**Total Deficiency Cost:** \$5,540  
**Deficiency Description:** *Interior wood doors in wood frames are visually in need of refurbishment.*

**Description of Work:** *Refurbish and restain the wood door.*

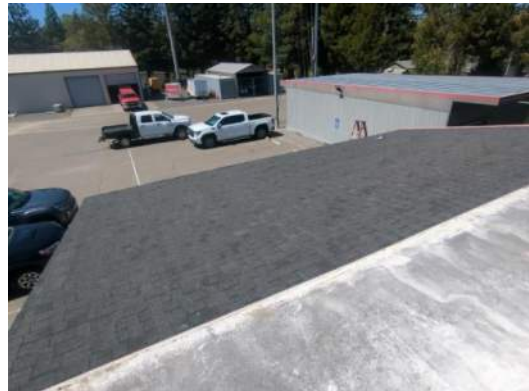
**Item No.:** B3010.10.001  
**Floor/Room:** Roof / -  
**Priority:** **Potential - Long Term (4-5 Years)**  
**Quantity/Unit of Measure:** 1,200/SF  
**Total Deficiency Cost:** \$69,100  
**Deficiency Description:** *Asphalt composition roof is showing signs of wear.*

**Description of Work:** *Remove and replace asphalt composition shingle roofing.*

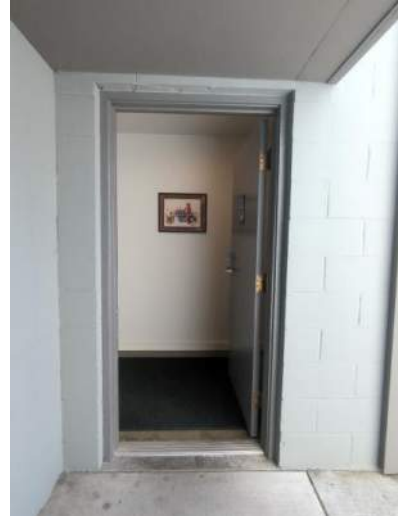
**Deficiency Description:** *Exterior wood entrance door, frame and hardware is approaching the end of its useful life.*

**Comments:** *Steel door in wood frame. Interior grade door, typ.*

**Description of Work:** *Replace with steel door, frame, and hardware.*

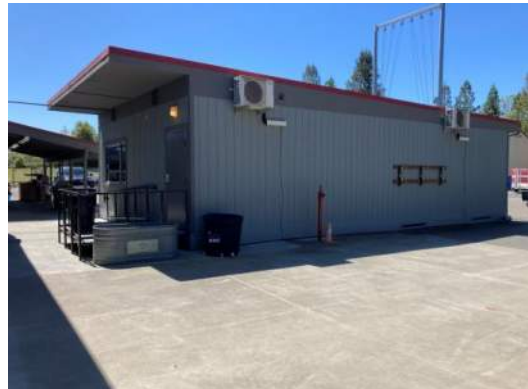
**Item No.:** F1020.40.001  
**Floor/Room:** Site / -  
**Priority:** **Immediate (0-1 Years)**  
**Quantity/Unit of Measure:** 1/LS  
**Total Deficiency Cost:** \$882,300  
**Deficiency Description:** *Modular building is approaching the end of its useful life.*

**Description of Work:** *Replace modular building in kind.*

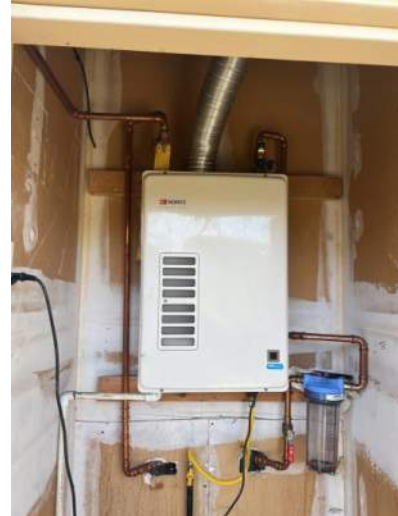
**Item No.:** D2010.20.001  
**Floor/Room:** 1st Floor / Water Heater  
**Priority:** **Planned - Long Term (6-10 Years)**  
**Quantity/Unit of Measure:** 1/EA  
**Total Deficiency Cost:** \$3,970  
**Deficiency Description:** *Tankless water heater is approaching the end of its expected useful life.*

**Description of Work:** *Provide equipment replacement and installation.*

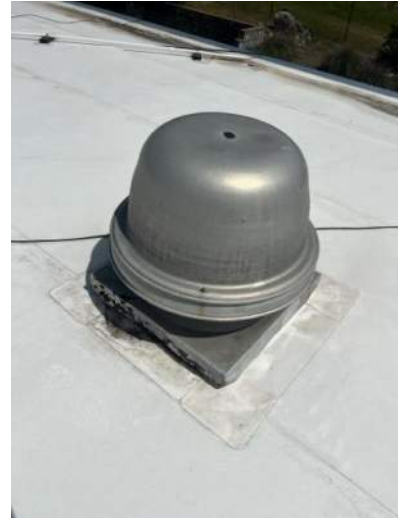
**Item No.:** D3060.30.005  
**Floor/Room:** Roof / -  
**Priority:** **Crucial (1-2 Years)**  
**Quantity/Unit of Measure:** 1/EA  
**Total Deficiency Cost:** \$7,460  
**Deficiency Description:** *Roof exhaust fan is approaching the end of its expected useful life.*

**Description of Work:** *Provide equipment replacement and installation.*

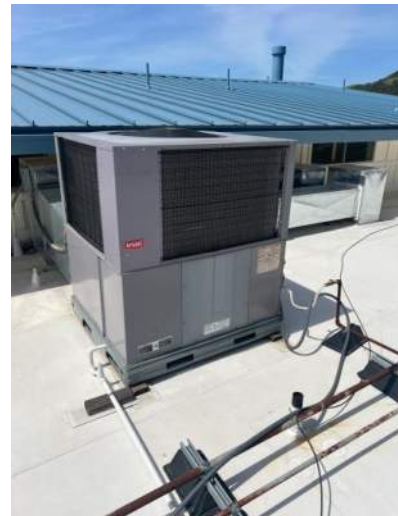
**Item No.:** D3030.10.018  
**Floor/Room:** Roof / -  
**Priority:** **Planned - Long Term (6-10 Years)**  
**Quantity/Unit of Measure:** 1/EA  
**Total Deficiency Cost:** \$59,850  
**Deficiency Description:** *Rooftop mounted packaged DX AC unit (5 tons) is approaching the end of its expected useful life.*

**Description of Work:** *Provide equipment replacement and installation.*

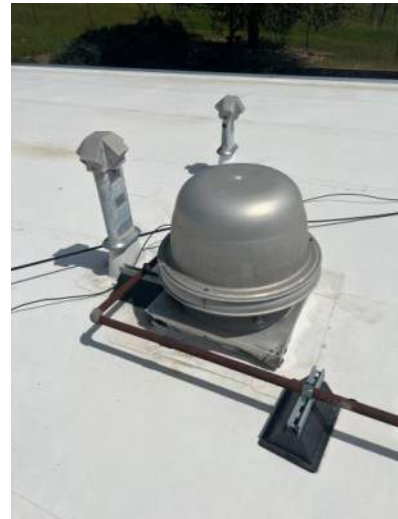
**Item No.:** D3060.30.005  
**Floor/Room:** Roof / -  
**Priority:** **Crucial (1-2 Years)**  
**Quantity/Unit of Measure:** 1/EA  
**Total Deficiency Cost:** \$7,460  
**Deficiency Description:** *Roof exhaust fan is approaching the end of its expected useful life.*

**Description of Work:** *Provide equipment replacement and installation.*

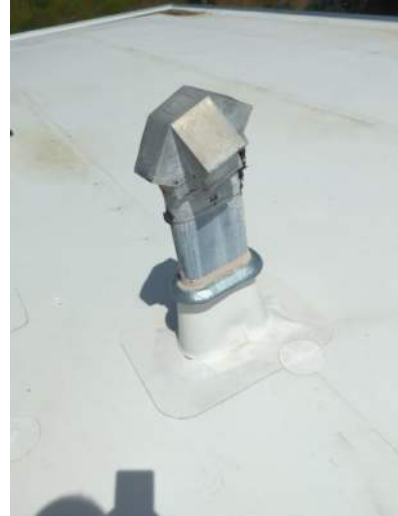
**Record ID:** 632  
**System:** D3060 - VENTILATION

**Item No.:** D3060.70.001  
**Floor/Room:** Roof / -  
**Priority:** **Impending (2-3 Years)**  
**Quantity/Unit of Measure:** 2/SF  
**Total Deficiency Cost:** \$0  
**Deficiency Description:** *Roof vent cap is loose.*

**Description of Work:** *Provide equipment maintenance.*

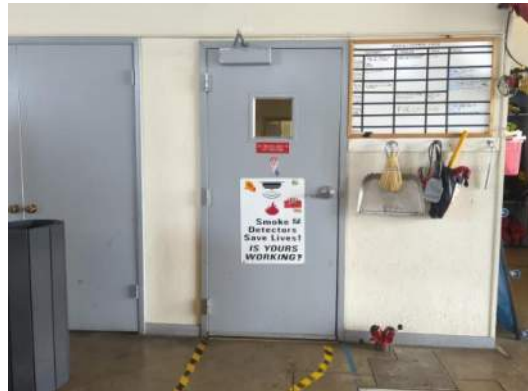
**Record ID:** 633  
**System:** C1030 - INTERIOR DOORS

**Item No.:** C1030.10.003  
**Floor/Room:** 1st Floor / Apparatus Bay  
**Priority:** **Impending (2-3 Years)**  
**Quantity/Unit of Measure:** 3/EA  
**Total Deficiency Cost:** \$31,830  
**Deficiency Description:** *Interior metal door is at or approaching the end of its useful life.*

**Comments:** *Door gets caught on frame.*

**Description of Work:** *Replace interior hollow metal door.*

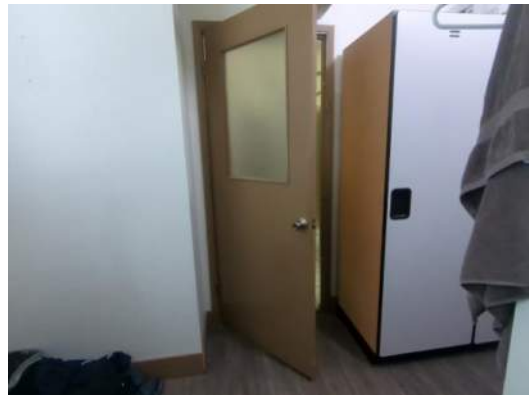
**Item No.:** C1030.10.001  
**Floor/Room:** 1st Floor / Dorm  
**Priority:** **Crucial (1-2 Years)**  
**Quantity/Unit of Measure:** 12/EA  
**Total Deficiency Cost:** \$89,470  
**Deficiency Description:** *Interior wood door is at or approaching the end of its useful life.*

**Comments:** *All interior doors.*

**Description of Work:** *Replace with new wood door.*

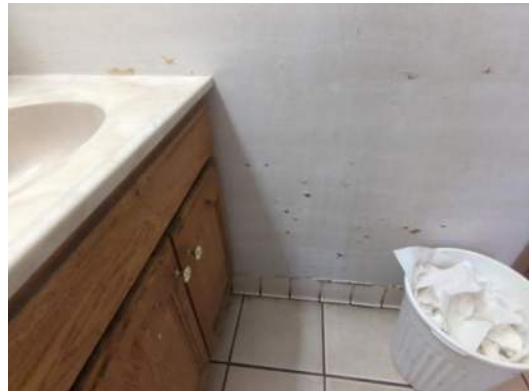
**Record ID:** 636  
**System:** C2010 - WALL FINISHES

**Item No.:** C2010.20.003  
**Floor/Room:** 1st Floor / Bathroom  
**Priority:** **Necessary - Long Term (3-4 Years)**  
**Quantity/Unit of Measure:** 36/SF  
**Total Deficiency Cost:** \$810  
**Deficiency Description:** *Fiberglass reinforced paneling is at or approaching the end of its useful life.*

**Description of Work:** *Replace the fiberglass reinforced paneling.*

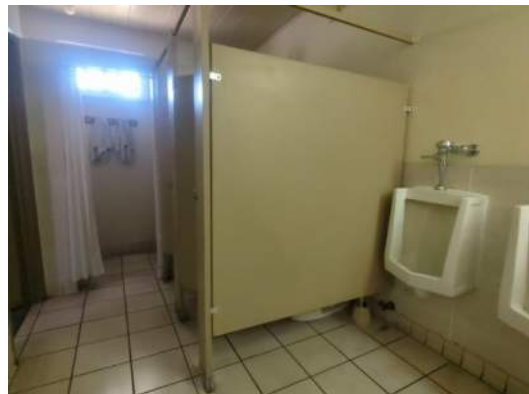
**Record ID:** 637  
**System:** C1090 - INTERIOR SPECIALTIES

**Item No.:** C1090.25.001  
**Floor/Room:** 1st Floor / Bathroom  
**Priority:** **Crucial (1-2 Years)**  
**Quantity/Unit of Measure:** 3/EA  
**Total Deficiency Cost:** \$12,190  
**Deficiency Description:** *Toilet partitions are past their useful life.*

**Description of Work:** *Replace the toilet partitions.*

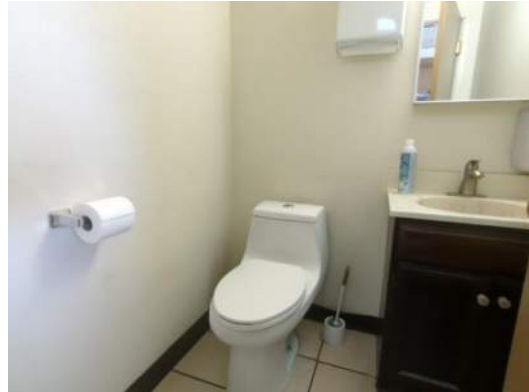
**Item No.:** C2010.70.001  
**Floor/Room:** 1st Floor / Toilet Room  
**Priority:** **Necessary - Long Term (3-4 Years)**  
**Quantity/Unit of Measure:** 100/SF  
**Total Deficiency Cost:** \$2,320  
**Deficiency Description:** *Painted gypsum wallboard is showing signs of wear.*

**Description of Work:** *Patch and paint the gypsum wallboard.*

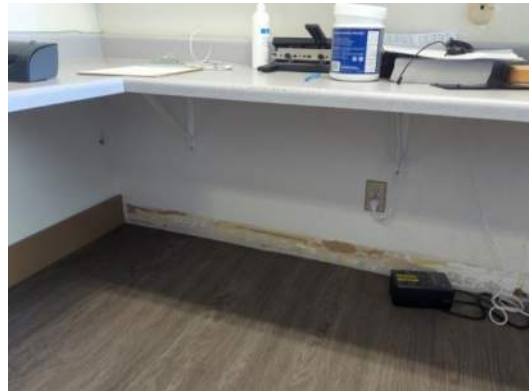
**Record ID:** 639  
**System:** C1010 - INTERIOR PARTITIONS

**Item No.:** C1010.10.001  
**Floor/Room:** 1st Floor / Office  
**Priority:** **Crucial (1-2 Years)**  
**Quantity/Unit of Measure:** 25/SF  
**Total Deficiency Cost:** \$180  
**Deficiency Description:** *Painted gypsum wallboard is in poor condition with several cracks.*

**Description of Work:** *Remove and replace existing gypsum board with a new gypsum board and expansion joints. Tape and paint.*

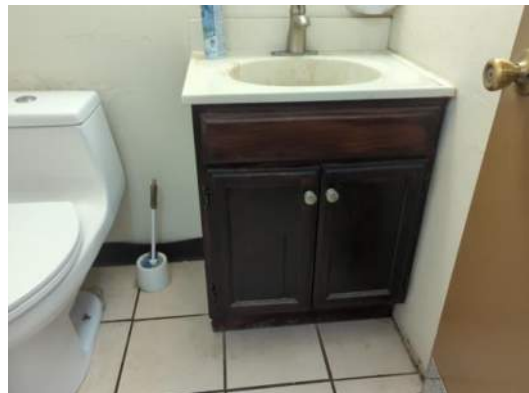
**Record ID:** 640  
**System:** E2010 - FIXED FURNISHINGS

**Item No.:** E2010.30.004  
**Floor/Room:** 1st Floor / Bathroom  
**Priority:** **Impending (2-3 Years)**  
**Quantity/Unit of Measure:** 4/LF  
**Total Deficiency Cost:** \$6,370  
**Deficiency Description:** *The existing casework is at or is approaching the end of its useful life.*

**Description of Work:** *Replace original wood cabinets and countertops.*

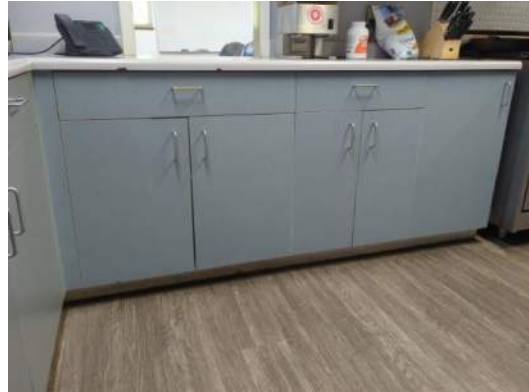
**Item No.:** E2010.30.009  
**Floor/Room:** 1st Floor / Kitchen  
**Priority:** **Impending (2-3 Years)**  
**Quantity/Unit of Measure:** 32/LF  
**Total Deficiency Cost:** \$76,090  
**Deficiency Description:** *Plastic laminate casework is at or will be approaching the end of its expected useful life.*

**Description of Work:** *Provide new plastic laminate casework (upper, lower, and countertop)*

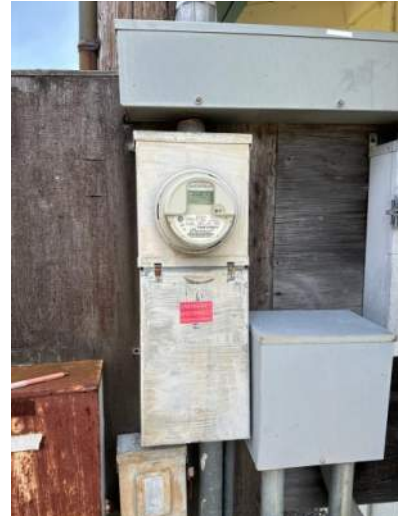
**Record ID:** 722  
**System:** D5020 - ELECTRICAL SERVICE AND DISTRIBUTION

**Item No.:** D5020.10.001  
**Floor/Room:** Site / -  
**Priority:** **Immediate (0-1 Years)**  
**Quantity/Unit of Measure:** 1/EA  
**Total Deficiency Cost:** \$8,290  
**Deficiency Description:** *The 225A (120/240V, 1P) meter main is approaching the end of its expected useful life.*

**Description of Work:** *Replace the existing metered main with a new metered main.*

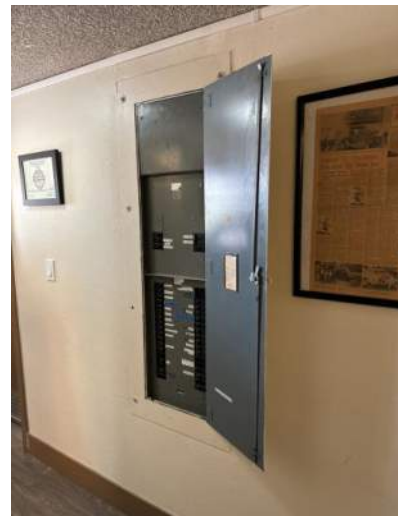
**Record ID:** 726  
**System:** D5020 - ELECTRICAL SERVICE AND DISTRIBUTION

**Item No.:** D5020.30.1002  
**Floor/Room:** 1st / Corridor  
**Priority:** **Immediate (0-1 Years)**  
**Quantity/Unit of Measure:** 1/EA  
**Total Deficiency Cost:** \$18,440  
**Deficiency Description:** *The 225A (42 ckts, 120/240V, 3P) panelboard is approaching the end of its expected useful life.*

**Comments:** *Cover is bent.*

**Description of Work:** *Replace the existing panelboard with a new panelboard.*

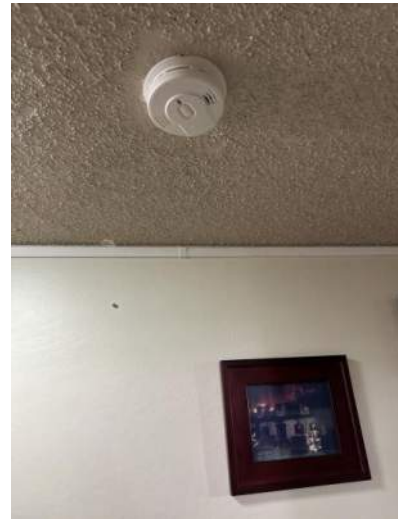
**Item No.:** D7050.10.023  
**Floor/Room:** 1st / Various  
**Priority:** Immediate (0-1 Years)  
**Quantity/Unit of Measure:** 5,500/SF  
**Total Deficiency Cost:** \$122,910  
**Deficiency Description:** *The existing fire alarm system is non-addressable and is lacking devices.*

**Description of Work:** *Provide a complete, site-wide, fully addressable fire alarm system.*

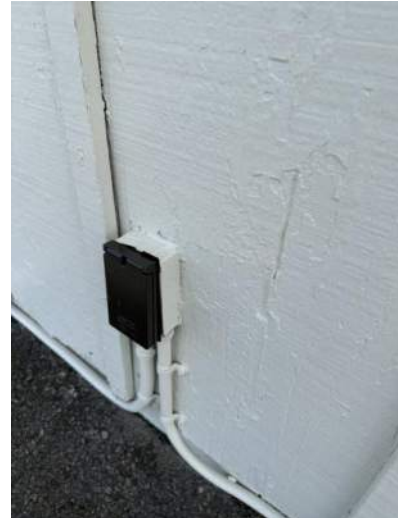
**Record ID:** 728  
**System:** D5030 - GENERAL PURPOSE ELECTRICAL POWER

**Item No.:** D5030.50.011  
**Floor/Room:** Site / -  
**Priority:** Immediate (0-1 Years)  
**Quantity/Unit of Measure:** 1/EA  
**Total Deficiency Cost:** \$170  
**Deficiency Description:** *Wweatherproof receptacle cover is loose or damaged.*

**Description of Work:** *Replace the existing receptacle with a new weatherproof receptacle.*

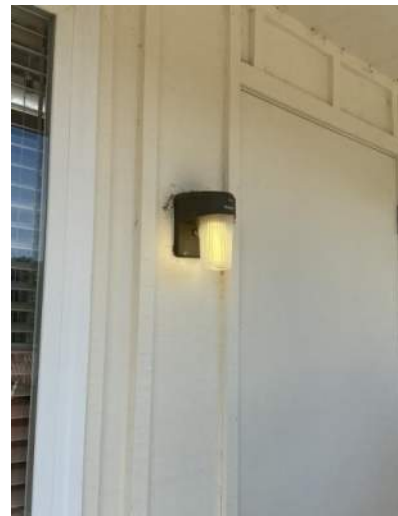
**Record ID:** 729  
**System:** D5040 - LIGHTING

**Item No.:** D5040.50.303  
**Floor/Room:** 1st / Exterior  
**Priority:** Immediate (0-1 Years)  
**Quantity/Unit of Measure:** 2/EA  
**Total Deficiency Cost:** \$4,160  
**Deficiency Description:** *The 13 lamp watts glass wall pack is approaching the end of its useful life and should be replaced.*

**Description of Work:** *Replace the existing lighting fixture with a new lighting fixture.*

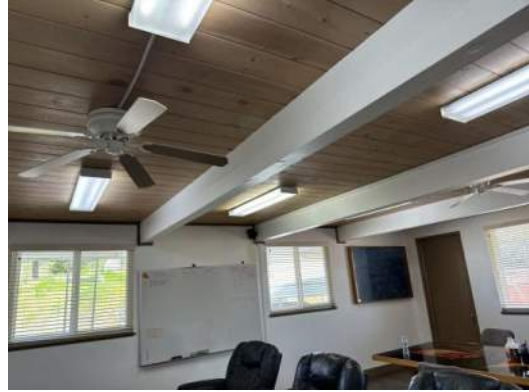
**Item No.:** D5040.50.009  
**Floor/Room:** 1st / Various  
**Priority:** Immediate (0-1 Years)  
**Quantity/Unit of Measure:** 5,500/SF  
**Total Deficiency Cost:** \$307,280  
**Deficiency Description:** Interior lighting systems are at or are approaching the end of their expected useful lives.

**Description of Work:** Replace the existing interior lighting systems and associated wiring devices, switches and controls.

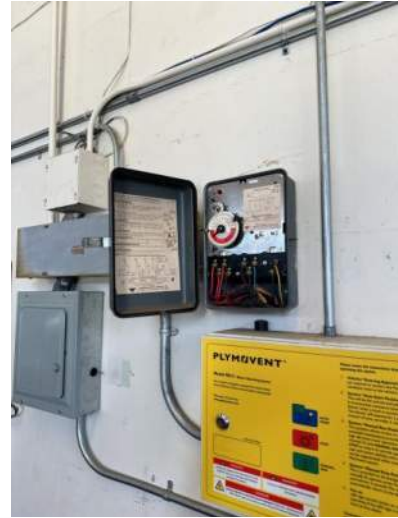
**Record ID:** 733  
**System:** D5040 - LIGHTING

**Item No.:** D5040.10.001  
**Floor/Room:** 1st / Apparatus Bay  
**Priority:** Immediate (0-1 Years)  
**Quantity/Unit of Measure:** 1/EA  
**Total Deficiency Cost:** \$740  
**Deficiency Description:** The time clock is approaching the end of its expected useful life.

**Description of Work:** Replace the existing time clock with a new time clock.
