# SONOMA COUNTY FIRE DISTRICT MASTER PLAN

DRAFT REPORT | NOV 19, 2024

PREPARED BY KITCHELL AND SHAH KAWASAKI ARCHITECTS

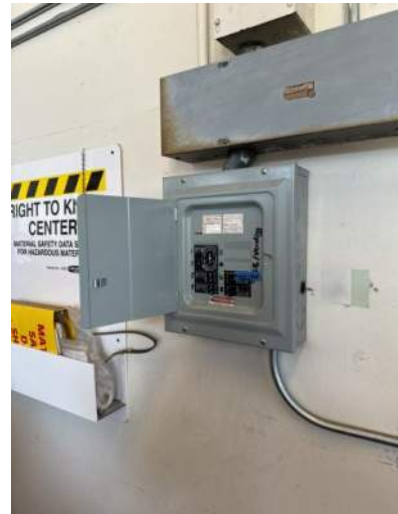
**Record ID:** 734  
**System:** D5020 - ELECTRICAL SERVICE AND DISTRIBUTION

**Item No.:** D5020.30.4001  
**Floor/Room:** 1st Floor / Apparatus Bay  
**Priority:** Immediate (0-1 Years)  
**Quantity/Unit of Measure:** 1/EA  
**Total Deficiency Cost:** \$4,920  
**Deficiency Description:** The 100A (18 ccts, 20A plug-in breakers, 1P) load center is approaching the end of its expected useful life.

**Description of Work:** Replace the existing load center with a new load center.

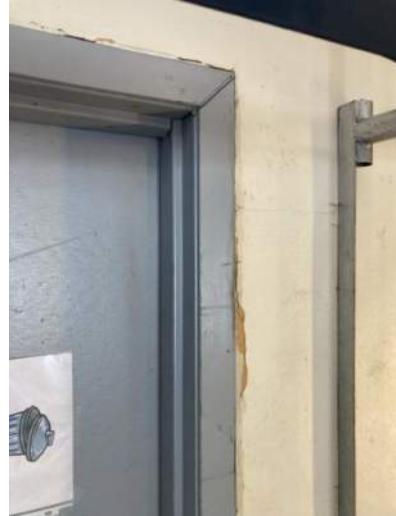
**Item No.:** B2050.10.005  
**Floor/Room:** 1st Floor / Apparatus Bay  
**Priority:** Potential - Long Term (4-5 Years)  
**Quantity/Unit of Measure:** 1/EA  
**Total Deficiency Cost:** \$5,770

**Deficiency Description:** *Exterior wood entrance door, frame and hardware is approaching the end of its useful life.*

**Description of Work:** *Replace wood door, frame, and hardware.*

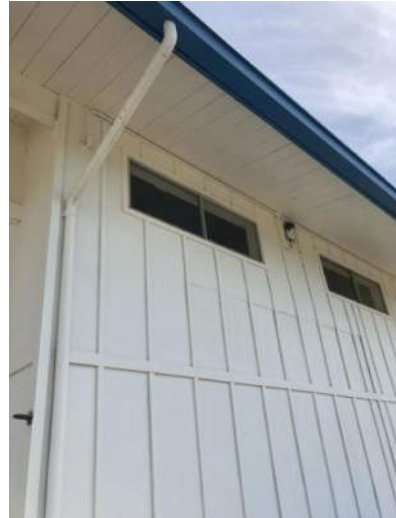
**Record ID:** 870  
**System:** B2020 - EXTERIOR WINDOWS

**Item No.:** B2020.20.003  
**Floor/Room:** 1st Floor / Exterior  
**Priority:** Potential - Long Term (4-5 Years)  
**Quantity/Unit of Measure:** 144/SF  
**Total Deficiency Cost:** \$85,690

**Deficiency Description:** *Metal transom window is approaching the end of its useful life.*

**Description of Work:** *Replace metal window.*

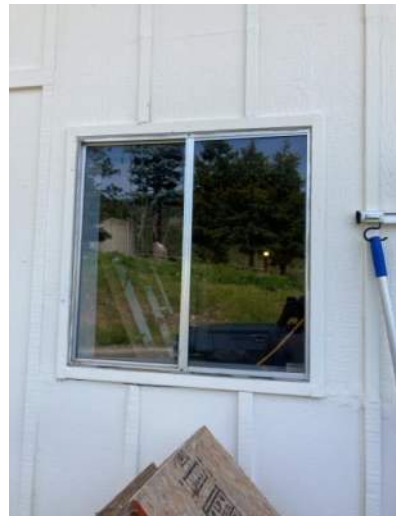
**Record ID:** 871  
**System:** B2020 - EXTERIOR WINDOWS

**Item No.:** B2020.20.003  
**Floor/Room:** 1st Floor / Exterior  
**Priority:** Potential - Long Term (4-5 Years)  
**Quantity/Unit of Measure:** 16/SF  
**Total Deficiency Cost:** \$9,520

**Deficiency Description:** *Metal window is approaching the end of its useful life.*

**Description of Work:** *Replace metal window.*

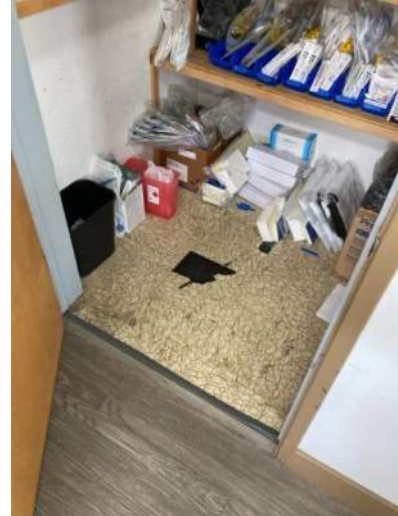
**Item No.:** C2030.50.001  
**Floor/Room:** 1st Floor / Dayroom Closet  
**Priority:** Potential - Long Term (4-5 Years)  
**Quantity/Unit of Measure:** 16/SF  
**Total Deficiency Cost:** \$470  
**Deficiency Description:** Vinyl composition tile is approaching the end of its useful life.

**Description of Work:** Remove the existing vinyl composition tile and replace.

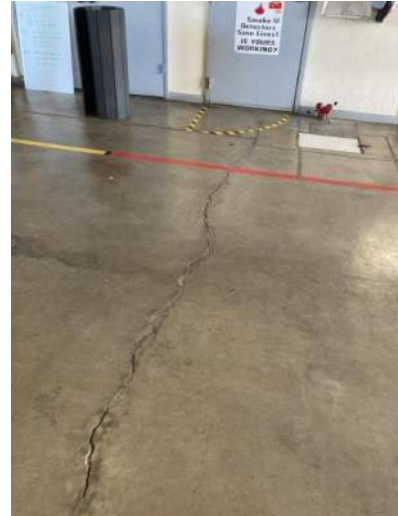
**Record ID:** 874  
**System:** A4010 - STANDARD SLABS-ON-GRADE

**Item No.:** A4010.10.001  
**Floor/Room:** 1st Floor / Apparatus Bay  
**Priority:** Potential - Long Term (4-5 Years)  
**Quantity/Unit of Measure:** 16/LF  
**Total Deficiency Cost:** \$440  
**Deficiency Description:** Excessive cracks were detected in the floor slab-on-grade.

**Description of Work:** Fill the slab-on-grade cracks with sealant.

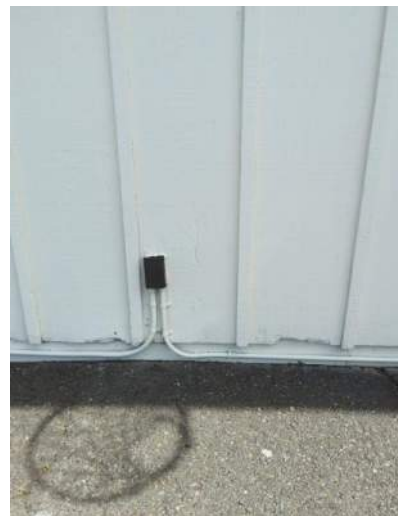
**Record ID:** 917  
**System:** B2010 - EXTERIOR WALLS

**Item No.:** B2010.10.001  
**Floor/Room:** Exterior / Exterior  
**Priority:** Impending (2-3 Years)  
**Quantity/Unit of Measure:** 20/SF  
**Total Deficiency Cost:** \$340  
**Deficiency Description:** Plywood siding is approaching the end of its useful life.

**Comments:** Wood rot at base of west wall.

**Description of Work:** Remove and replace the existing plywood siding with new plywood siding. Prime and paint.

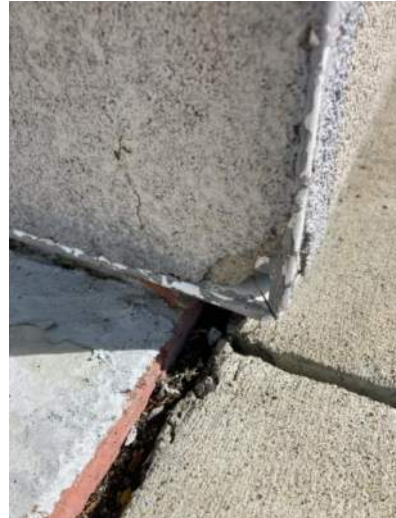
**Record ID:** 550  
**System:** B2010 - EXTERIOR WALLS

**Item No.:** B2010.10.009  
**Floor/Room:** Site / -  
**Priority:** **Necessary - Long Term (3-4 Years)**  
**Quantity/Unit of Measure:** 2,000/SF  
**Total Deficiency Cost:** \$125,420

**Description of Work:** *Clean, patch, and repair the cement plaster wall finish.*

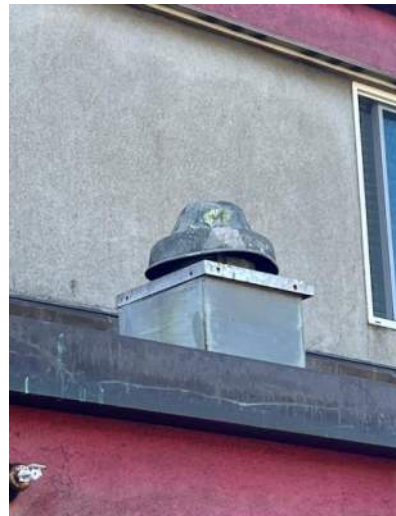
**Record ID:** 556  
**System:** D3060 - VENTILATION

**Item No.:** D3060.30.004  
**Floor/Room:** Roof / -  
**Priority:** **Crucial (1-2 Years)**  
**Quantity/Unit of Measure:** 1/EA  
**Total Deficiency Cost:** \$5,090

**Description of Work:** *Provide equipment replacement and installation.*

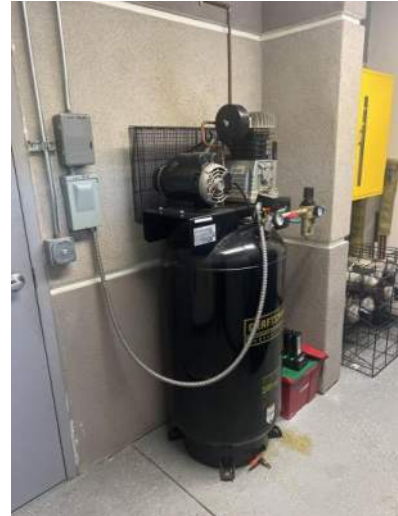
**Record ID:** 570  
**System:** D2060 - PROCESS SUPPORT PLUMBING SYSTEMS

**Item No.:** D2060.10.001  
**Floor/Room:** 1st Floor / Air Compressor  
**Priority:** **Potential - Long Term (4-5 Years)**  
**Quantity/Unit of Measure:** 1/EA  
**Total Deficiency Cost:** \$19,180  
**Deficiency Description:** *Air compressor is approaching the end of its expected useful life.*

**Description of Work:** *Provide equipment replacement and installation.*

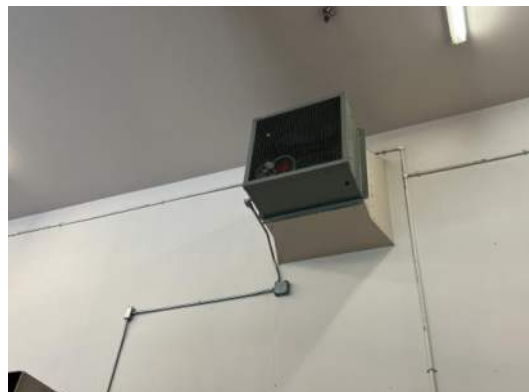
**Record ID:** 573  
**System:** D3060 - VENTILATION

**Item No.:** D3060.30.007  
**Floor/Room:** 1st Floor / Apparatus  
**Priority:** **Impending (2-3 Years)**  
**Quantity/Unit of Measure:** 2/EA  
**Total Deficiency Cost:** \$14,150  
**Deficiency Description:** *Sidewall ventilator is approaching the end of its expected useful life.*

**Description of Work:** *Provide equipment replacement and installation.*

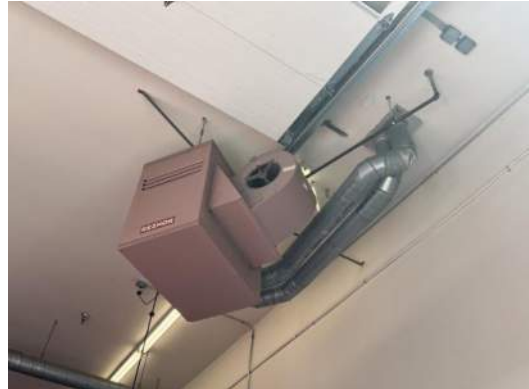
**Record ID:** 575  
**System:** D3020 - HEATING SYSTEMS

**Item No.:** D3020.70.003  
**Floor/Room:** 1st Floor / Apparatus  
**Priority:** **Planned - Long Term (6-10 Years)**  
**Quantity/Unit of Measure:** 1/EA  
**Total Deficiency Cost:** \$14,800  
**Deficiency Description:** *Gas fired unit heater is approaching the end of its expected useful life.*

**Description of Work:** *Provide equipment replacement and installation.*

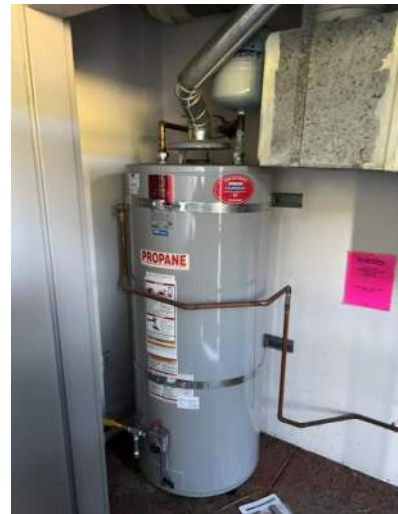
**Record ID:** 580  
**System:** D2010 - DOMESTIC WATER DISTRIBUTION

**Item No.:** D2010.20.003  
**Floor/Room:** 1st Floor / Mech Closet  
**Priority:** **Planned - Long Term (6-10 Years)**  
**Quantity/Unit of Measure:** 1/EA  
**Total Deficiency Cost:** \$30,830  
**Deficiency Description:** *Gas fired water heater is approaching the end of its expected useful life.*

**Comments:** *Propane water heater.*

**Description of Work:** *Provide equipment replacement and installation.*

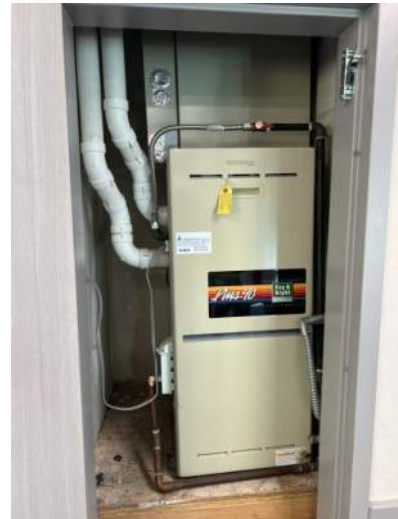
**Item No.:** D3020.10.007  
**Floor/Room:** 1st Floor / Community Room (Thomas Burke)

**Priority:** **Impending (2-3 Years)**  
**Quantity/Unit of Measure:** 1/EA  
**Total Deficiency Cost:** \$18,760  
**Deficiency Description:** *Gas-fired furnace is approaching the end of its expected useful life.*

**Description of Work:** *Provide equipment replacement and installation.*

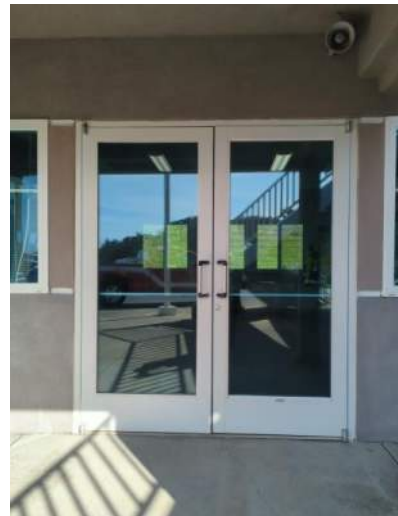
**Item No.:** B2020.10.001  
**Floor/Room:** 1st Floor / Community Room

**Priority:** **Impending (2-3 Years)**  
**Quantity/Unit of Measure:** 2/EA  
**Total Deficiency Cost:** \$1,420  
**Deficiency Description:** *Double door is hard to operate, in need of adjustment.*

**Comments:** *Community Room exterior entrance.*

**Description of Work:** *Inspect doors. Repair/tune up as necessary to make properly operable.*

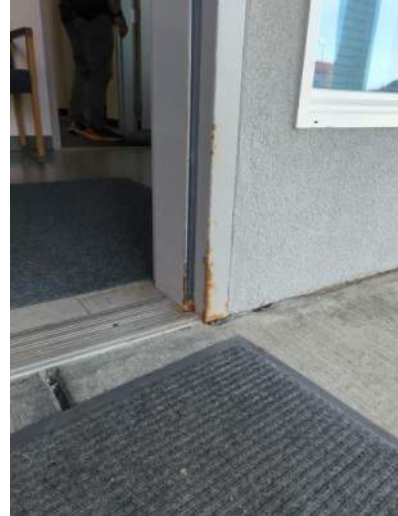
**Record ID:** 590  
**System:** B2050 - EXTERIOR DOORS AND GRILLES

**Item No.:** B2050.10.006  
**Floor/Room:** 1st Floor / Lobby  
**Priority:** **Crucial (1-2 Years)**  
**Quantity/Unit of Measure:** 6/EA  
**Total Deficiency Cost:** \$44,570  
**Deficiency Description:** *Doors are past useful life. Door frames are corroded.*

**Comments:** *At lobby, apparatus bay, rear apparatus bay, mech room, and community room exit door. The doors are wood.*

**Description of Work:** *Replace with steel door, frame, and hardware.*

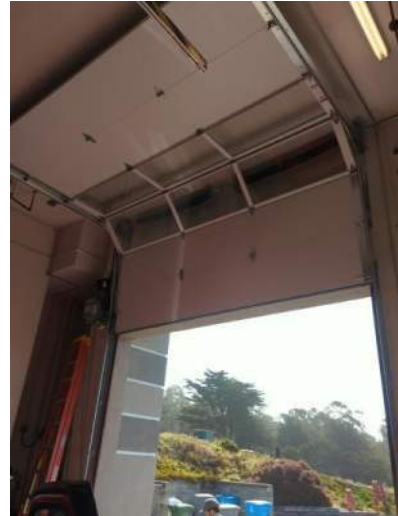
**Record ID:** 592  
**System:** B2050 - EXTERIOR DOORS AND GRILLES

**Item No.:** B2050.30.002  
**Floor/Room:** 1st Floor / Exterior  
**Priority:** **Necessary - Long Term (3-4 Years)**  
**Quantity/Unit of Measure:** 1/EA  
**Total Deficiency Cost:** \$20,300  
**Deficiency Description:** *Center Bay door is approaching the end of its expected useful life.*

**Comments:** *East door has been replaced more recently.*

**Description of Work:** *Provide equipment replacement and installation.*

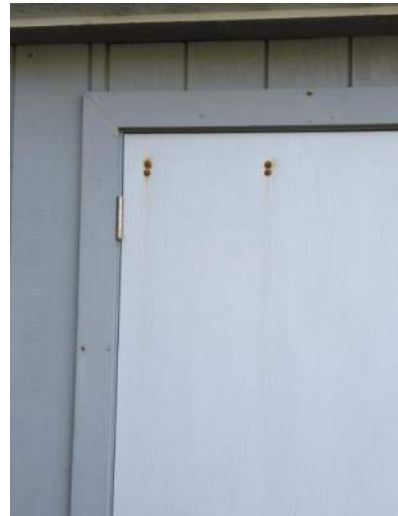
**Record ID:** 595  
**System:** B2050 - EXTERIOR DOORS AND GRILLES

**Item No.:** B2050.90.004  
**Floor/Room:** 1st Floor / Compressor Room  
**Priority:** **Impending (2-3 Years)**  
**Quantity/Unit of Measure:** 1/EA  
**Total Deficiency Cost:** \$5,320  
**Deficiency Description:** *Hardware is corroded.*

**Comments:** *Compressor room door.*

**Description of Work:** *Replace the associated hardware.*

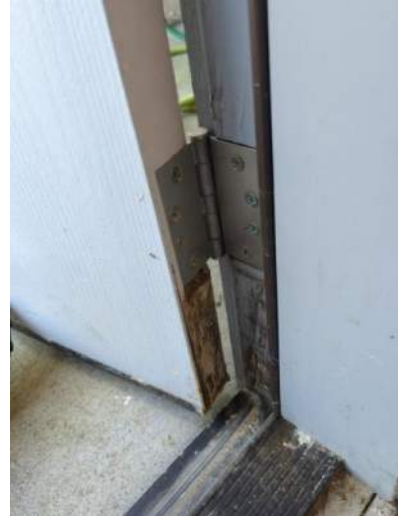
**Item No.:** B2050.10.006  
**Floor/Room:** 1st Floor / Compressor Room  
**Priority:** **Crucial (1-2 Years)**  
**Quantity/Unit of Measure:** 1/EA  
**Total Deficiency Cost:** \$7,430  
**Deficiency Description:** *Compressor room wood door: wood rot hinge side bottom of door.*

**Description of Work:** *Replace with steel door, frame, and hardware.*

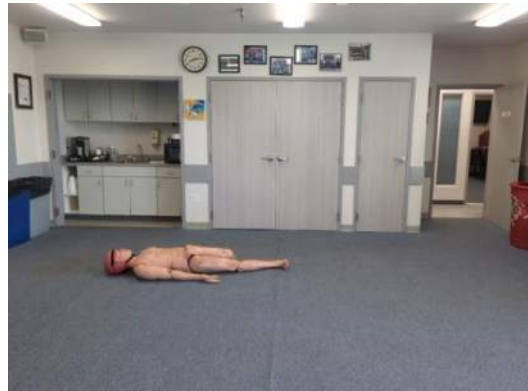
**Record ID:** 598  
**System:** C2030 - FLOORING

**Item No.:** C2030.75.002  
**Floor/Room:** 1st Floor / Community Room  
**Priority:** **Potential - Long Term (4-5 Years)**  
**Quantity/Unit of Measure:** 400/SF  
**Total Deficiency Cost:** \$12,270  
**Deficiency Description:** *Rolled carpet seams are failing.*

**Description of Work:** *Remove existing rolled carpeting and replace it with new 40 oz. nylon carpet.*

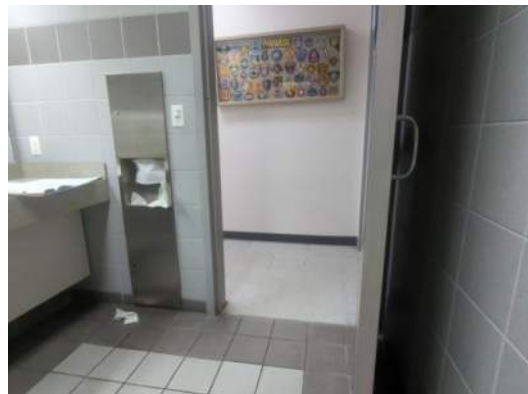
**Record ID:** 599  
**System:** C1030 - INTERIOR DOORS

**Item No.:** C1030.10.009  
**Floor/Room:** 1st Floor / Men's Toilet  
**Priority:** **Potential - Long Term (4-5 Years)**  
**Quantity/Unit of Measure:** 1/EA  
**Total Deficiency Cost:** \$1,140  
**Deficiency Description:** *Metal door and frame is corroded.*

**Description of Work:** *Refurbish/repair interior door and frame.*

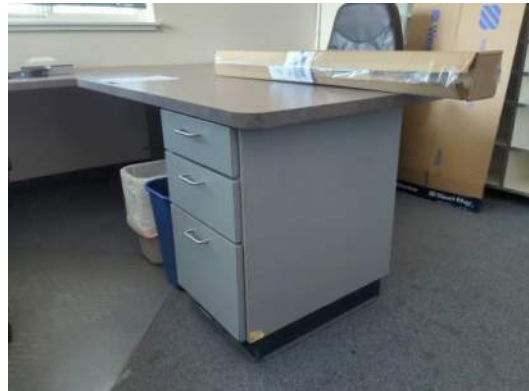
**Record ID:** 601  
**System:** E2010 - FIXED FURNISHINGS

**Item No.:** E2010.30.005  
**Floor/Room:** 1st Floor / Chief office  
**Priority:** Potential - Long Term (4-5 Years)  
**Quantity/Unit of Measure:** 3/LF  
**Total Deficiency Cost:** \$2,310  
**Deficiency Description:** *The existing casework is in need of refurbishment.*

**Description of Work:** *Repair, refurbish, and refinish the existing wood casework and counters.*

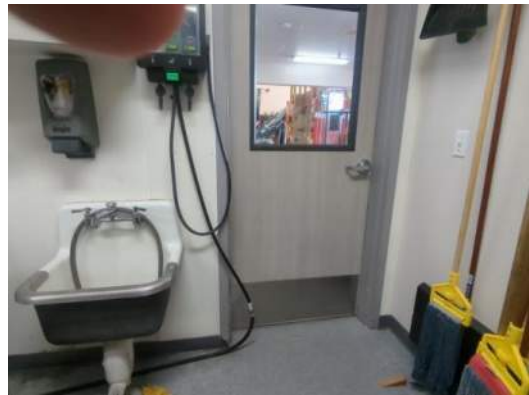
**Item No.:** C1030.90.003  
**Floor/Room:** 1st Floor / Laundry  
**Priority:** **Necessary - Long Term (3-4 Years)**  
**Quantity/Unit of Measure:** 1/EA  
**Total Deficiency Cost:** \$930  
**Deficiency Description:** *Metal door frames are in fair to poor condition.*

**Description of Work:** *Repair and refinish the metal door frames.*

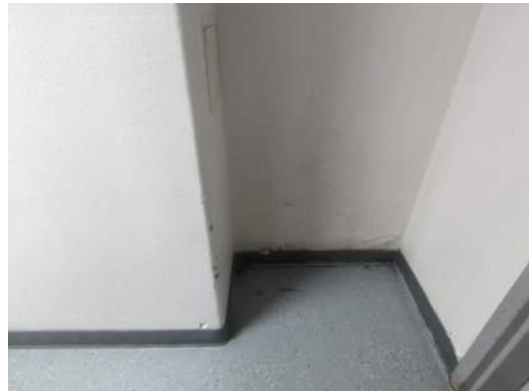
**Record ID:** 624  
**System:** C2010 - WALL FINISHES

**Item No.:** C2010.70.001  
**Floor/Room:** 1st Floor / Laundry  
**Priority:** **Necessary - Long Term (3-4 Years)**  
**Quantity/Unit of Measure:** 5/SF  
**Total Deficiency Cost:** \$130  
**Deficiency Description:** *Painted gypsum wallboard is showing signs of wear.*

**Description of Work:** *Patch and paint the gypsum wallboard.*

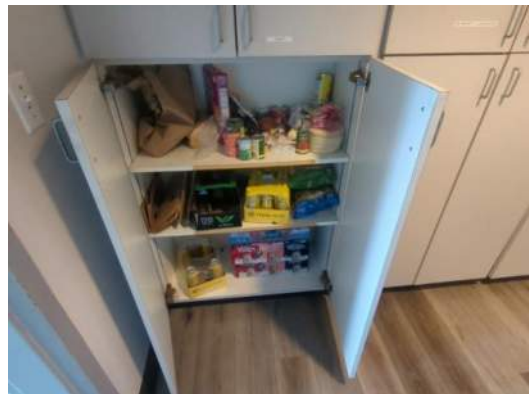
**Record ID:** 625  
**System:** E2010 - FIXED FURNISHINGS

**Item No.:** E2010.30.005  
**Floor/Room:** 2nd Floor / Hallway  
**Priority:** **Potential - Long Term (4-5 Years)**  
**Quantity/Unit of Measure:** 10/LF  
**Total Deficiency Cost:** \$7,680  
**Deficiency Description:** *The existing casework is in need of refurbishment.*

**Description of Work:** *Repair, refurbish, and refinish the existing wood casework and counters.*

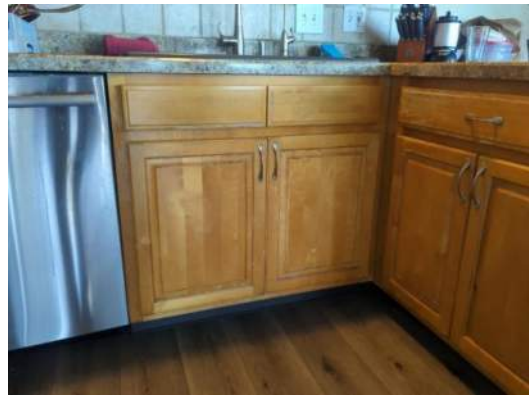
**Item No.:** E2010.30.005  
**Floor/Room:** 2nd Floor / Kitchen  
**Priority:** Potential - Long Term (4-5 Years)  
**Quantity/Unit of Measure:** 10/LF  
**Total Deficiency Cost:** \$7,680  
**Deficiency Description:** *The existing casework is in need of refurbishment.*

**Description of Work:** *Repair, refurbish, and refinish the existing wood casework and counters.*

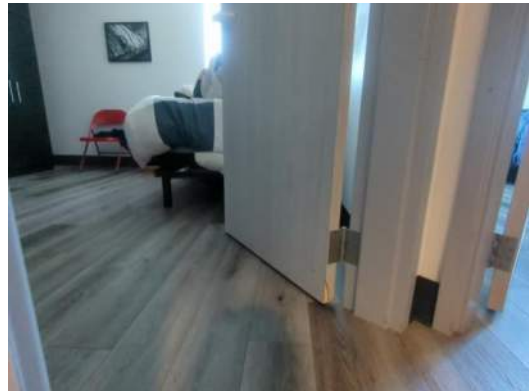
**Record ID:** 627  
**System:** B2050 - EXTERIOR DOORS AND GRILLES

**Item No.:** B2050.10.007  
**Floor/Room:** 2nd Floor / Dorm Room 2  
**Priority:** Potential - Long Term (4-5 Years)  
**Quantity/Unit of Measure:** 1/EA  
**Total Deficiency Cost:** \$6,000  
**Deficiency Description:** *Damaged plastic laminate on door edge.*

**Description of Work:** *Refurbish/repair wood door.*

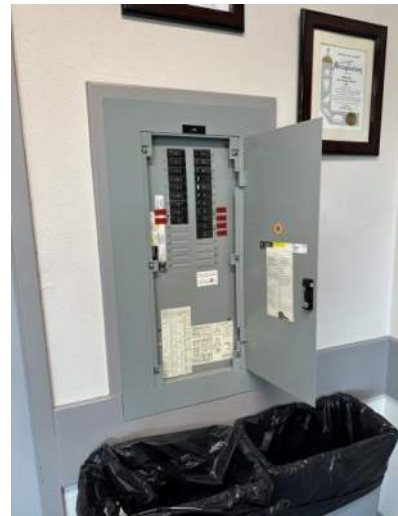
**Record ID:** 642  
**System:** D5020 - ELECTRICAL SERVICE AND DISTRIBUTION

**Item No.:** D5020.30.1001  
**Floor/Room:** 1st / Community  
**Priority:** Necessary - Long Term (3-4 Years)  
**Quantity/Unit of Measure:** 1/EA  
**Total Deficiency Cost:** \$9,440  
**Deficiency Description:** *The 100A (20 ckts, 120/240V, 3P) panelboard is approaching the end of its expected useful life.*

**Description of Work:** *Replace the existing panelboard with a new panelboard.*

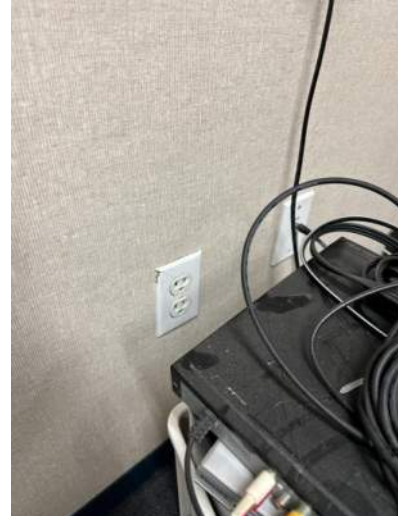
**Record ID:** 643  
**System:** D5030 - GENERAL PURPOSE ELECTRICAL POWER  
**Item No.:** D5030.50.008  
**Floor/Room:** 1st / Meeting  
**Priority:** Immediate (0-1 Years)  
**Quantity/Unit of Measure:** 1/EA  
**Total Deficiency Cost:** \$110  
**Deficiency Description:** A 20A duplex receptacle, 120V, grounded, is damaged and should be replaced.

**Description of Work:** Replace the damaged receptacle with a new receptacle.

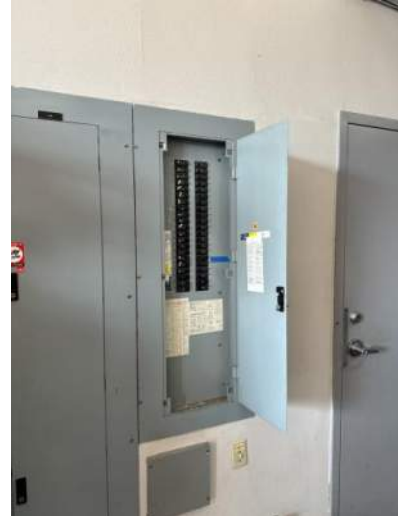
**Record ID:** 644  
**System:** D5020 - ELECTRICAL SERVICE AND DISTRIBUTION  
**Item No.:** D5020.30.1001  
**Floor/Room:** 1st / Apparatus  
**Priority:** Necessary - Long Term (3-4 Years)  
**Quantity/Unit of Measure:** 1/EA  
**Total Deficiency Cost:** \$9,440  
**Deficiency Description:** The 100A (20 ckts, 120/240V, 3P) panelboard is approaching the end of its expected useful life.

**Description of Work:** Replace the existing panelboard with a new panelboard.

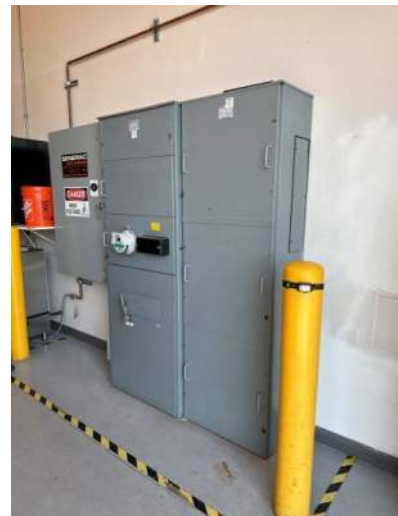
**Record ID:** 645  
**System:** D5020 - ELECTRICAL SERVICE AND DISTRIBUTION  
**Item No.:** D5020.10.302  
**Floor/Room:** 1st / Apparatus  
**Priority:** Necessary - Long Term (3-4 Years)  
**Quantity/Unit of Measure:** 1/EA  
**Total Deficiency Cost:** \$20,360  
**Deficiency Description:** The 400A metered main switchboard (3P, 120/208 ) is approaching the end of its expected useful life.

**Description of Work:** Replace the existing metered main switchboard with a new metered main switchboard.

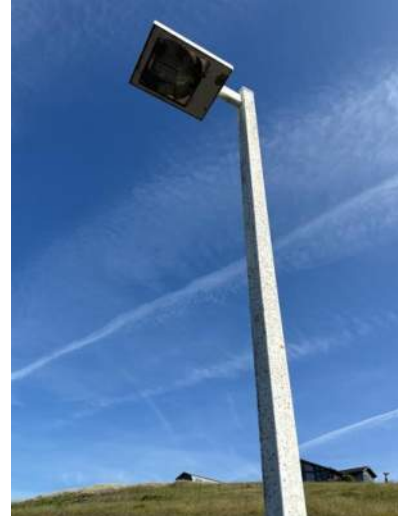
**Record ID:** 712  
**System:** G2020 - PARKING LOTS

**Item No.:** G2020.70.015  
**Floor/Room:** Site / -  
**Priority:** Immediate (0-1 Years)  
**Quantity/Unit of Measure:** 7/EA  
**Total Deficiency Cost:** \$88,650  
**Deficiency Description:** *Exterior lighting: Pole and pole mounted fixture is in poor condition.*

**Description of Work:** *Demolish existing pole and pole mounted fixture and Install/ replace with new.*

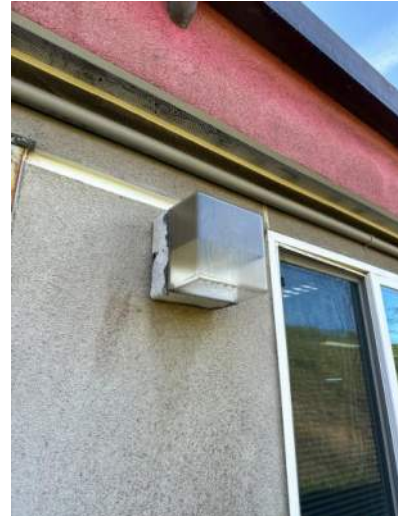
**Record ID:** 713  
**System:** D5040 - LIGHTING

**Item No.:** D5040.50.304  
**Floor/Room:** Site / -  
**Priority:** Immediate (0-1 Years)  
**Quantity/Unit of Measure:** 13/EA  
**Total Deficiency Cost:** \$19,860  
**Deficiency Description:** *The wall pack is approaching the end of its useful life and should be replaced.*

**Description of Work:** *Replace the existing lighting fixture with a new lighting fixture.*

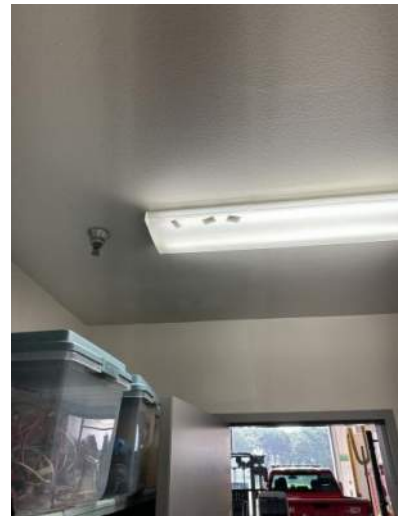
**Record ID:** 715  
**System:** D5040 - LIGHTING

**Item No.:** D5040.50.009  
**Floor/Room:** All / Various  
**Priority:** Immediate (0-1 Years)  
**Quantity/Unit of Measure:** 8,500/SF  
**Total Deficiency Cost:** \$474,910  
**Deficiency Description:** *Interior lighting systems are at or are approaching the end of their expected useful lives.*

**Description of Work:** *Replace the existing interior lighting systems and associated wiring devices, switches and controls.*

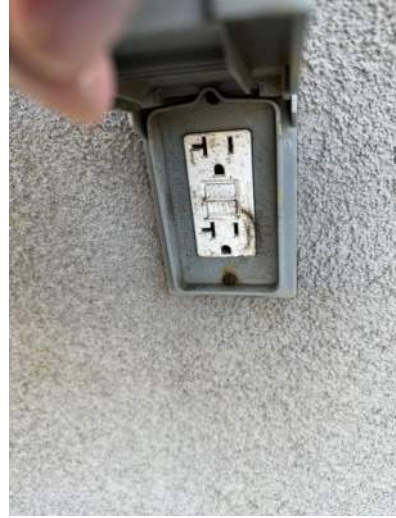
**Record ID:** 717  
**System:** D5030 - GENERAL PURPOSE ELECTRICAL POWER  
**Item No.:** D5030.50.011  
**Floor/Room:** Site / -  
**Priority:** Immediate (0-1 Years)  
**Quantity/Unit of Measure:** 10/EA  
**Total Deficiency Cost:** \$1,750  
**Deficiency Description:** *Weatherproof receptacles are damaged and should be replaced.*

**Description of Work:** *Replace the existing receptacle with a weatherproof receptacle,*

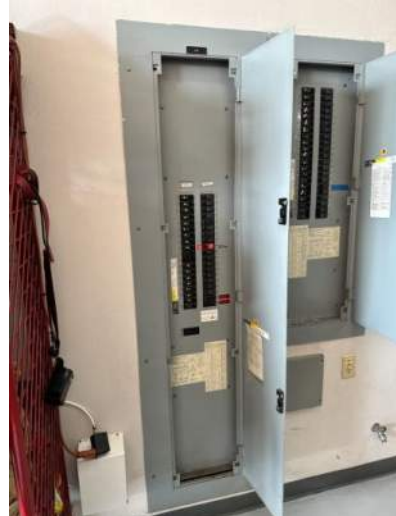
**Record ID:** 718  
**System:** D5020 - ELECTRICAL SERVICE AND DISTRIBUTION  
**Item No.:** D5020.30.1002  
**Floor/Room:** 1st / Apparatus  
**Priority:** Necessary - Long Term (3-4 Years)  
**Quantity/Unit of Measure:** 1/EA  
**Total Deficiency Cost:** \$21,000  
**Deficiency Description:** *The 225A (42 ckts, 120/240V, 3P) panelboard is approaching the end of its expected useful life.*

**Comments:** *Missing screws.*

**Description of Work:** *Replace the existing panelboard with a new panelboard.*

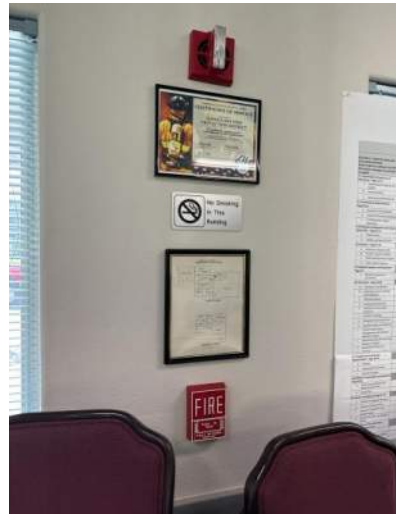
**Record ID:** 719  
**System:** D7050 - DETECTION AND ALARM  
**Item No.:** D7050.10.018  
**Floor/Room:** All / Various  
**Priority:** Immediate (0-1 Years)  
**Quantity/Unit of Measure:** 30/EA  
**Total Deficiency Cost:** \$39,660  
**Deficiency Description:** *The fire alarm field devices are at the end of its expected useful life.*

**Description of Work:** *Replace the existing devices.*

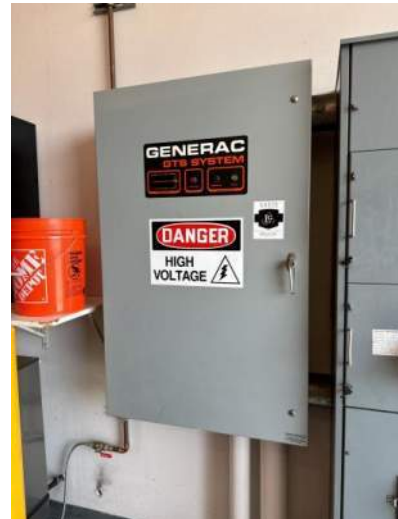
**Item No.:** D5010.70.007  
**Floor/Room:** 1st / Apparatus  
**Priority:** Immediate (0-1 Years)  
**Quantity/Unit of Measure:** 1/EA  
**Total Deficiency Cost:** \$28,970  
**Deficiency Description:** *The 400A 3-pole automatic transfer switch (ATS) is approaching the end of its expected useful life.*

**Description of Work:** *Replace the existing 3-pole ATS with a new 3-pole ATS.*

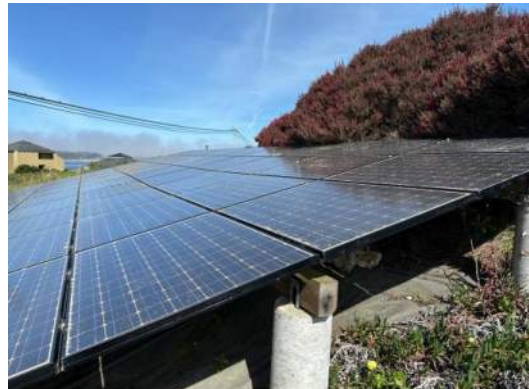
**Record ID:** 721  
**System:** D5010 - FACILITY POWER GENERATION

**Item No.:** D5010.30.003  
**Floor/Room:** Site / -  
**Priority:** Necessary - Long Term (3-4 Years)  
**Quantity/Unit of Measure:** 20,000/W  
**Total Deficiency Cost:** \$814,480  
**Deficiency Description:** *The ground mouted photovoltaic power system is in approaching the end of its useful life.*

**Comments:** *108 panels*

**Description of Work:** *Replace the existing photovoltaic power system and with a new one.*

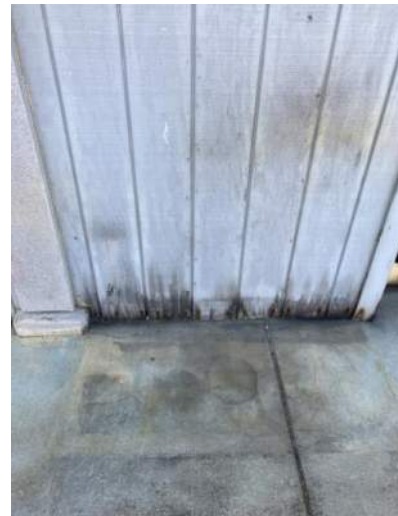
**Record ID:** 839  
**System:** B2010 - EXTERIOR WALLS

**Item No.:** B2010.10.003  
**Floor/Room:** 1st Floor / Exterior  
**Priority:** Necessary - Long Term (3-4 Years)  
**Quantity/Unit of Measure:** 50/SF  
**Total Deficiency Cost:** \$1,480  
**Deficiency Description:** *Wood decay on exterior siding.*

**Description of Work:** *Replace the existing wood siding. Place a new siding over building paper and plywood sheathing.*

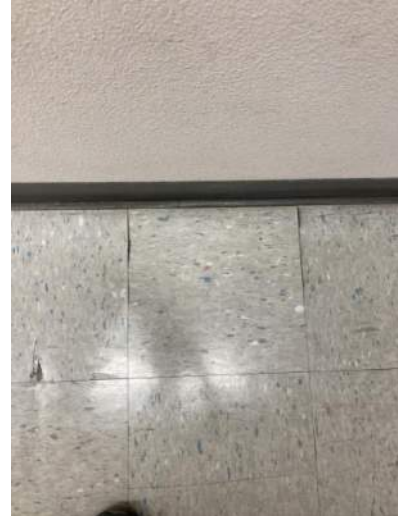
**Record ID:** 849  
**System:** C2030 - FLOORING  
**Item No.:** C2030.50.001  
**Floor/Room:** 1st Floor / Hallway  
**Priority:** Potential - Long Term (4-5 Years)  
**Quantity/Unit of Measure:** 200/SF  
**Total Deficiency Cost:** \$5,770  
**Deficiency Description:** Vinyl composition tile is approaching the end of its useful life.

**Comments:** Evident subgrade water intrusion in the slab on grade with staining of vinyl composition tile joints and some loose tiles.

**Description of Work:** Remove the existing vinyl composition tile and replace.

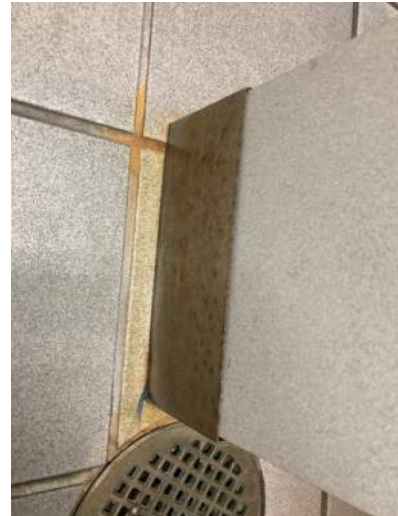
**Record ID:** 850  
**System:** C1090 - INTERIOR SPECIALTIES  
**Item No.:** C1090.25.001  
**Floor/Room:** 1st Floor / Mens RR  
**Priority:** Potential - Long Term (4-5 Years)  
**Quantity/Unit of Measure:** 1/EA  
**Total Deficiency Cost:** \$4,590  
**Deficiency Description:** Corroding on the base of partition in the mens restroom.

**Description of Work:** Replace the toilet partitions.

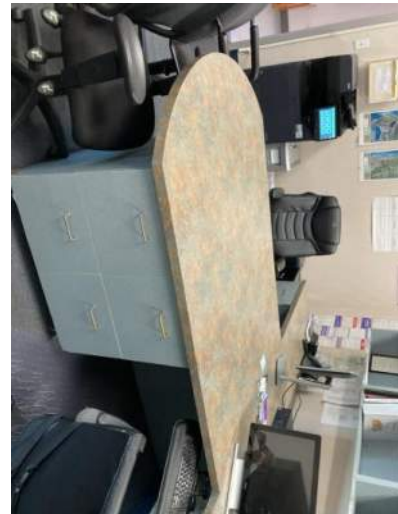
**Record ID:** 851  
**System:** E2010 - FIXED FURNISHINGS  
**Item No.:** E2010.30.001  
**Floor/Room:** 1st Floor / Office  
**Priority:** Potential - Long Term (4-5 Years)  
**Quantity/Unit of Measure:** 10/LF  
**Total Deficiency Cost:** \$1,540  
**Deficiency Description:** Plastic laminate countertops are at or are approaching the end of their useful life.

**Description of Work:** Repair or replace plastic laminate countertops.

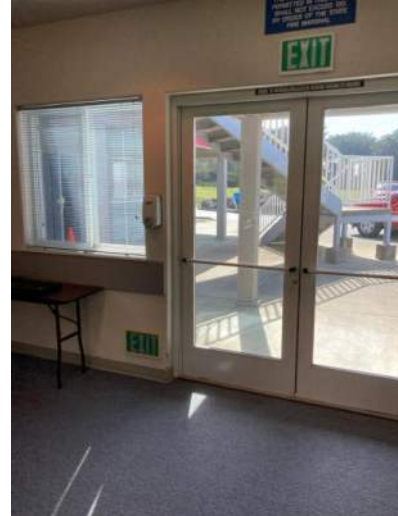
**Item No.:** C2030.90.001  
**Floor/Room:** 1st Floor / Conference  
**Priority:** Potential - Long Term (4-5 Years)  
**Quantity/Unit of Measure:** 40/LF  
**Total Deficiency Cost:** \$740  
**Deficiency Description:** 6" Vinyl wall base is approaching the end of its useful life.

**Description of Work:** Replace the vinyl wall base.

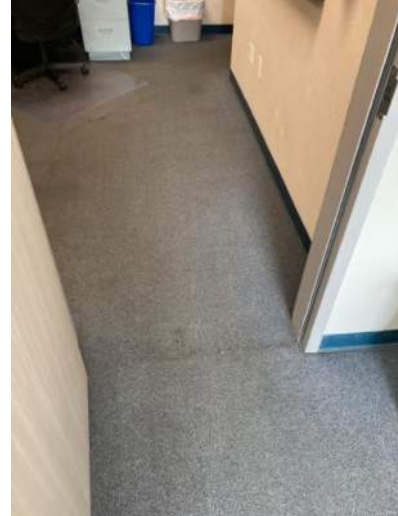
**Record ID:** 853  
**System:** C2030 - FLOORING

**Item No.:** C2030.75.001  
**Floor/Room:** 1st Floor / Chief's office  
**Priority:** Potential - Long Term (4-5 Years)  
**Quantity/Unit of Measure:** 8/SF  
**Total Deficiency Cost:** \$230  
**Deficiency Description:** Carpet tile is damaged.

**Description of Work:** Replace carpet tile.

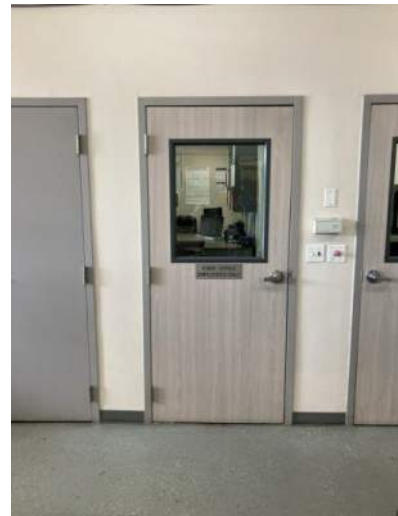
**Record ID:** 854  
**System:** C2030 - FLOORING

**Item No.:** C2030.75.003  
**Floor/Room:** 1st Floor / App bay  
**Priority:** Potential - Long Term (4-5 Years)  
**Quantity/Unit of Measure:** 3/LF  
**Total Deficiency Cost:** \$100  
**Deficiency Description:** Rubber transition strip / carpet threshold is deteriorating.

**Description of Work:** Remove and replace rubber strip.

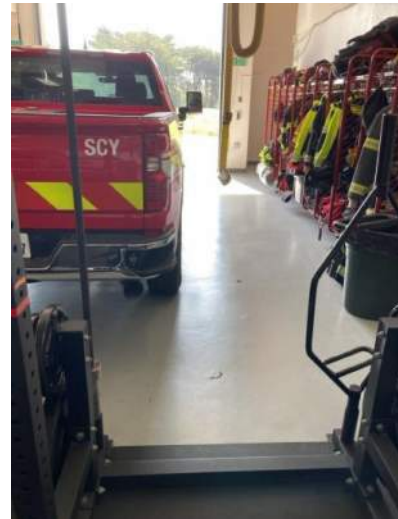
**Record ID:** 855  
**System:** C2030 - FLOORING

**Item No.:** C2030.10.002  
**Floor/Room:** 1st Floor / App bay  
**Priority:** Potential - Long Term (4-5 Years)  
**Quantity/Unit of Measure:** 400/SF  
**Total Deficiency Cost:** \$23,030  
**Deficiency Description:** *Epoxy is approaching the end of its useful life.*

**Description of Work:** *Remove the existing epoxy and replace.*

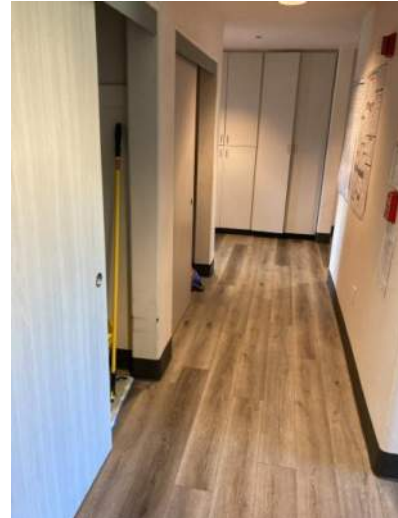
**Record ID:** 860  
**System:** C2010 - WALL FINISHES

**Item No.:** C2010.70.001  
**Floor/Room:** 2nd Floor / Living quarters hallway closet  
**Priority:** Potential - Long Term (4-5 Years)  
**Quantity/Unit of Measure:** 10/SF  
**Total Deficiency Cost:** \$230  
**Deficiency Description:** *Painted gypsum wallboard is showing signs of wear.*

**Description of Work:** *Patch and paint the gypsum wallboard.*

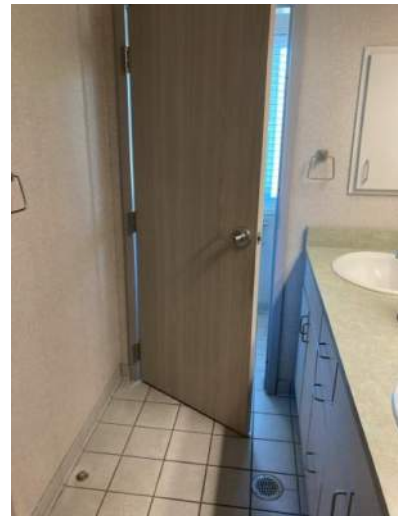
**Record ID:** 861  
**System:** C1030 - INTERIOR DOORS

**Item No.:** C1030.10.008  
**Floor/Room:** 2nd Floor / -  
**Priority:** Potential - Long Term (4-5 Years)  
**Quantity/Unit of Measure:** 3/EA  
**Total Deficiency Cost:** \$3,450  
**Deficiency Description:** *Interior wood door is in visual need of refurbishment.*

**Description of Work:** *Refurbish and restain the wood door.*

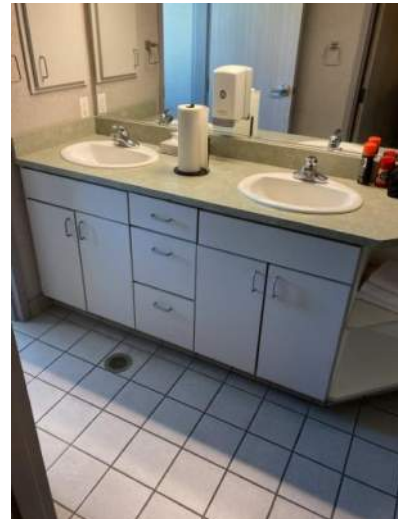
**Record ID:** 862  
**System:** E2010 - FIXED FURNISHINGS

**Item No.:** E2010.30.001  
**Floor/Room:** 2nd Floor / Living quarter restroom  
**Priority:** Potential - Long Term (4-5 Years)  
**Quantity/Unit of Measure:** 6/LF  
**Total Deficiency Cost:** \$910  
**Deficiency Description:** *Plastic laminate countertops are at or are approaching the end of their useful life.*

**Description of Work:** *Repair or replace plastic laminate countertops.*

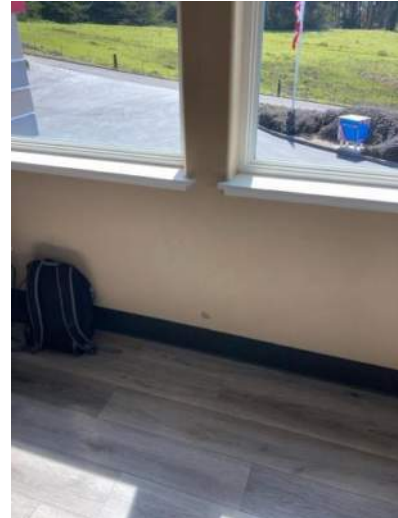
**Record ID:** 865  
**System:** C2010 - WALL FINISHES

**Item No.:** C2010.70.T05  
**Floor/Room:** 2nd Floor / Day room  
**Priority:** Potential - Long Term (4-5 Years)  
**Quantity/Unit of Measure:** 50/SF  
**Total Deficiency Cost:** \$1,370  
**Deficiency Description:** *Wall paint is showing signs of wear.*

**Description of Work:** *Repaint walls.*

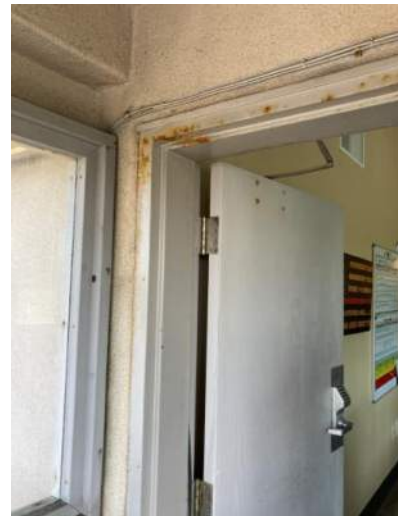
**Record ID:** 866  
**System:** B2050 - EXTERIOR DOORS AND GRILLES

**Item No.:** B2050.10.006  
**Floor/Room:** 2nd Floor / Balcony  
**Priority:** Potential - Long Term (4-5 Years)  
**Quantity/Unit of Measure:** 1/EA  
**Total Deficiency Cost:** \$8,410  
**Deficiency Description:** *Exterior steel entrance door, frame and hardware is approaching the end of its useful life.*

**Description of Work:** *Replace steel door, frame, and hardware.*

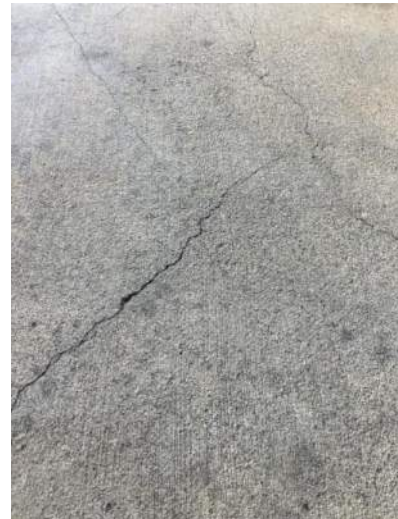
**Record ID:** 867  
**System:** A4010 - STANDARD SLABS-ON-GRADE

**Item No.:** A4010.10.001  
**Floor/Room:** 2nd Floor / Balcony  
**Priority:** Potential - Long Term (4-5 Years)  
**Quantity/Unit of Measure:** 10/LF  
**Total Deficiency Cost:** \$270  
**Deficiency Description:** Excessive cracks were detected in concrete patio deck.

**Description of Work:** Fill the patio deck cracks with sealant.

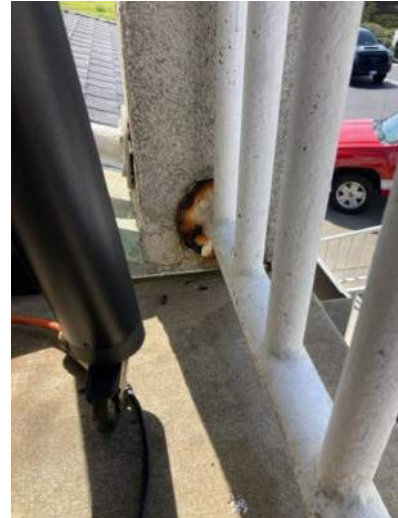
**Record ID:** 868  
**System:** B2080 - EXTERIOR WALL APPURTENANCES

**Item No.:** B2080.50.004  
**Floor/Room:** 2nd Floor / Balcony  
**Priority:** Crucial (1-2 Years)  
**Quantity/Unit of Measure:** 15/LF  
**Total Deficiency Cost:** \$6,360  
**Deficiency Description:** Guardrail is showing signs of corrosion.

**Description of Work:** Repair/replace handrails/guardrails.
